ARM Group LLC

July 15, 2020

Re: Comment Response Letter:
Response and Development Completion
Report - Area B: Parcel B15, Revision 0
Tradepoint Atlantic
Sparrows Point, MD 21219

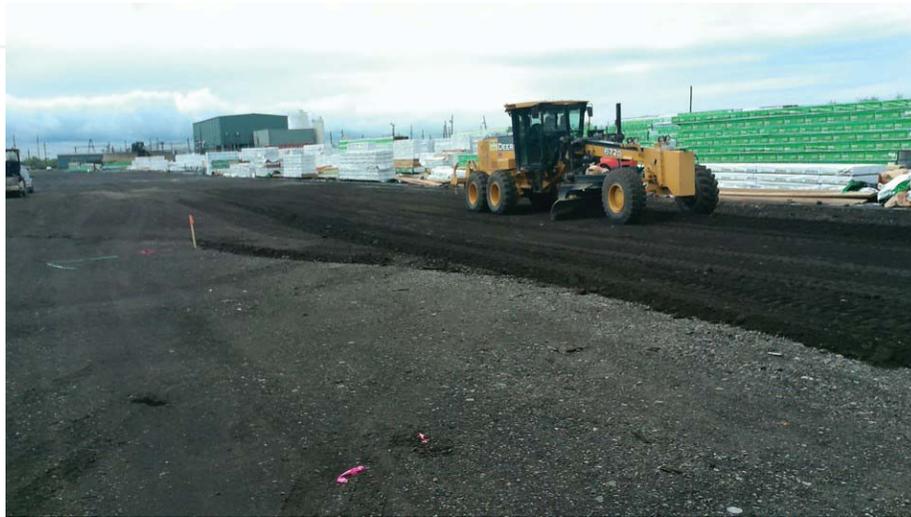
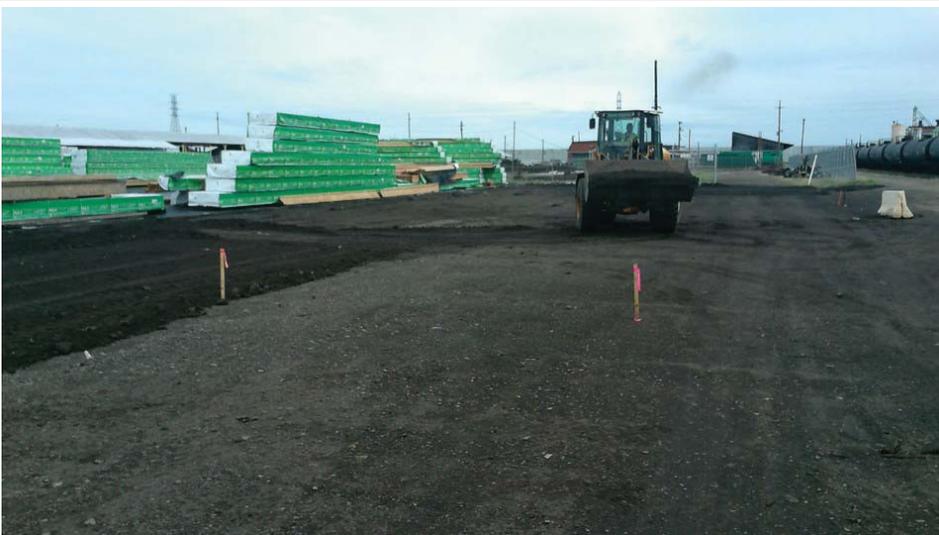
Date: 4 / 17 / 17
Photo Page No. 1

Gray & Son worked grading (cutting to 0 elevation for paving) the sub-grade for the future parking and lumber storage south of the existing lot. The subgrade was observed as construction equipment was driven on it and it generally appeared stable. Dust level testing was performed around the construction activity using a TSI DustTrak II testing devise. Test results generally met project requirements. Gray & Son used a water truck to control the dust and it rained lightly several times during the day.

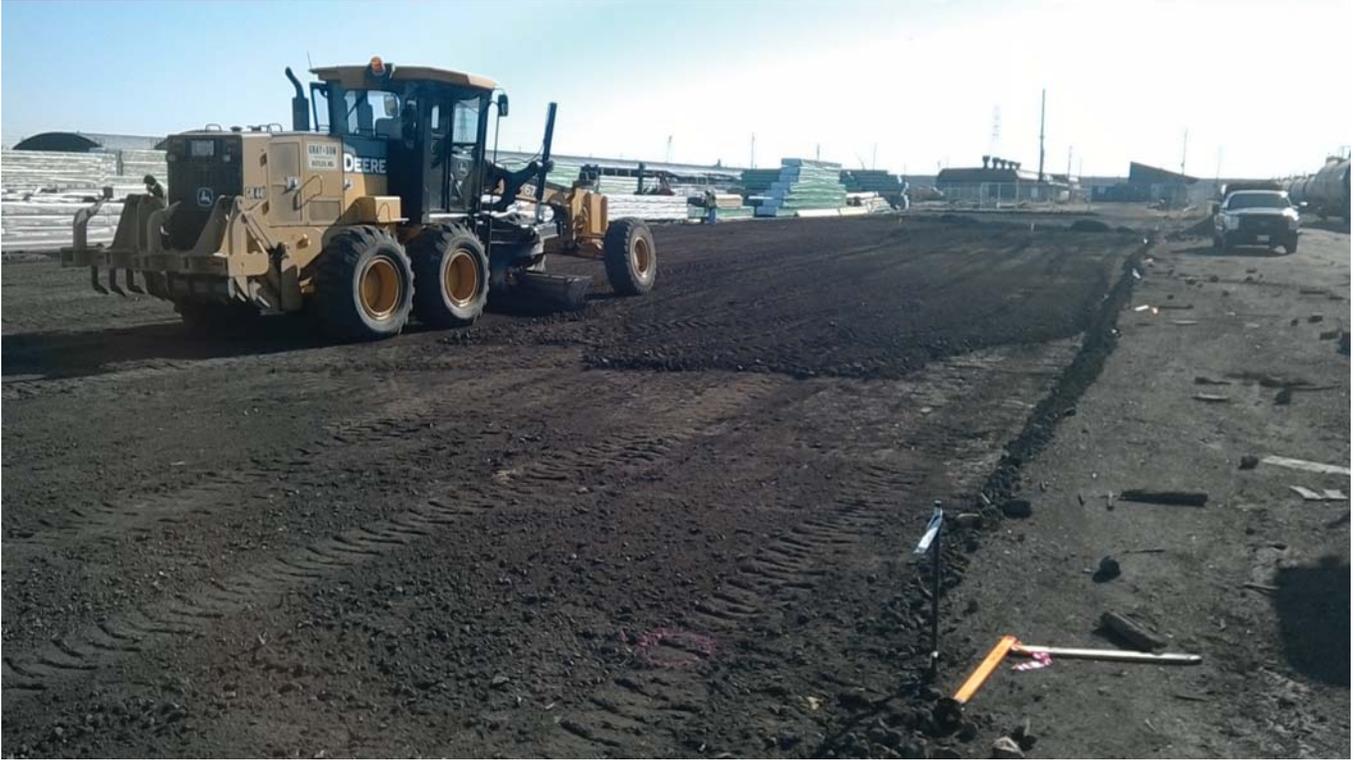
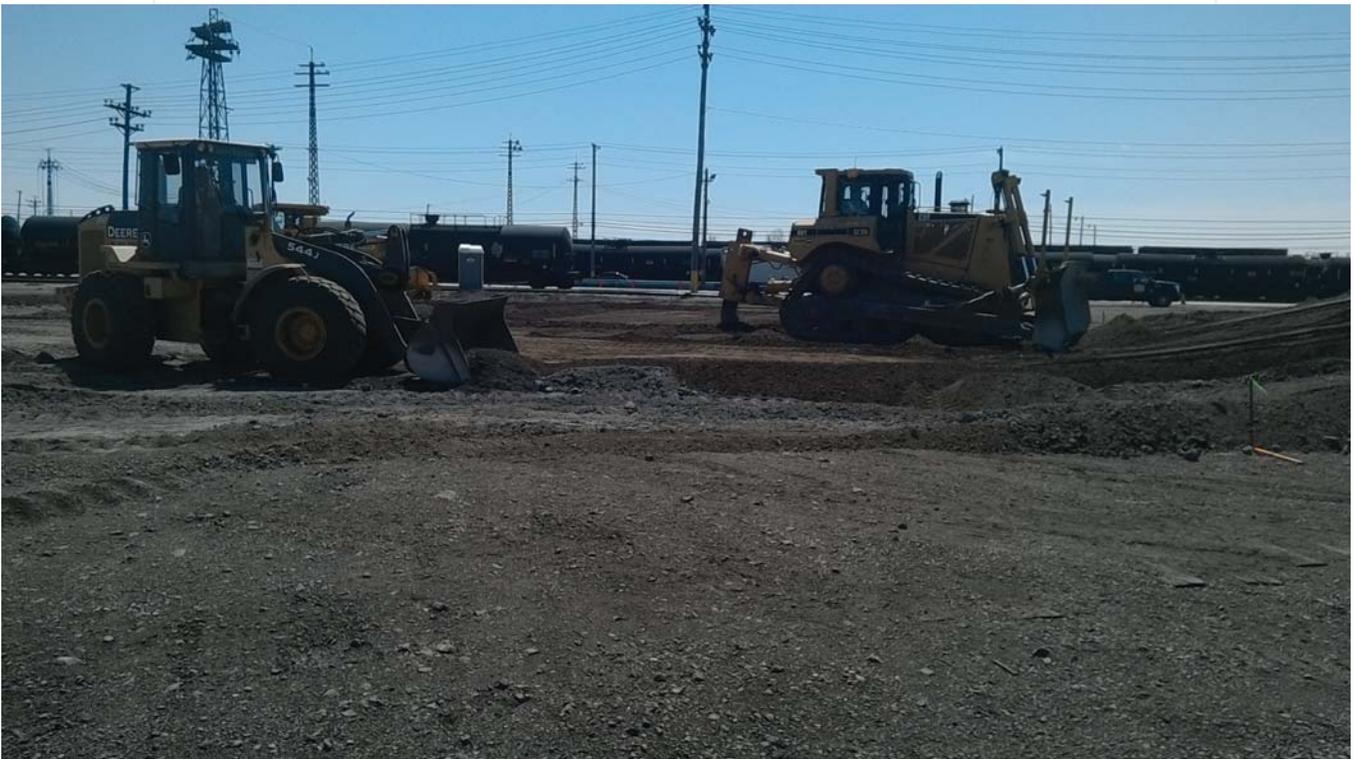
Date: 04 / 18 / 2017
Photo Page No. 1

Gray & Son, foreman, Gary and crew, fine grade the Eastern end of the roadway sub grade. From hub locations 18008 & 18046 to 18084 & 18035. The cut/fill area ranged from C-3.0" to F-.47" in an area approx. 300'x65'. Once the long stretch of area West to East had been fine graded and ready for blacktop. Gray & Son moved to the South West corner of site to continue fine grading. They found that they needed to cut approx. 8" from corner hub 18069 and more as they head North to hub 18071 at approx. 12" cut. They utilized Cat D8T dozer and Deere 672D grader to cut hardened slag from area.

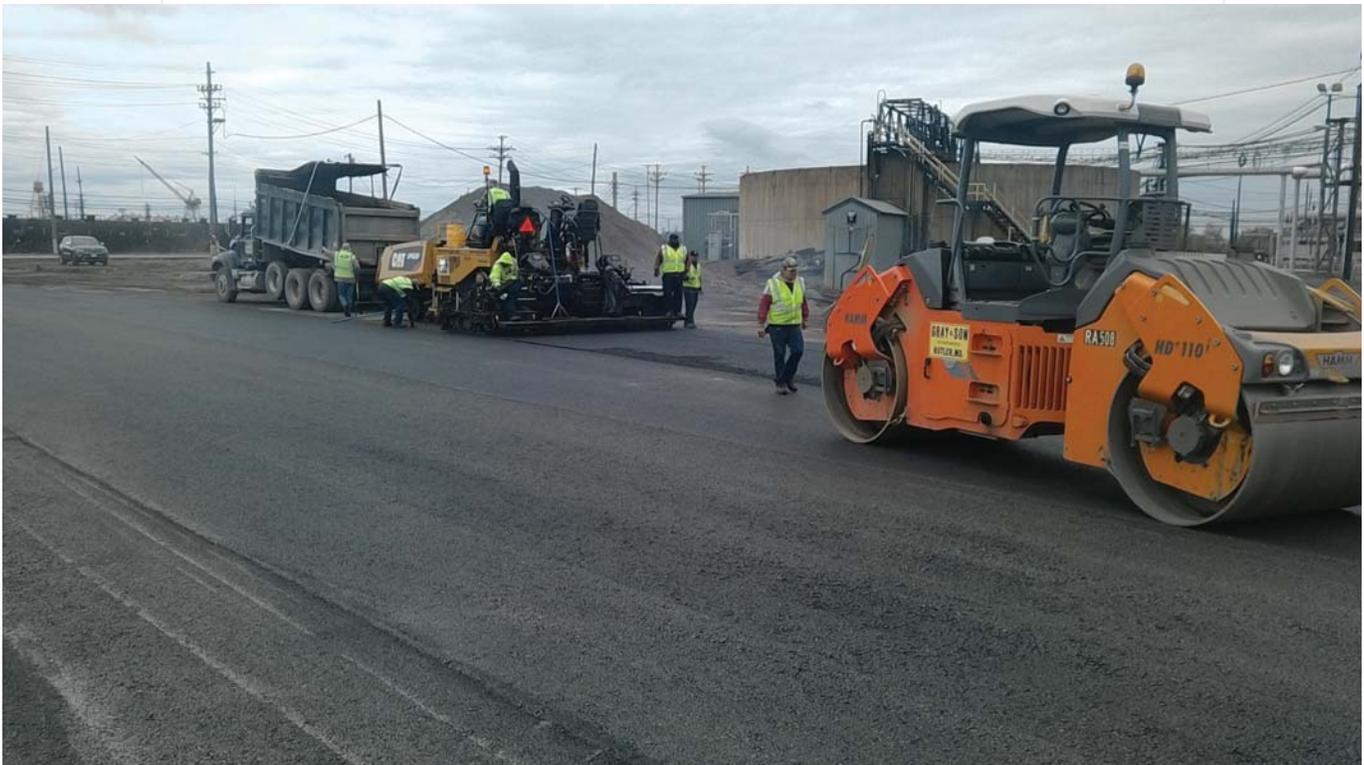
Photo taken from North edge of West lot, facing South
