May 29, 2019

Re: Lead Based Paint Survey Report
Former Lumber Shed
Area B: Parcel B23
Tradepoint Atlantic
Sparrows Point, MD 21219

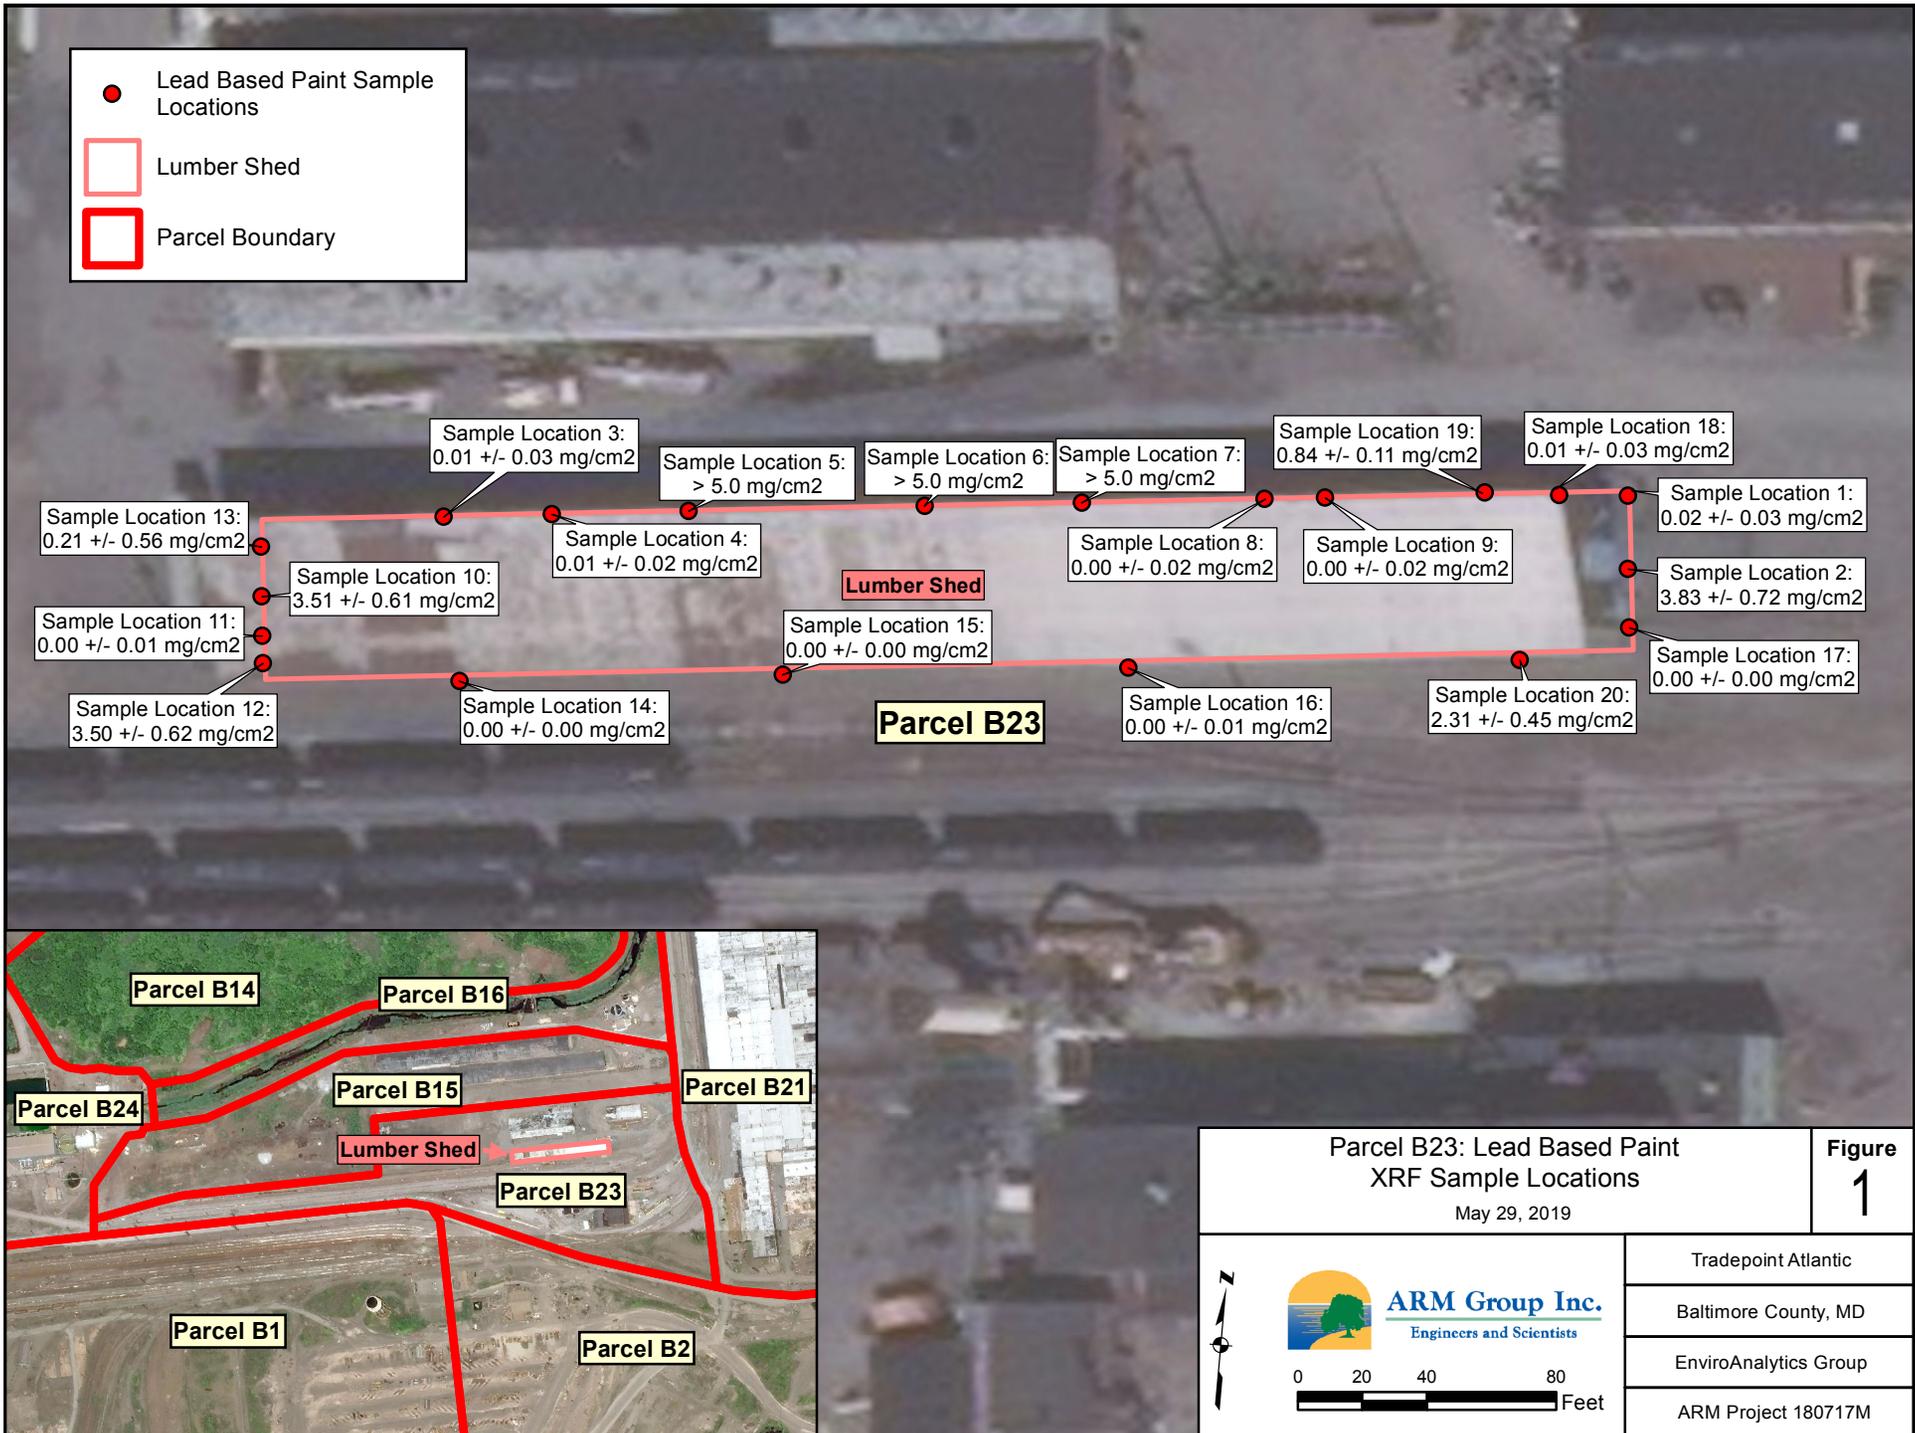
A photographic log has been provided as **Attachment 1** and shows the variety of paint samples analyzed for LBP using the XRF. A summary of sampling locations and XRF results can be found in **Table 1** (attached). For samples with very high lead concentrations, a measurement of $>5.0 \text{ mg/cm}^2$ was reported from the XRF; indicating that the material was classified as a LBP but the concentration of lead was above the instrument's upper limit of quantification. An aerial view of the former Lumber Shed that identifies the approximate locations of each LBP sample has been provided as **Figure 1** (attached).
