# **Maryland Department of Environment**

Inspector:	Ronald Wicks
AI ID:	3076
Site Name:	Patapsco WWTP
Facility Address:	3501 Asiatic Ave, Curtis Bay, MD 21226
County:	Baltimore City County
Start Date/Time:	January 30, 2023, 08:45 AM
End Date /Time:	February 23, 2023, 11:06 PM
Complaint Number: Media Type(s):	NPDES Municipal Major Surface Water
Contact(s): Neal Jackson Eric Johnson Andrea Buie Wendy Huang MDE

# **NPDES Municipal Major Surface Water**

Today, on January 30, 2023, I conducted a compliance evaluation inspection at the Patapsco WWTP, NPDES Discharge Permit number MD0021601 and State number 15-DP-0580.

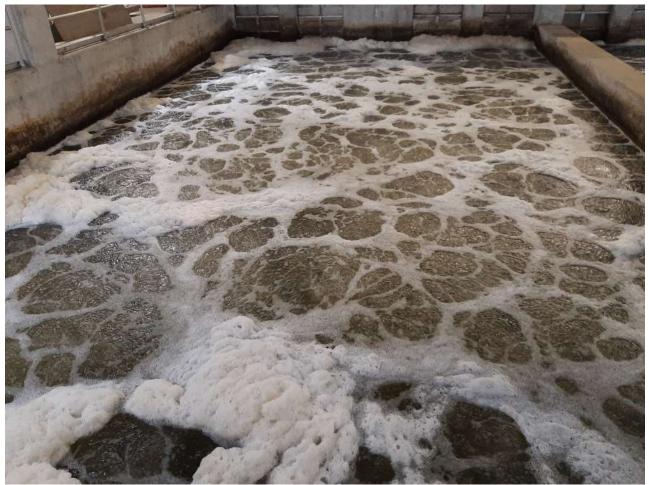
The Patapsco WWTP has been working with VWT to resolve the problem. I was informed that there is no longer a problem with the leakage of media and all media being discharged are from the residual in the backwash mud wells. During an inspection of the BAF mud well where the backwash is discharged before going into clarifier #3, I observed that the amount of media has declined by and the entire surface of the water in the mud well is no longer covered with a heavy layer of media. The Patapsco WWTP submitted on 1/5/23 an SOP informing the Department how

the media would be removed. The Patapsco WWTP must continue to clean the mud wells in order to prevent further discharges of media and prevent issues with media clogging pumps and other sensitive treatment works equipment.

1/30/23 BAF cell in operation

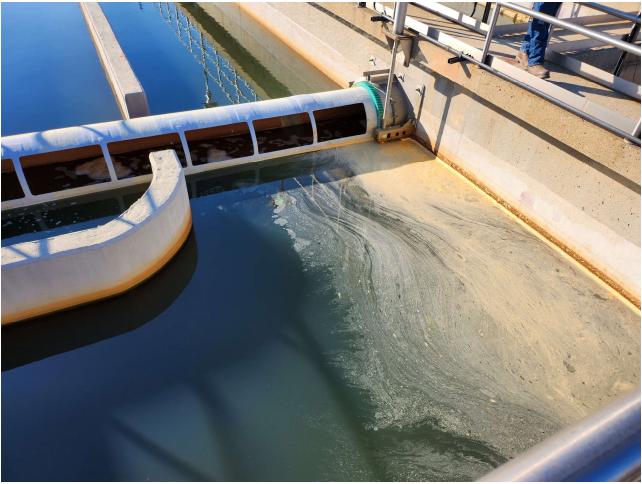
Next, I inspected the chlorine contact basins prior to the final discharge. There are 4 contact chambers and all 4 are currently online. Each contact chamber has 3 scum logs or troughs to remove floating scum. During this inspection none of the scum logs were being used to collect FOG although there was evidence of scum in the contact chambers. Currently there was no manual skimming being done at the chlorine contact basins. There was scum and solids observed in the chlorine contact basins.

1/30/23 Chlorine contact basin

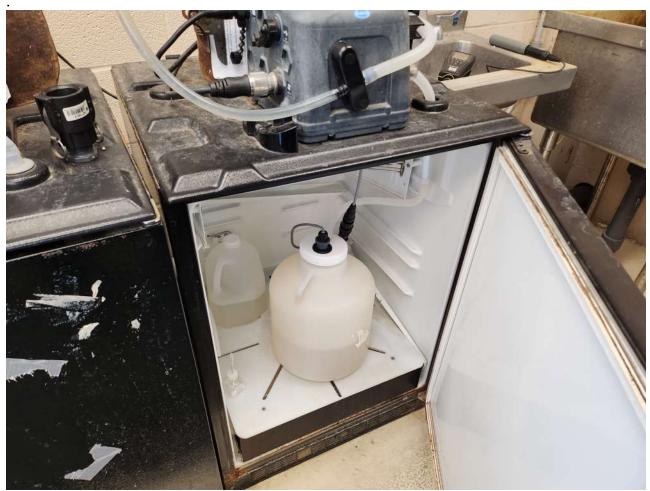
The facility is collecting a 24-hr, flow-proportioned composite samples at Outfall 001 in accordance with the requirements of the permit. The primary refrigerated, automatic composite sampler was inspected, and I found that the temperature of the compartment was satisfactory, and the sampling container was also clean. The temperature of the refrigerated compartment was 5 degrees C, which meets 40 CFR Part 136 requirements. I inspected the final effluent in the sampling container and observed that the composite sample was a medium amber color with suspended particulates.

Next, I inspected the quality assurance data for the routine field measurements (DO, pH, total residual chlorine (TRC) conducted at each shift at the Outfalls. The secondary standards used to verify the accuracy of the colorimeter used to monitor TRC show that the results obtained are

1/30/23 Automatic sampling equipment

outside of the acceptance limits of the standardization check kit. Either a calibration curve must be prepared for the colorimeter, or the colorimeter must be replaced with an accurate meter.
