ARM Group LLC

Re: Delineation/Characterization Work Plan:
PAH & PCB Impacted Soil
Area B: Parcel B23
Tradepoint Atlantic
Sparrows Point, Maryland 21219

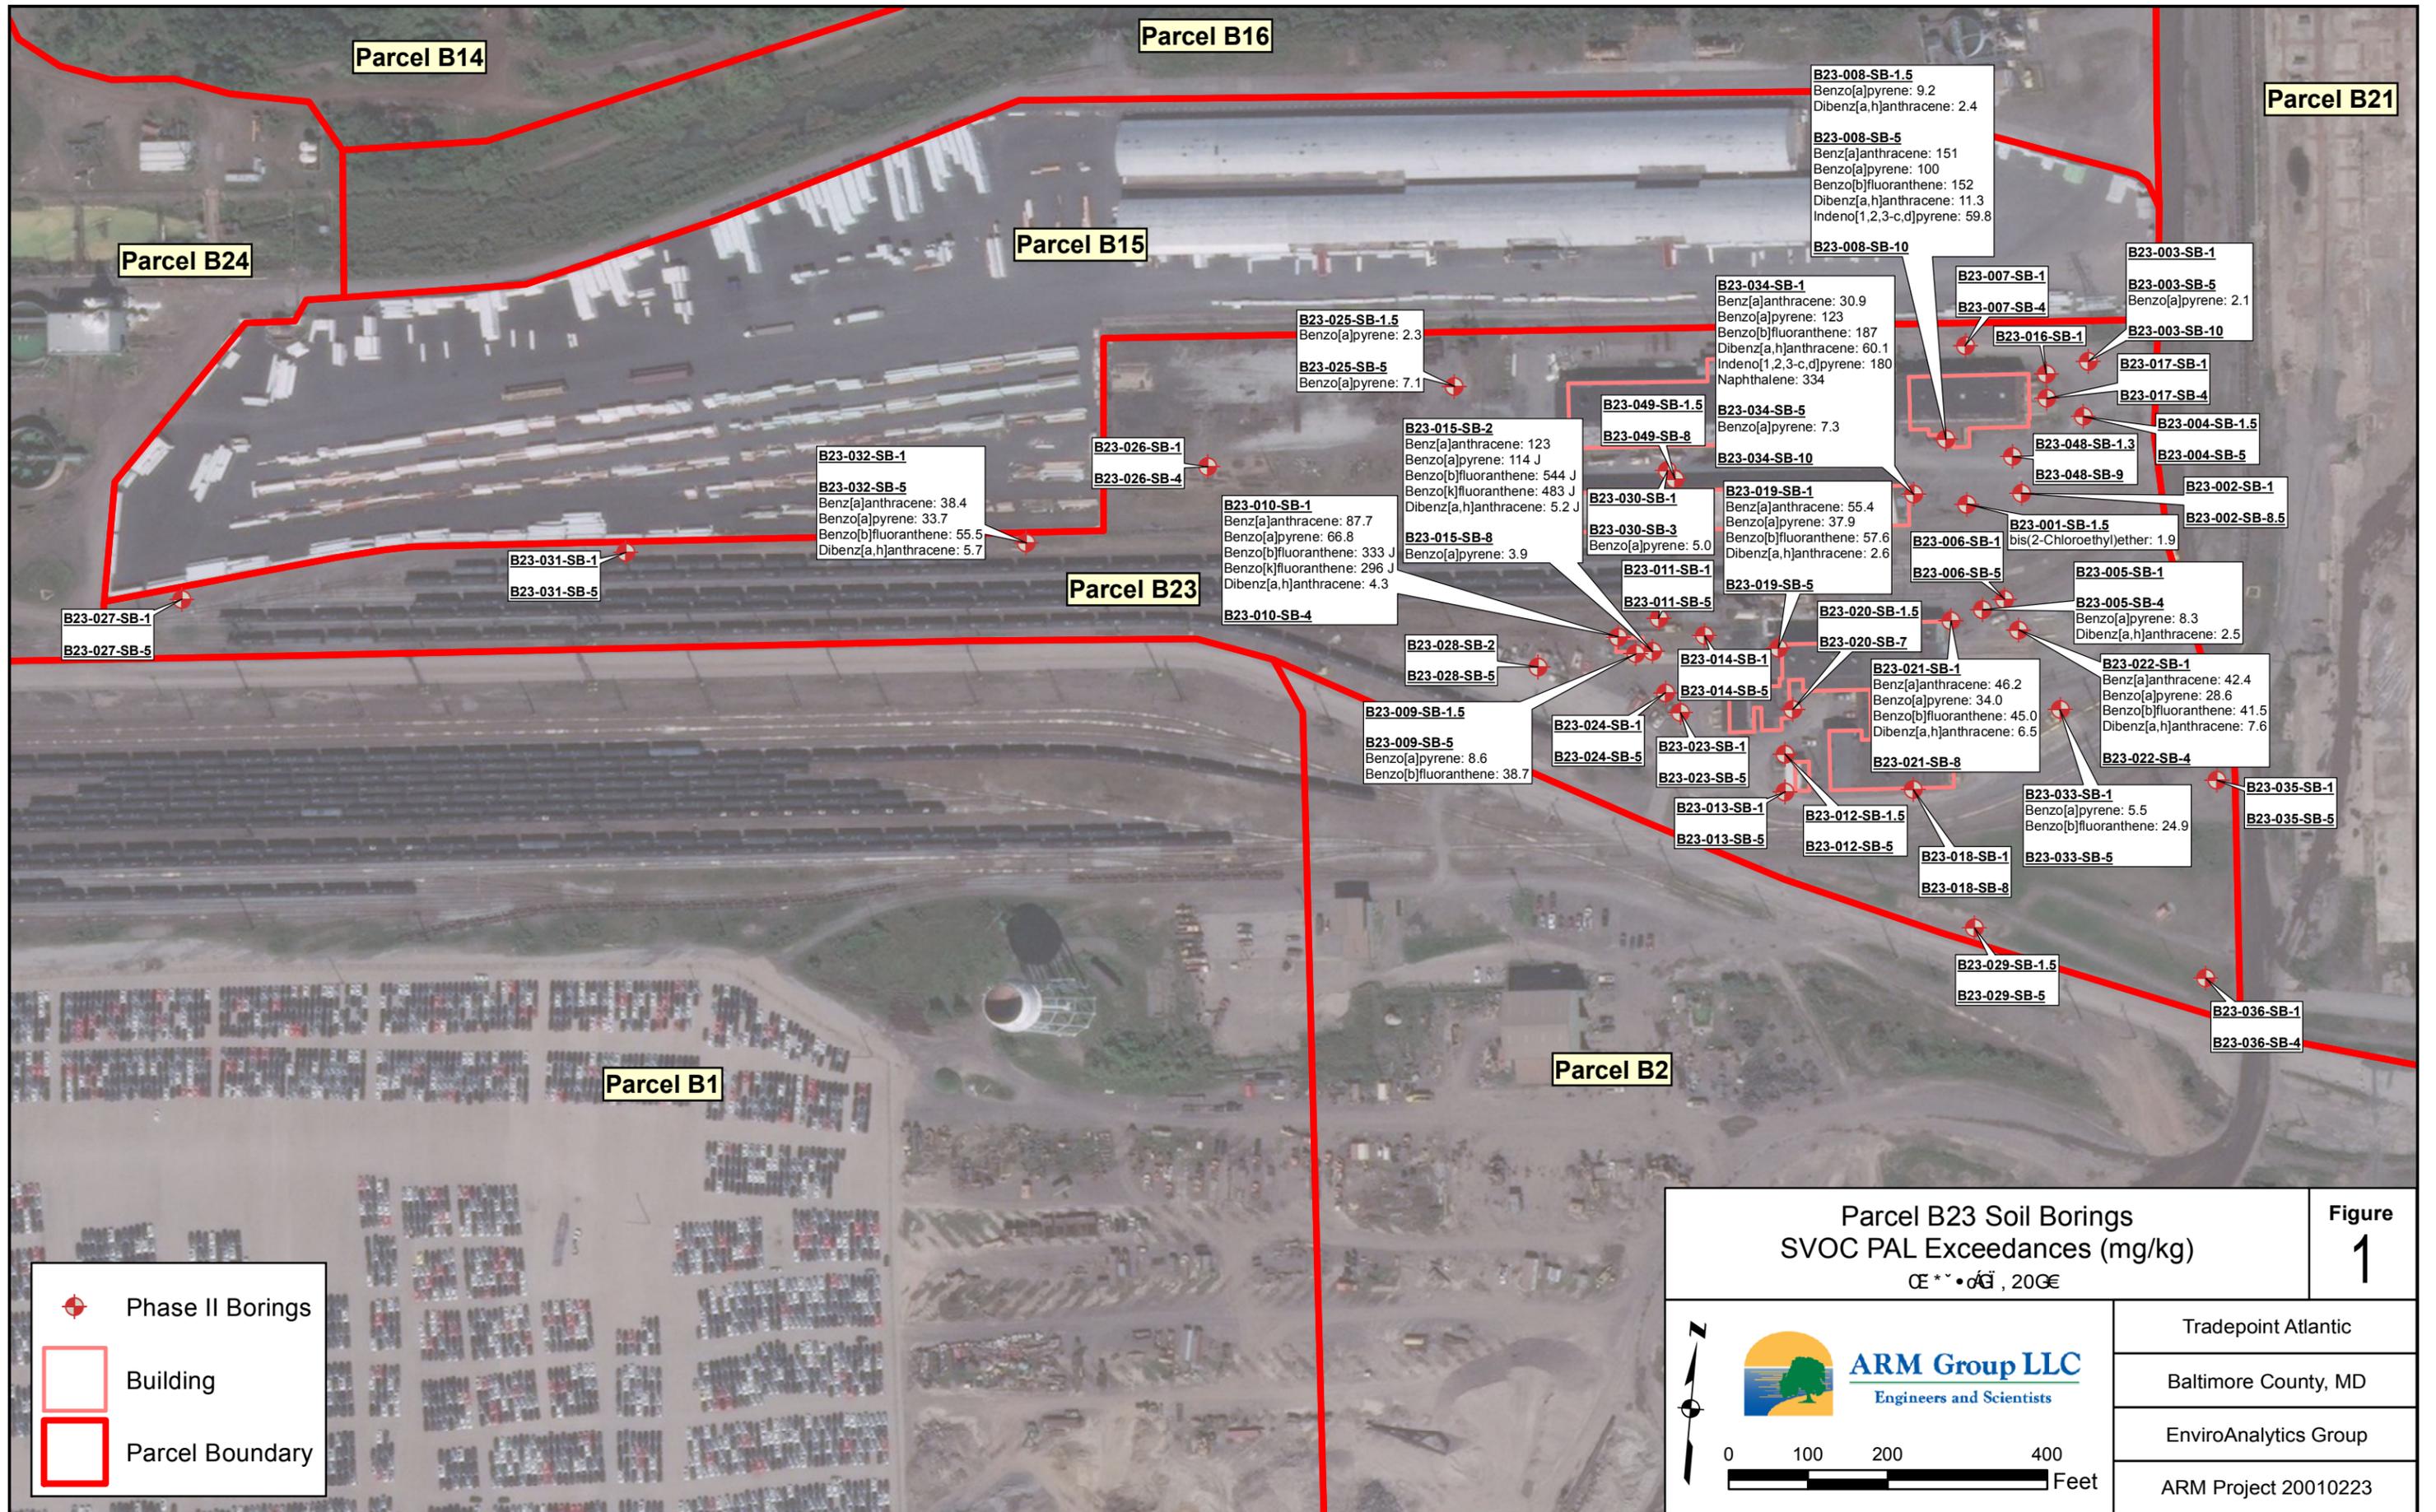
Figure 1

Parcel B23 Soil Borings SVOC PAL Exceedances (mg/kg)
 CE * 10⁻⁶ / 10³, 20CE

An initial review of the analytical results from the soil investigation identified elevated concentrations of semi-volatile organic compounds (SVOCs), in particular select polynuclear aromatic hydrocarbons (PAHs), in the shallow soil samples obtained at locations B23-010-SB, B23-015-SB, and B23-034-SB, and elevated concentrations of polychlorinated biphenyls (PCBs) in the shallow soil sample collected at location B23-016-SB. Each of these sample locations had elevated PAH or PCB concentrations above their respective Project Action Limits (PALs) in the shallow (0 to 1 foot below ground surface (bgs)) sample interval. PAL exceedances of SVOCs and PCBs observed during the Phase II Investigation are presented on **Figure 1** and **Figure 2**, respectively.

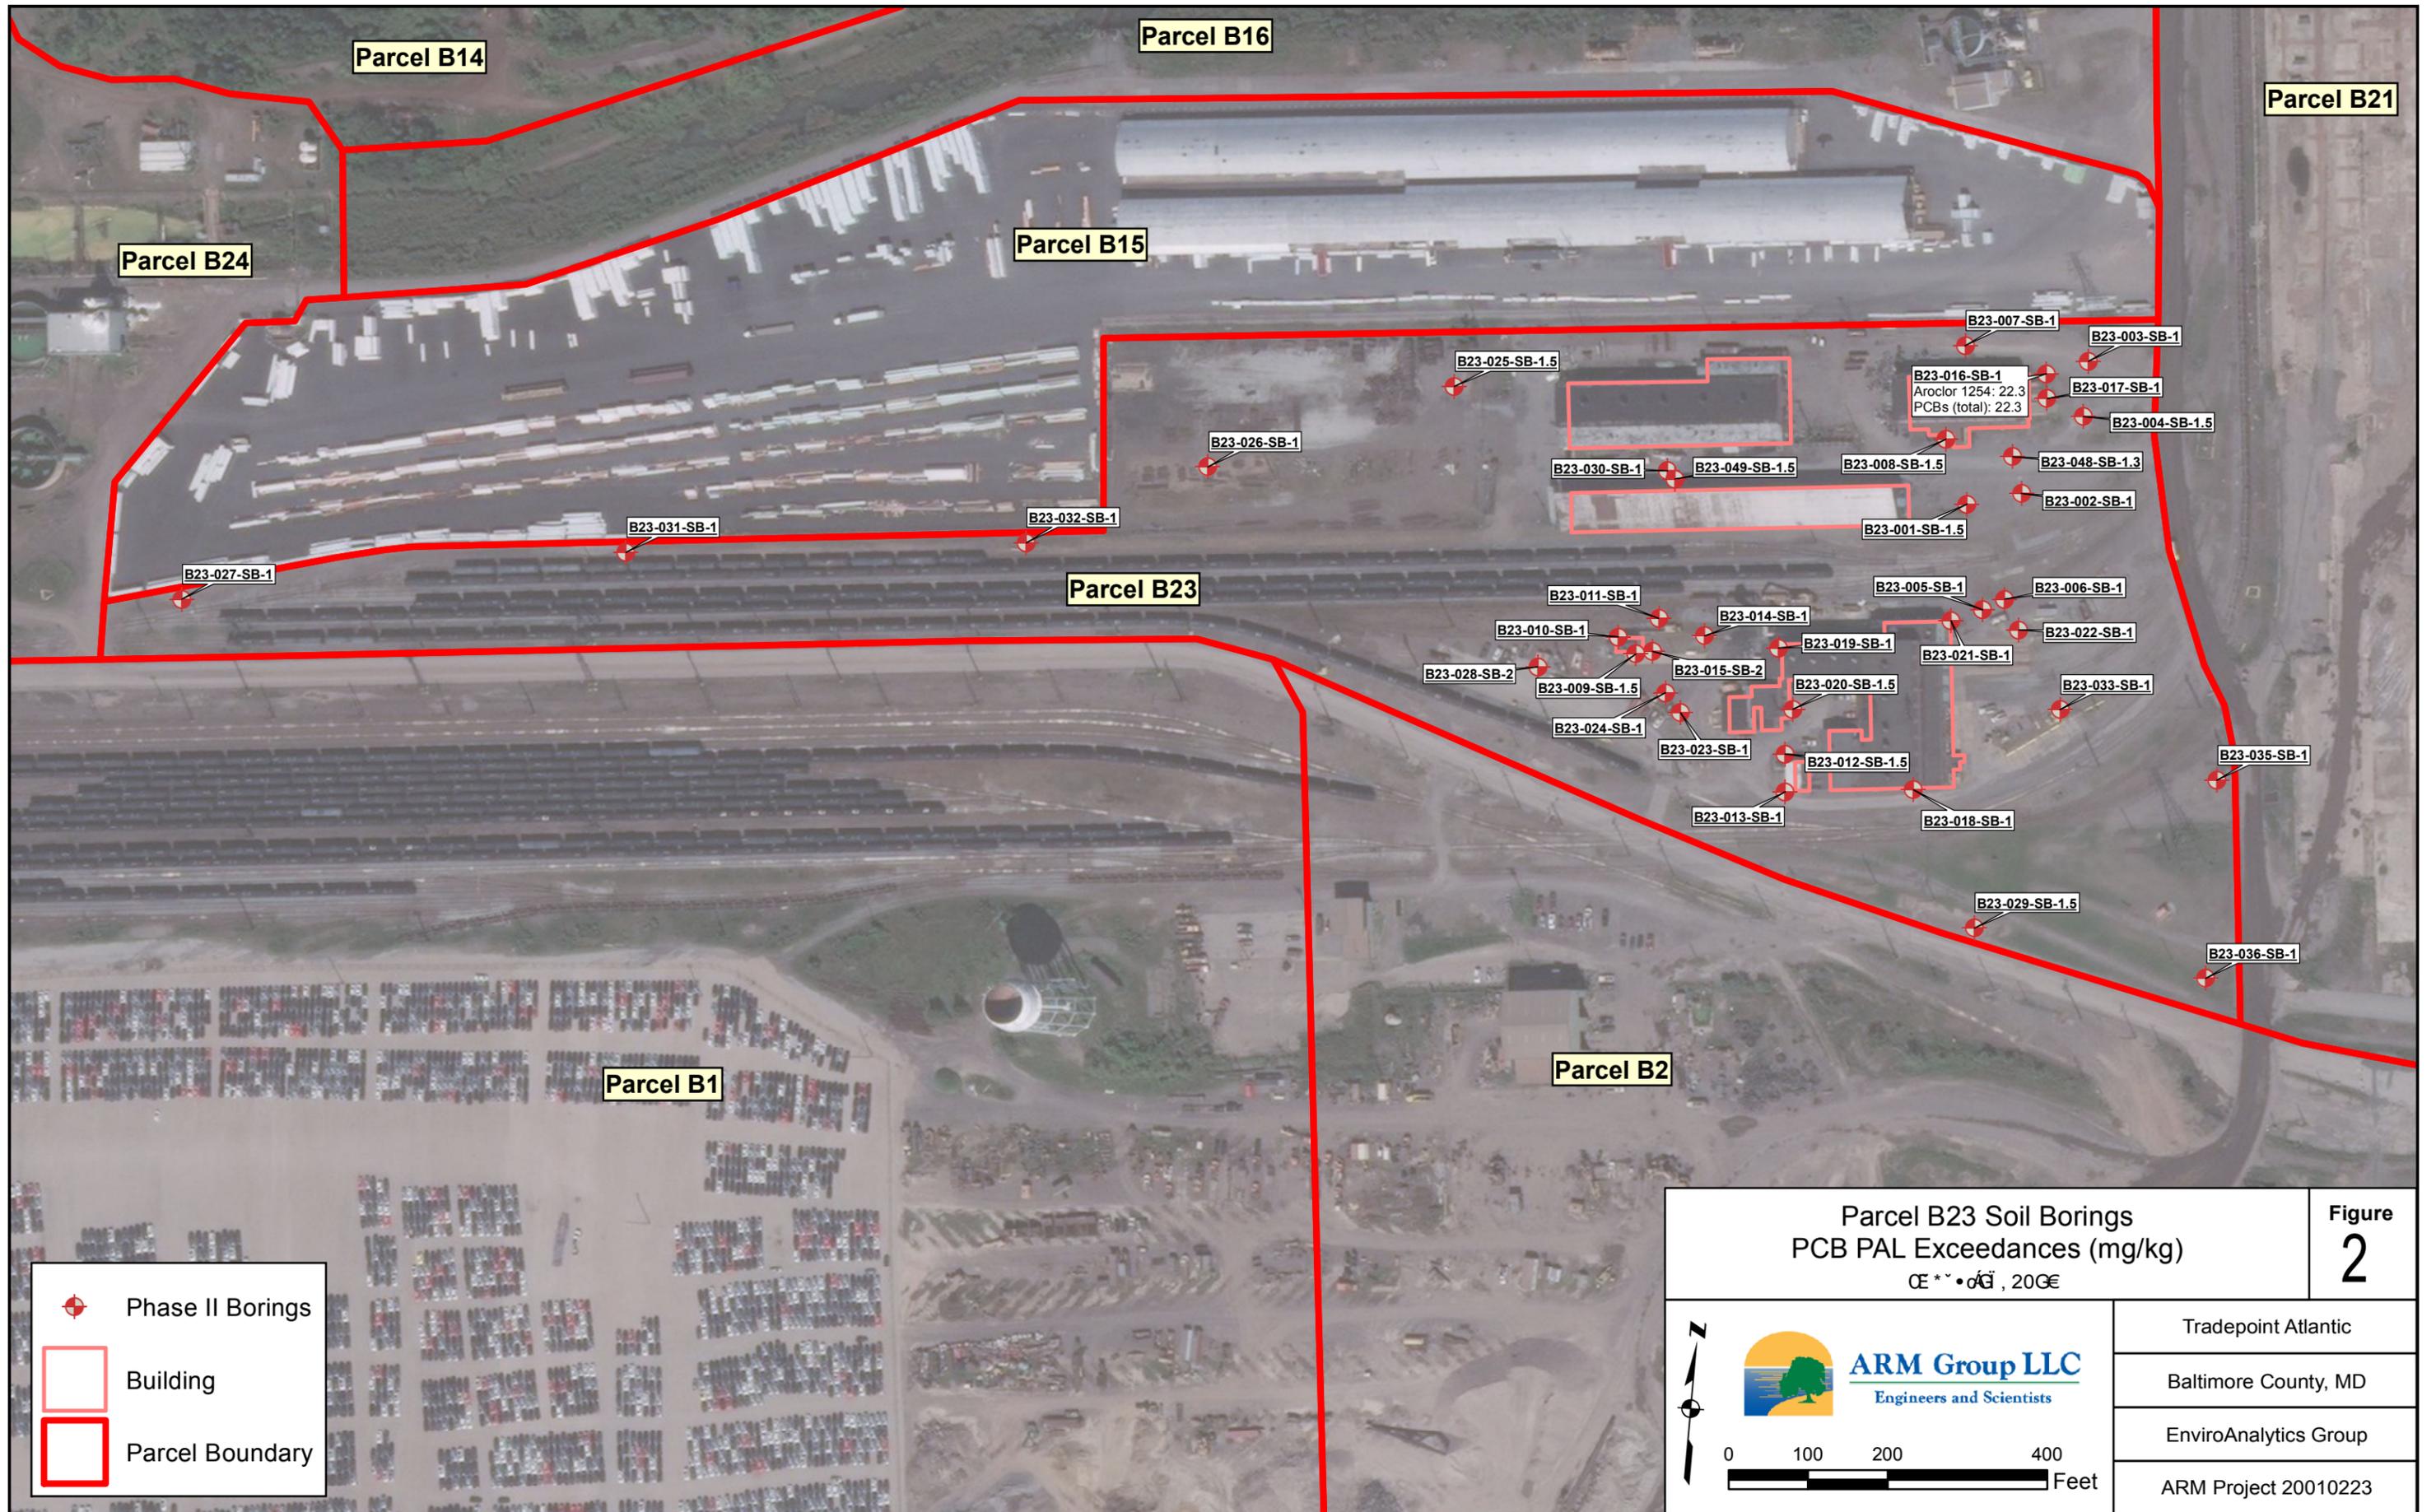
Parcel B23 Soil Borings PCB PAL Exceedances (mg/kg) <small>CE * 10⁻⁶ / 10³, 20CE</small>		Figure 2

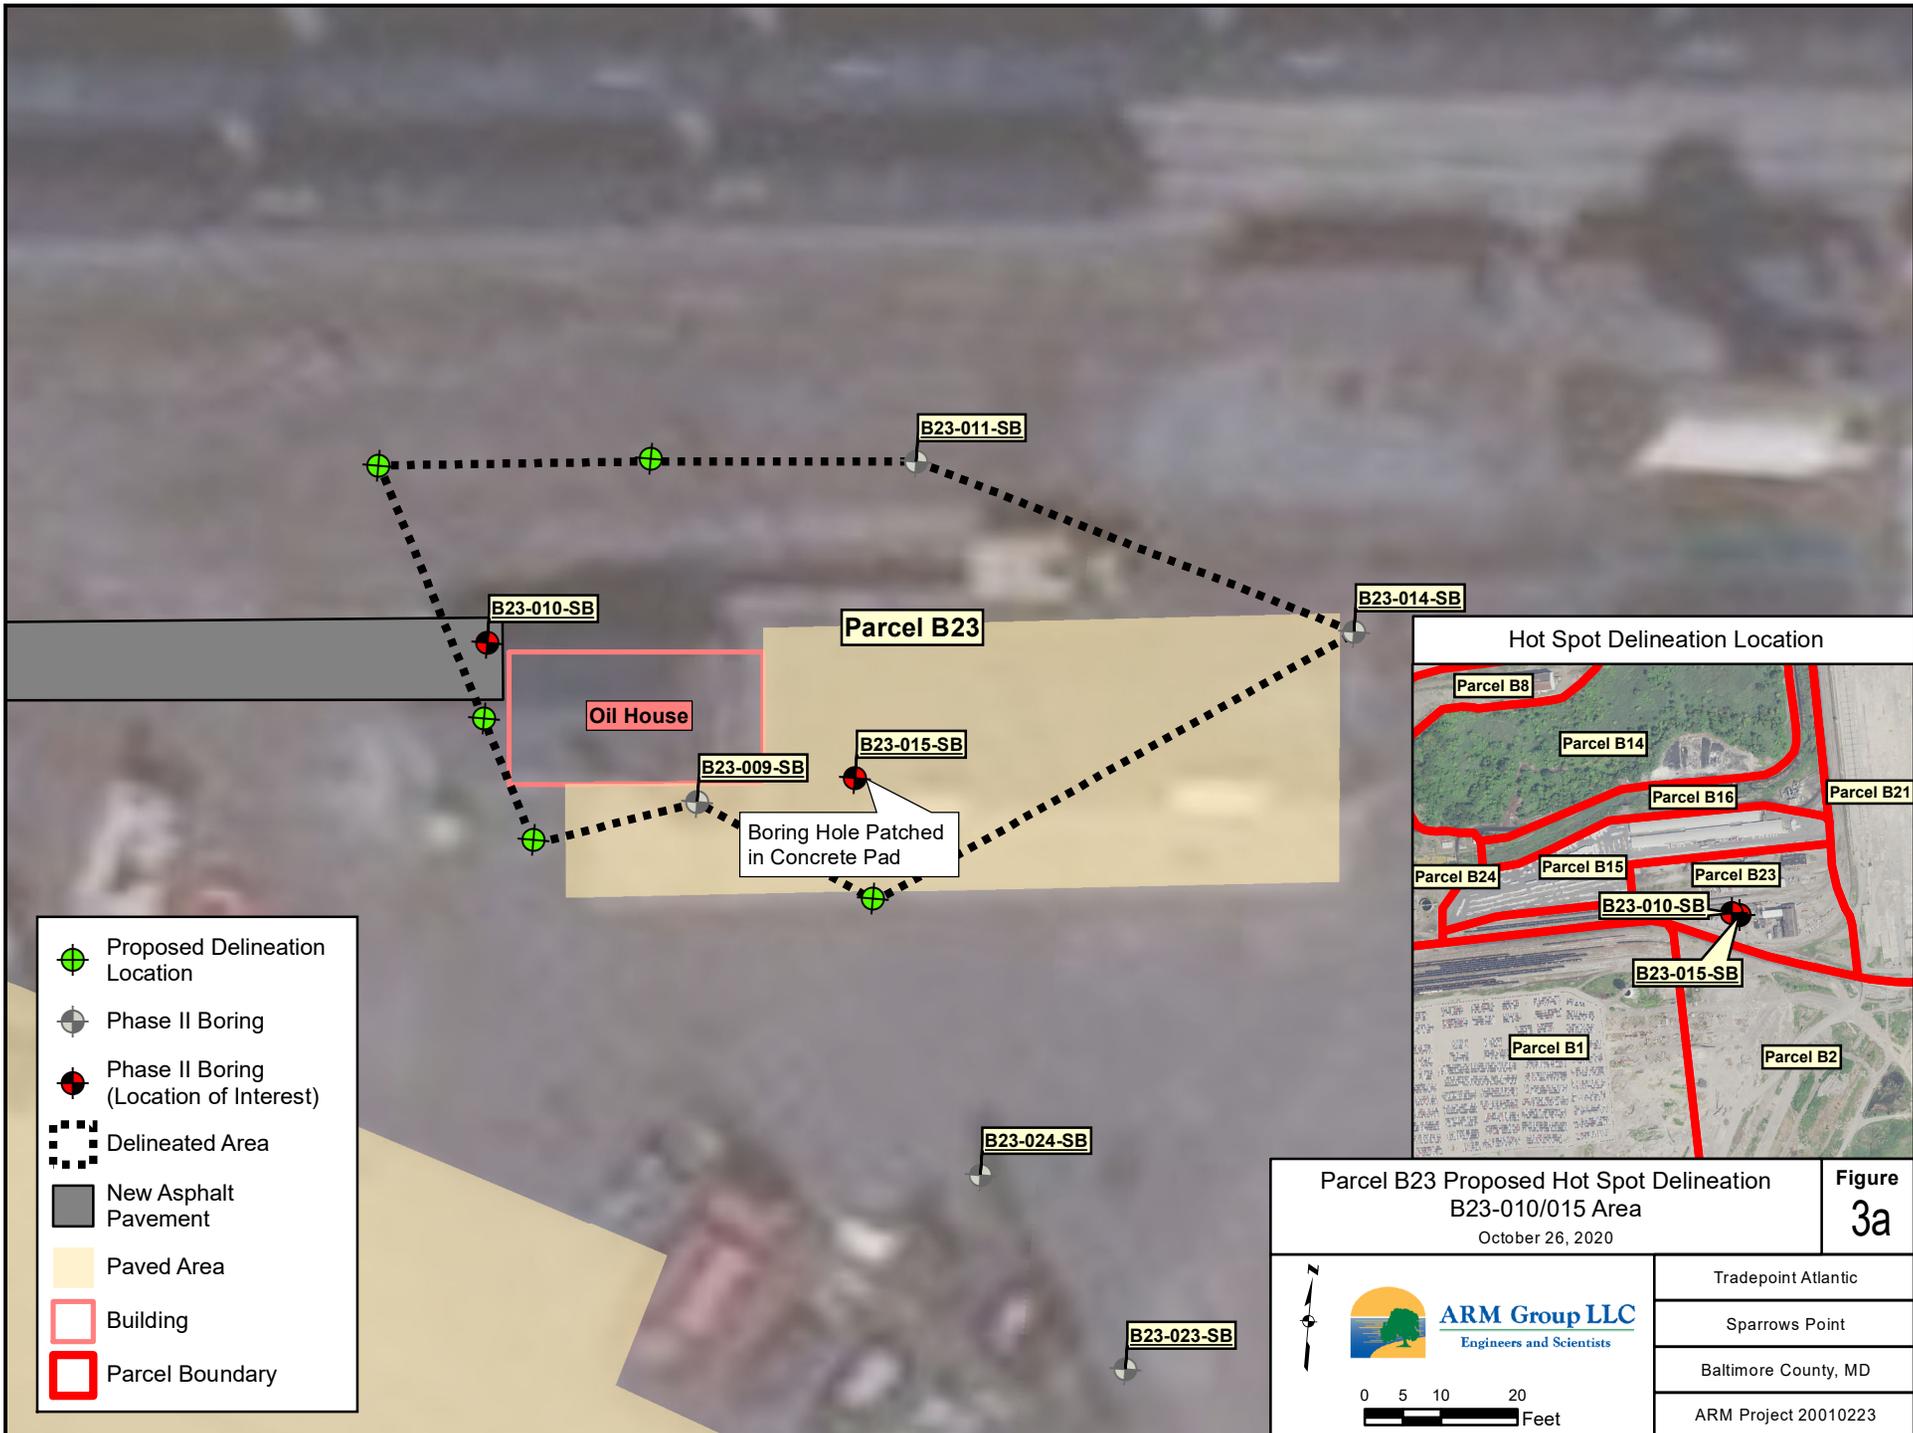
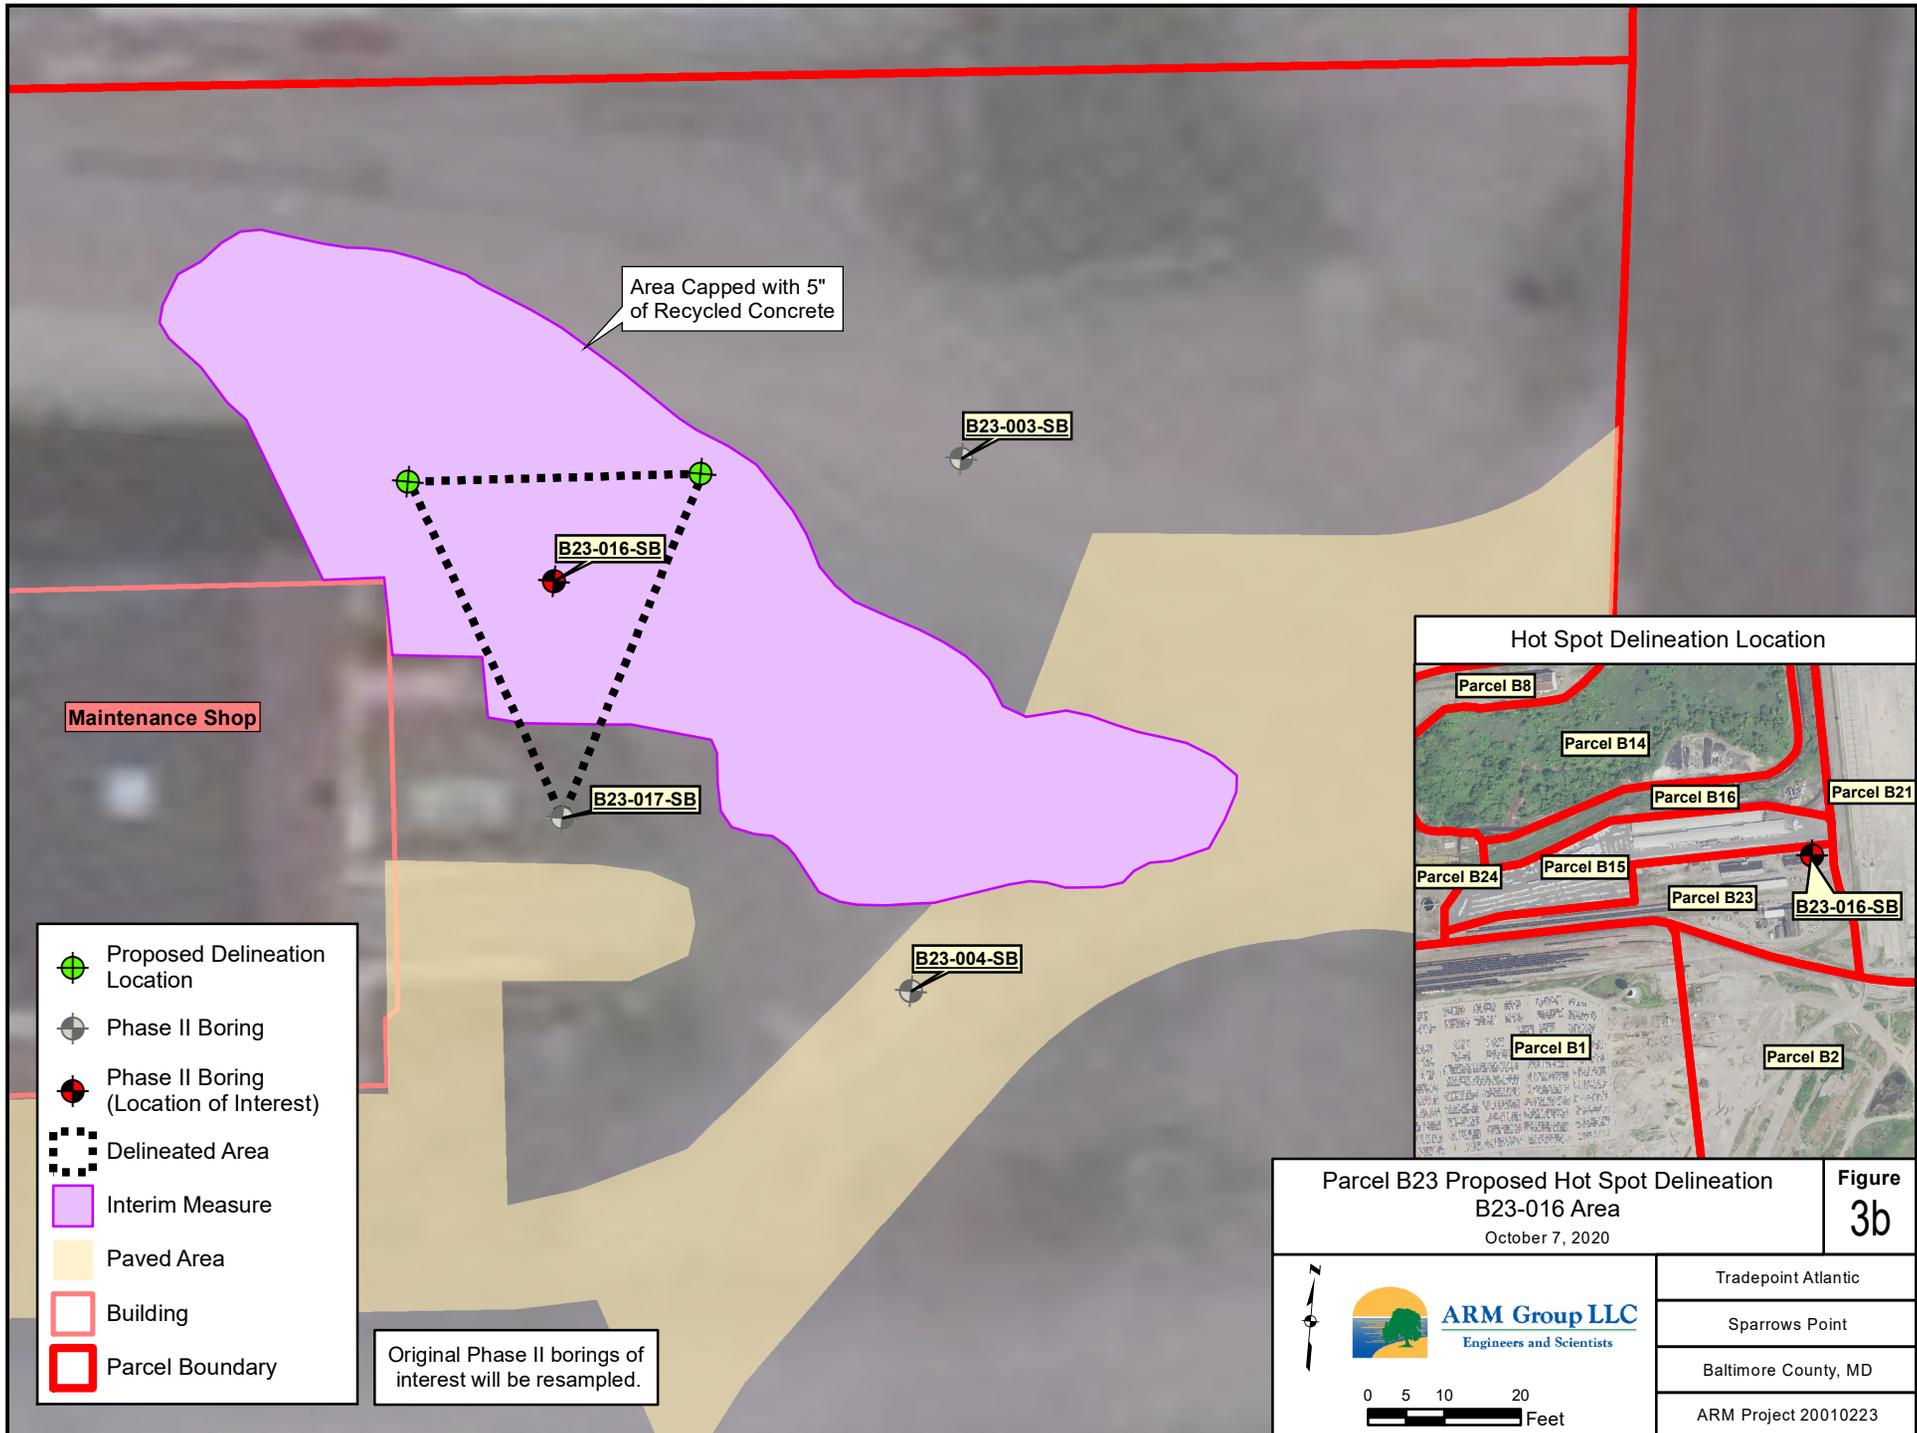
Original Phase II borings of interest will be resampled.

The proposed delineation includes five new delineation borings (and three previous Phase II borings) around the original B23-010-SB and B23-015-SB locations, two new delineation borings (and one previous Phase II boring) around the original B23-016-SB location, and three new delineation borings around the original B23-034-SB location. In addition, B23-016-SB and B23-034-SB will be resampled as noted above. The proposed delineation borings and triangulated areas are shown on **Figure 3a/3b/3c**. Due to the configuration of the existing pavements and interim remedies installed at the Site, the proposed delineation locations do not have a uniform offset from the original locations of interest. Based on the analytical results obtained from these delineation locations, the sampling grids may be modified (with additional borings added) to improve the resolution or expand the delineation grids if necessary. The analytical results will be evaluated according to the Composite Worker SLRA approach to determine whether expansion of the interim remedies or alternative response actions (such as excavation) are warranted.

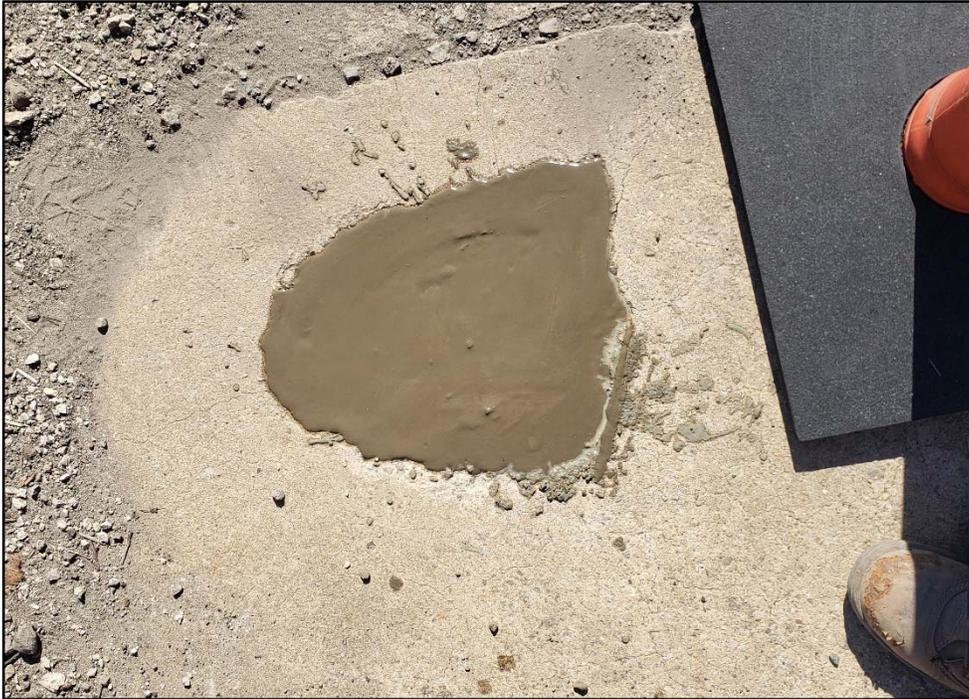
060820-1: Concrete patch installed at boring hole for B23-015-SB.

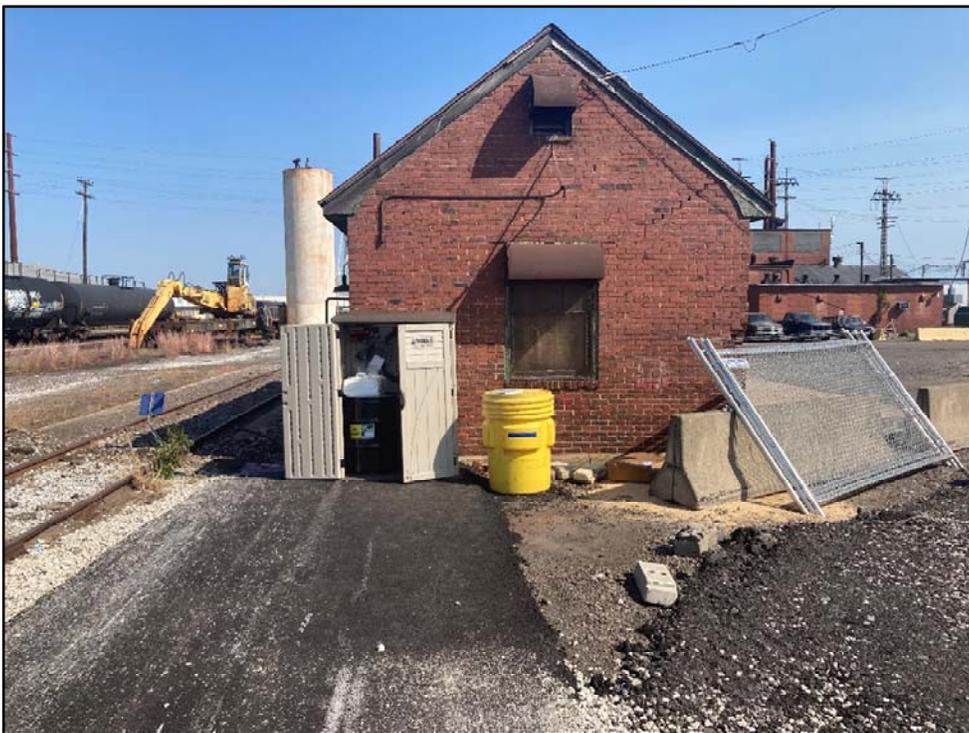
100720-1: New asphalt pavement covering boring B23-010-SB.

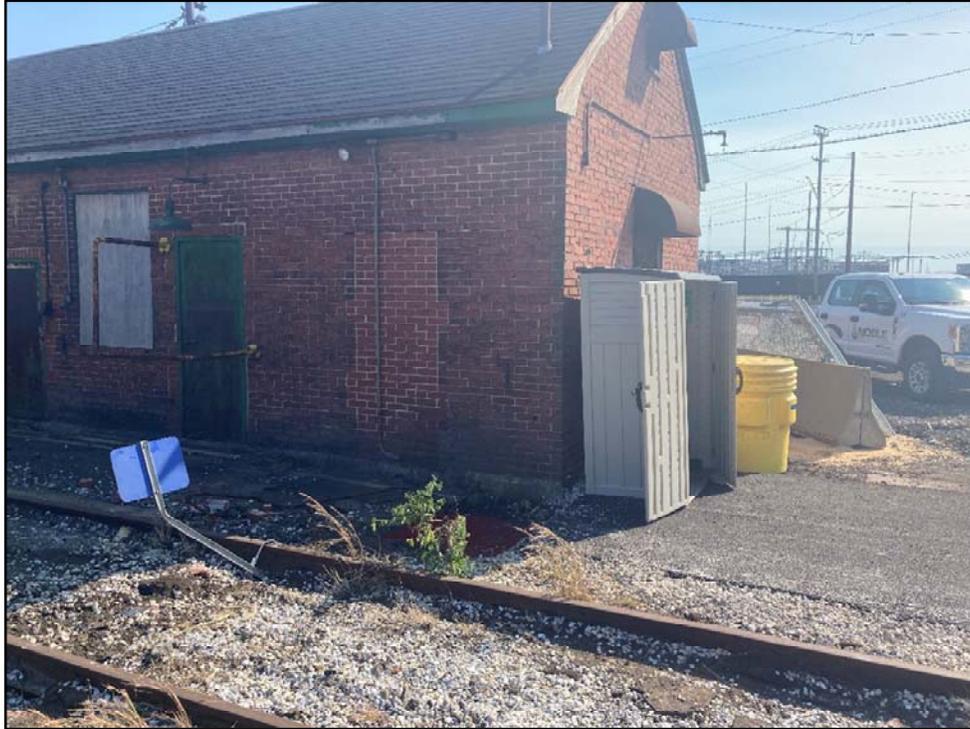
100720-2: New asphalt pavement covering boring B23-010-SB.

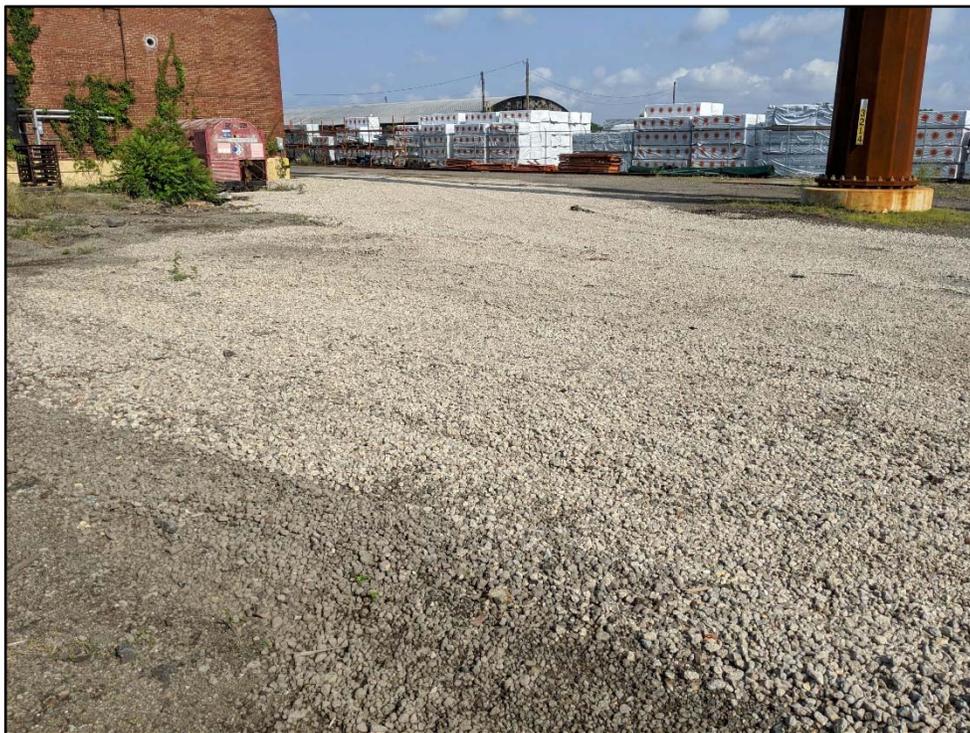
070820-1: Crushed recycled concrete temporary cap installed covering boring B23-016-SB.

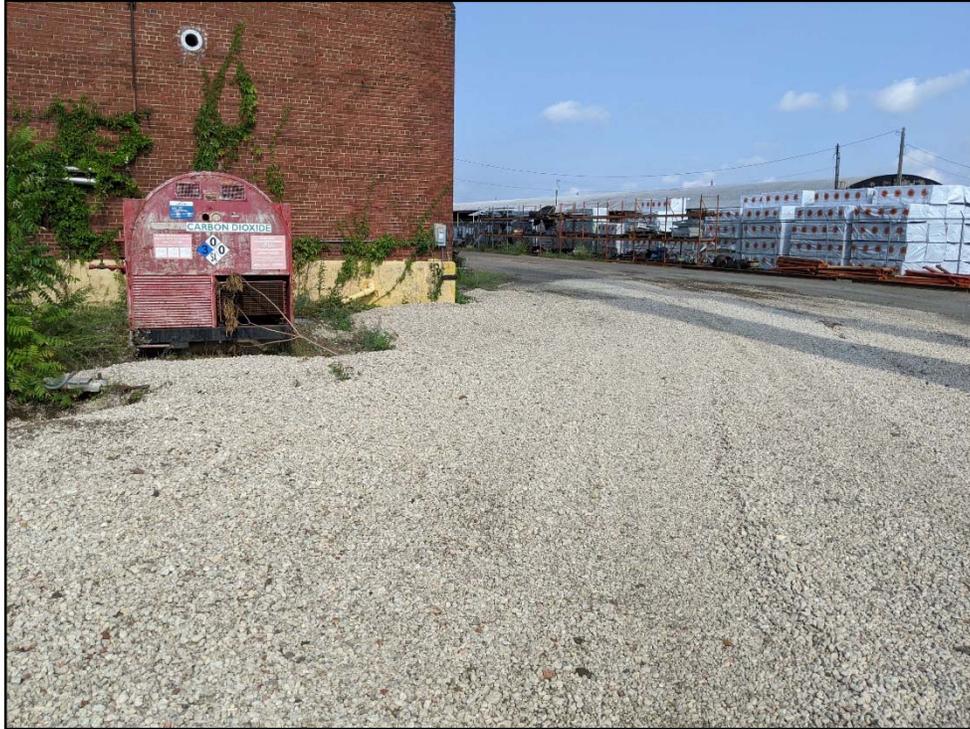
070820-2: Crushed recycled concrete temporary cap installed covering boring B23-016-SB.

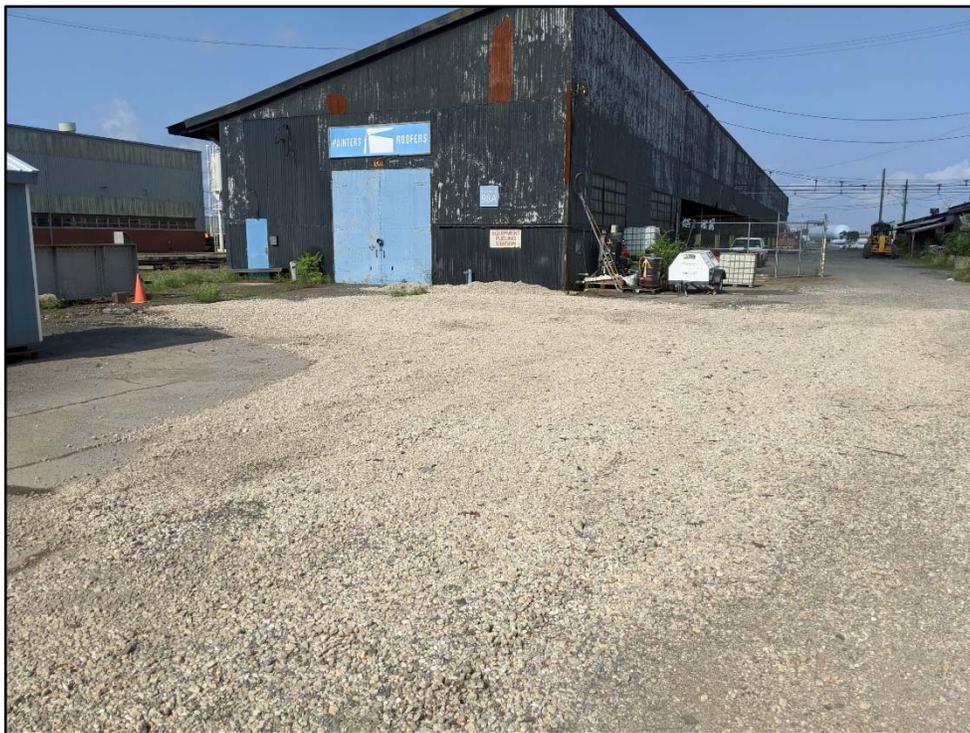
070820-3: Crushed recycled concrete temporary cap installed covering boring B23-034-SB.

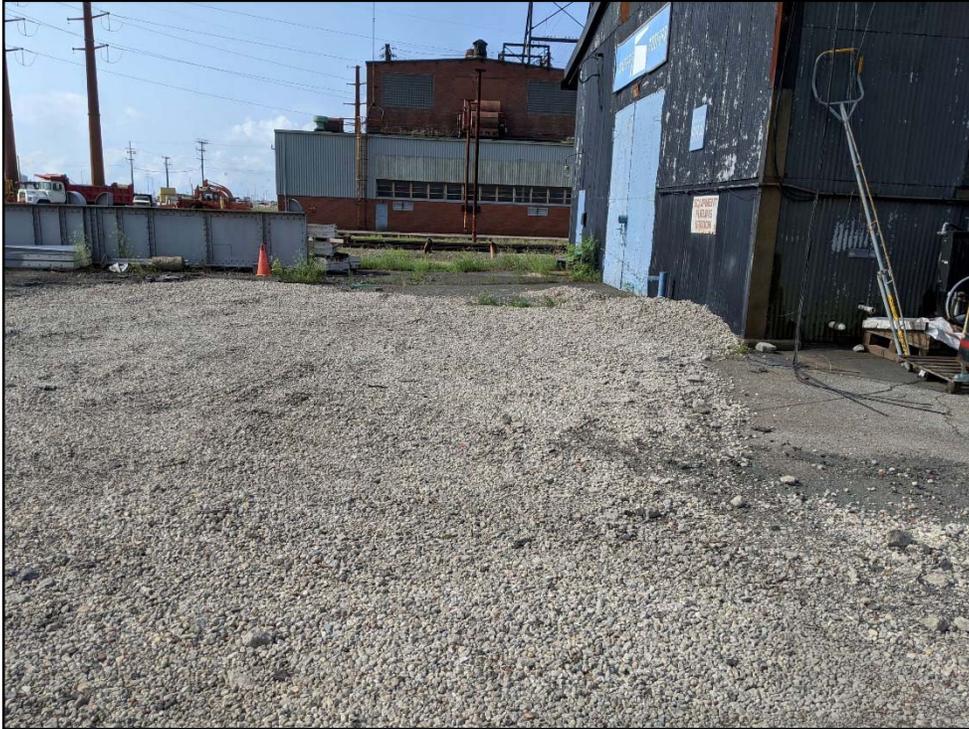
070820-4: Crushed recycled concrete temporary cap installed covering boring B23-034-SB.
