**A TECHNICAL MANUAL ON THE  
EFFECTS OF TREE AND WOODY  
VEGETATION ROOT PENETRATIONS  
ON THE SAFETY OF EARTHEN DAMS**

**Dr. B. Dan Marks, P.E.  
Dr. Bruce A. Tschantz, P.E.**

**December 2002**

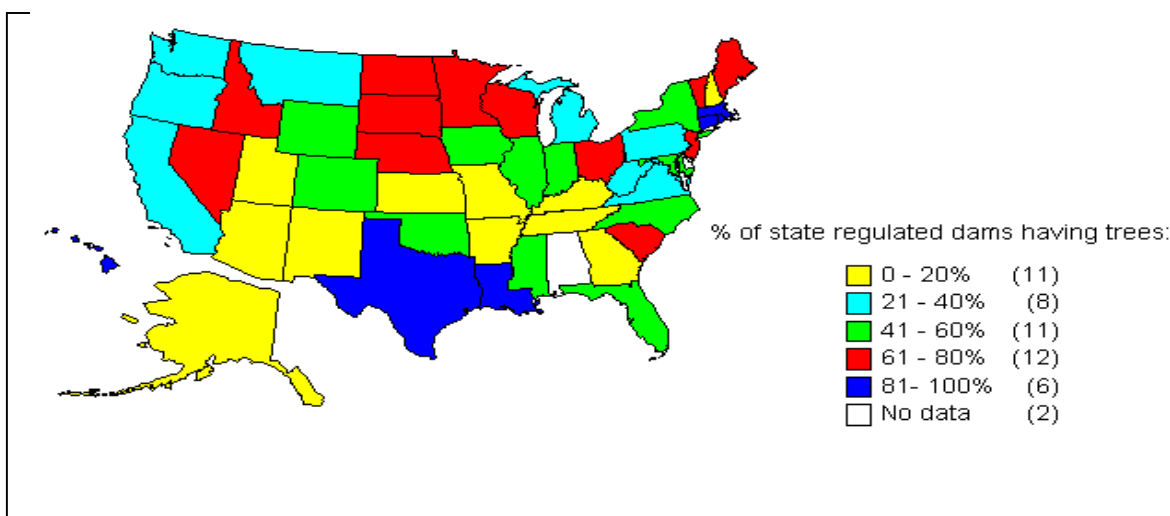
**Figure 1. Estimated percentages of state-regulated dams having trees.**

According to the 1998-99 National Inventory of Dams (NID) data, there are approximately 76,700 dams of significant size<sup>1</sup> and hazard category in the 50 states (USCOE, 1999). Most of these dams are regulated by the jurisdictional states, but many are not because of specific exemption clauses or different size or hazard restrictions. Because some states have lower size definitions for their dams than used for the NID count, the actual number of state-regulated dams is much higher (about 94,000). In Tennessee over 40 percent of the approximately 1000 inventoried dams *not* subject to regulation because of statutorily named county exclusions or agricultural use exemptions. Most of these unregulated dams and some of the regulated dams in Tennessee have troublesome trees and brush growing on their faces and crests. Some states estimate that as many as 95 percent of their regulated dams have trees. Figure 1 illustrates the general magnitude and range of the tree growth on regulated dams in 48 states where this information is reported (ASDSO, 2000). About half of the state-regulated dams are estimated to have excessive tree growth.

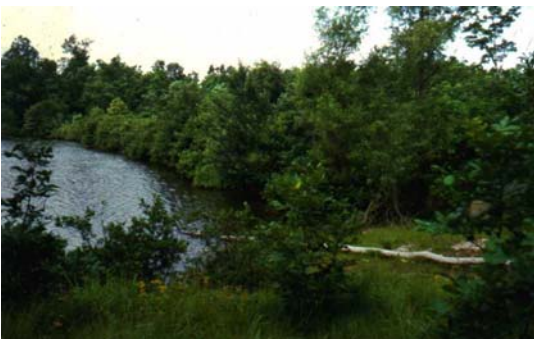
**Figure 3. Example dam with inspection-hindering trees in Tennessee.**

The problem most commonly noted by state officials is that trees, woody vegetation, briars, and vines interfere with effective safety inspections. Figure 3 illustrates this problem for a dam located in Tennessee.

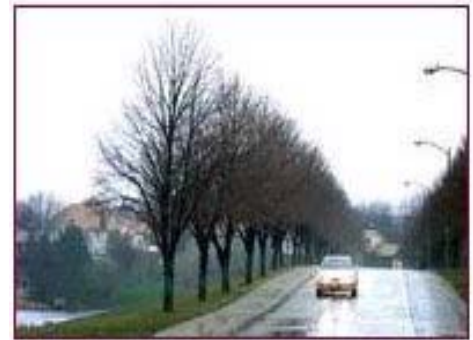
**Figure 2. Example dam with problematic trees in Nebraska.**

Of the 48 states that responded to the above seven questions (Alabama and Delaware did not reply), all state dam safety officials indicated that they consider trees and plant growth on dams to be a safety problem. One eastern state dam safety engineer goes so far to say that trees are probably the major problem that he has to deal with. He notes further that most of the trouble occurs because owners (and some engineers) do not recognize trees as problems and become complacent as trees slowly grow into serious problems. Both state and federal officials agree that trees have no place on dams. Federal agencies like the Corps of Engineers, U. S. Bureau of Reclamation, and TVA, which own, operate and maintain their own dams, do not allow trees to grow on their structures. Figure 2 shows a problem dam in Nebraska where tree roots have been reported to penetrate the chimney drain and thus affect the

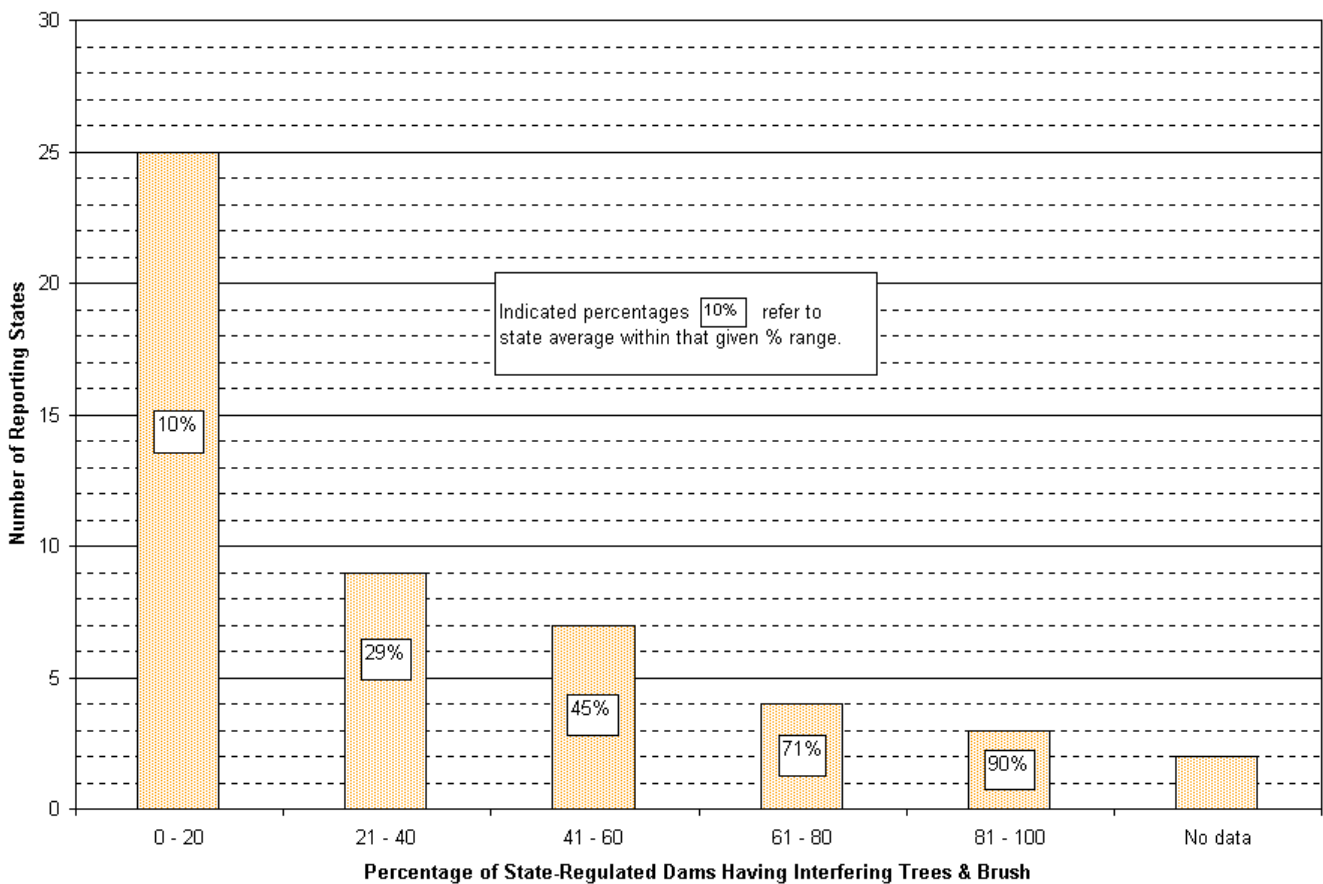
**Figure 4. Estimated percentages of state-regulated dams where trees and brush are considered a deterrent to effective safety inspections.**

Figure 4 gives a breakdown of the percentage ranges of regulated dams where the 48 reporting state dam safety officials shown in Figure 1 estimate that trees and brush hinder safety inspections in their respective states (ASDSO, 1999). While half the states report having only 20 percent or fewer dams with significant trees and woody vegetation that hinder inspections, vegetation on an estimated 30,000 or nearly a third of the collective state-regulated dams, is reported to obstruct effective dam safety inspections.

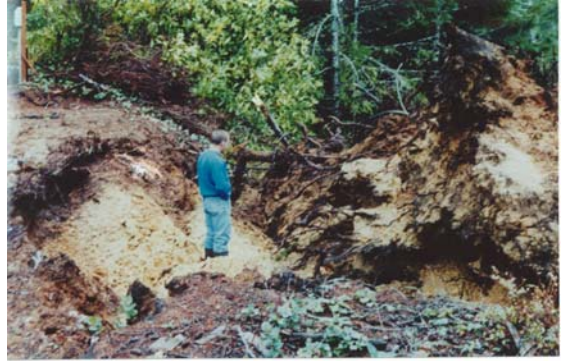
**Figure 5. Serious damage by uprooted tree to embankment stability at a dam in Oregon.**

- Uprooted trees that produce large voids and reduced freeboard; and/or reduced x-section for maintaining stability as shown in Figure 5.
- Decaying roots that create seepage paths and internal erosion problems.
- Interfering with effective dam safety monitoring, inspection and maintenance for seepage, cracking, sinkholes, slumping, settlement, deflection, and other signs of stress
- Hindering desirable vegetative cover and causing embankment erosion
- Obstructing emergency spillway capacity
- Falling trees causing possible damage to spillways and outlet facilities
- Clogging embankment underdrain systems
- Cracking, uplifting or displacing concrete structures and other facilities

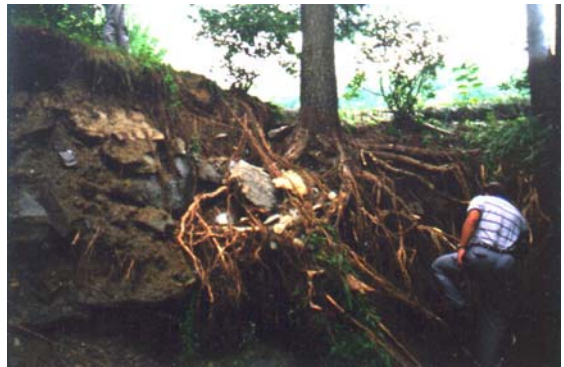
**Figure 6. Tree root induced scouring on crest and downstream face of Coffey dam in Kansas.**

- Inducing local turbulence and scouring around trees in emergency spillways and during overtopping as shown in Figure 6.

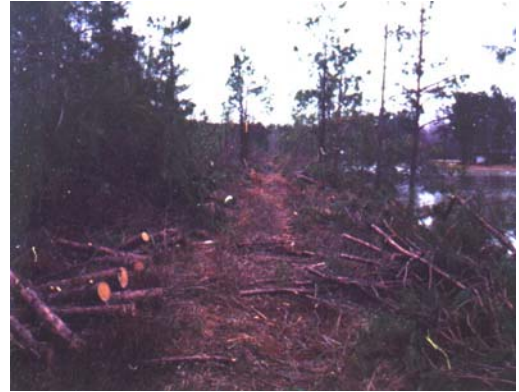
**Figure 6. Trees cut prior to removing stumps and roots from dam.**

Figures 6 and 7 illustrate extensive efforts necessary to restore a heavily wooded earthen dam to a desirable vegetated and maintained condition.

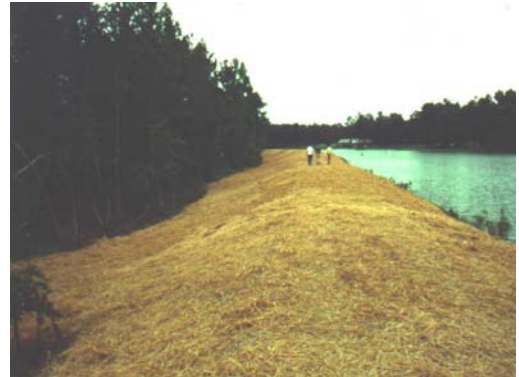
**Figure 7. Completed remediation job after removing stumps, seeding, fertilizing & mulching.**

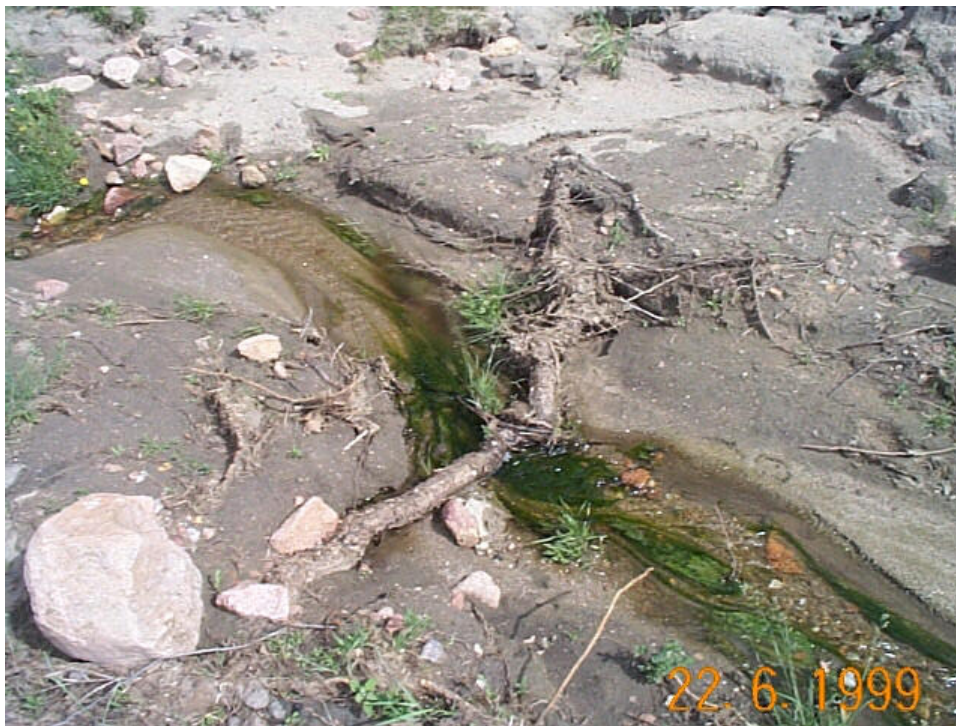
**Figure 9. Large pine tree root located in the channel of the breach opening of a failed Air Force Academy waste lagoon pond dam (David Eyre, Senior Civil Engineer, Air Force Academy, Colorado, 1999).**

safety problems. The most recent documented dam failure due to tree root penetration occurred in May 1999 at an unnamed Air Force Academy dam near Colorado Springs. Here, an approximately 13-ft. high dam with a pond capacity of less than 5 acre-feet of horse stable waste water failed, releasing its contents and injuring a horse in a stable located about 100 yards downstream. The failure occurred after more than 7 inches of rain had fallen in the previous 72 hours. The dam had several pine trees on its crest and faces, and the breach opening exposed an extensive, deep root system. Roots up to 4 inches in diameter were found in the breach area. Figure 9 shows an example of a large root exposed in the bottom of the channel at the breach. The dam had not overtopped, and the failure was attributed to internal erosion of the decomposed granite embankment material along the roots. A tree had been located directly over the breach.

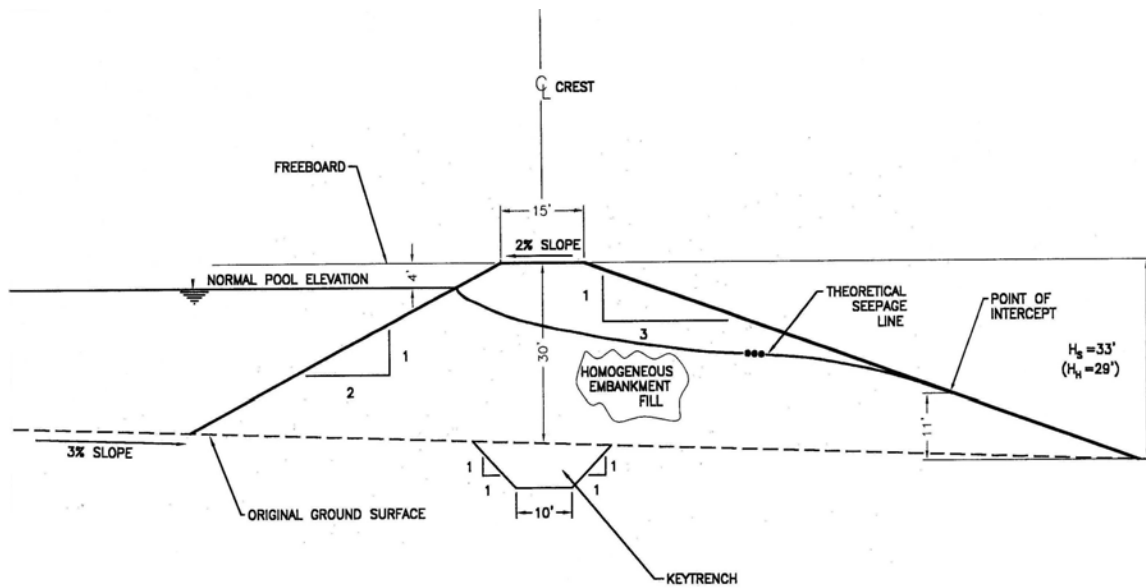
TYPICAL EMBANKMENT SECTION  
WITHOUT TOE DRAIN SYSTEM

The configuration of the example earthen dam consists of an upstream slope of 2:1 (horizontal to vertical), a crest width of fifteen feet, and a 3:1 (horizontal to vertical) downstream slope. The dam has a freeboard of four feet making the hydraulic height of the dam about 29 feet. The dam is founded on relatively impervious (compared to the embankment fill soil) material with a down gradient slope of about three percent. The example earthen dam section has a key trench directly below the centerline of the dam crest that has a bottom width of ten feet and side slopes of 1:1 (horizontal to vertical). The dam crest has a two-percent slope toward the impounded lake and the upstream slope has no protection system against tree and woody vegetation growth or wave erosion. The embankment of the example earthen dam is assumed to be homogeneous. Figure 1 is a representation of the example earthen dam configuration with the theoretical seepage line intercepting the downstream slope at about one-third the hydraulic height of the dam.

**Rule-of-Thumb:** *The phreatic surface intercepts the downstream slope of a homogeneous earthen dam at a vertical distance of about one-third the hydraulic height above the toe of the downstream slope, provided there is no internal drainage system in the dam embankment.*

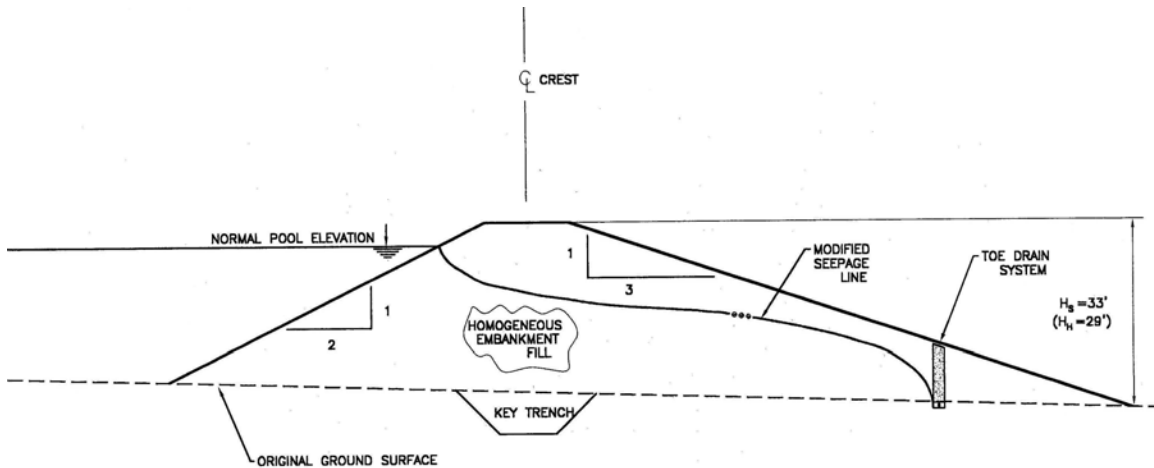
TYPICAL EMBANKMENT SECTION  
WITH TOE DRAIN SYSTEM

Figure 2 illustrates the example earthen dam with an embankment subdrain system located within the downstream embankment slope. The subdrain or embankment drain system is located at about the point of interception of the seepage line with the downstream slope if there was no embankment toe drain system within the downstream slope. As a result of the presence of the embankment subdrain system, the seepage line through the dam embankment has been modified (lowered) from the location of the theoretical seepage line for a homogeneous earthen dam embankment. The seepage line within an earthen dam is often mistakenly considered to have a permanent location.

However, the location of the seepage line is continually changing as a result of many influential factors. Fluctuations in the pool elevation, seasonal and long-term climatological conditions, and the growth of trees and woody vegetation in close proximity to the seepage line are some of the factors that influence changes in the location of the phreatic surface within an earthen dam embankment.

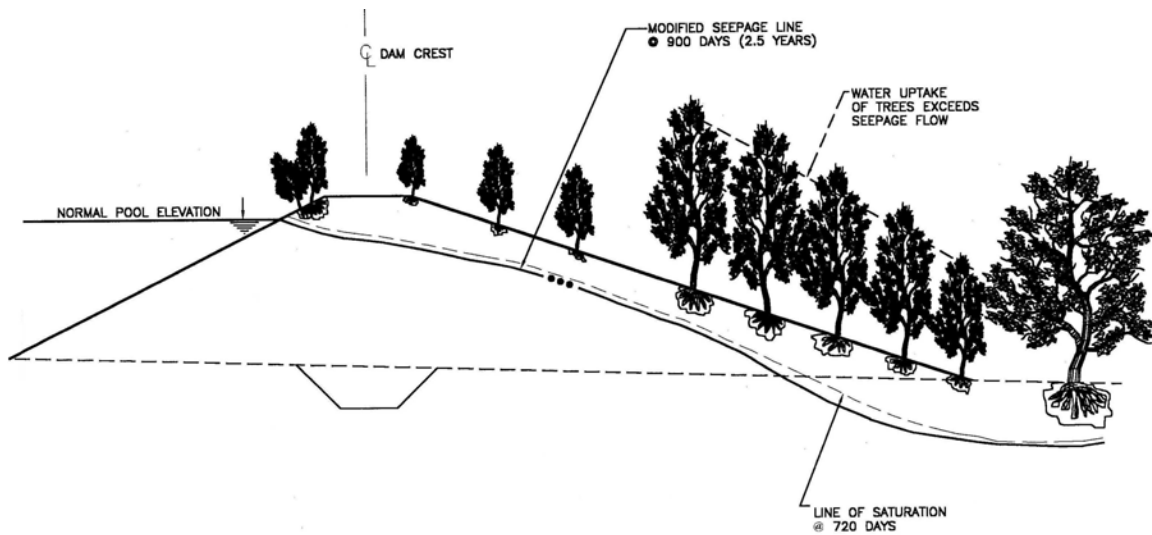
MODIFICATION OF SEEPAGE LINE  
WITH TREES & WOODY VEGETATION

The initiation of tree and woody vegetation growth on the downstream slope begins the soil moisture uptake cycle so that the line of saturation and the seepage line may never completely develop and intercept the downstream slope. The condition represented by Figure 6 might initially be considered to be beneficial to the stability of the dam embankment. However, one must understand that as the tree and woody vegetation growth continues compacted soils of the dam embankment are continually loosened by the penetration of major tree and woody vegetation root systems. Furthermore, trees that might appear healthy to an untrained inspector may be an unhealthy specimen and have a premature death leaving penetrating root systems to rot inside the dam embankment. Additionally, soil nutrients in the compacted soil embankment of an earthen dam may not be sufficient for development of growth beyond which the tree cannot be properly sustained without premature death. Regardless of the cause, trees and woody vegetation do die and cease to uptake soil moisture that they previously used. This change in soil moisture uptake will affect the zone of aeration, zone of saturation, and the location of the seepage line in the vicinity of the unhealthy or dead trees and woody vegetation.

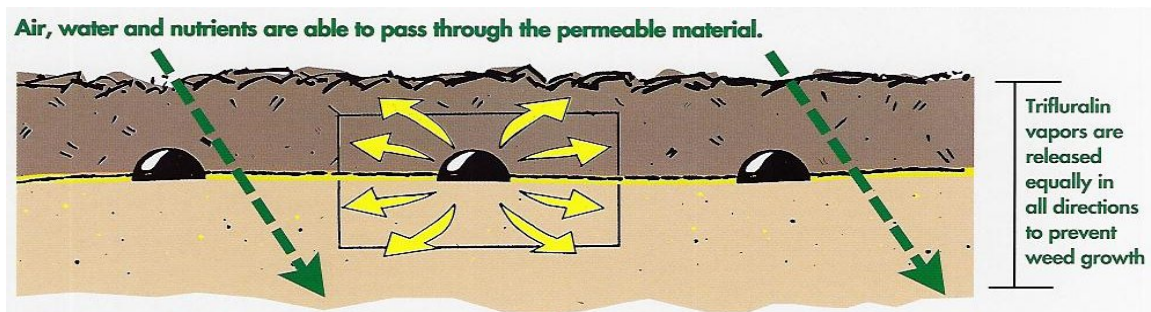
Figure 1. Chemical biocide barrier installation showing slow-releasing biocide nodules attached in a woven fabric matrix and installed under a cover of soil, mulch, gravel or stone (Biobarrier©).

One typical biocide product, called “Biobarrier©” is marketed and promoted, among other applications such as sidewalk and landfill cap protection, to prevent tree and plant roots from penetrating dams. The product consists of long-term, slow release nodules containing Trifluralin herbicide, that are bonded to a geotextile fabric as shown in Figure 1.

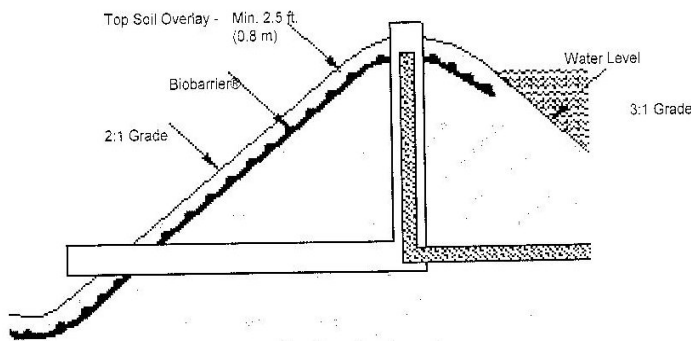
**Figure 2. Earth dam installation of chemical**

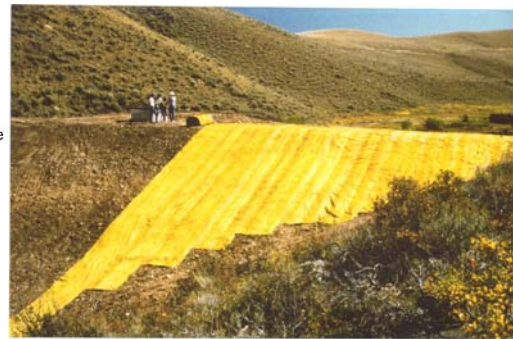
**Figure 3. Installed chemical barrier on a dam in Montana (Kershner, 1992)**

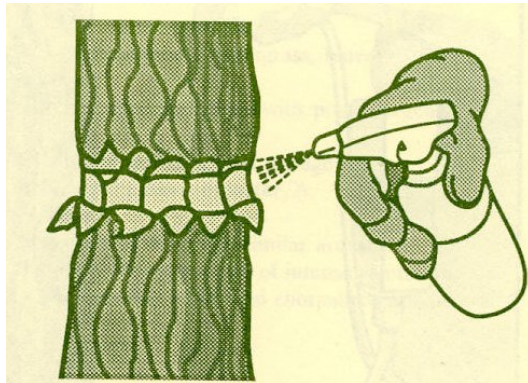
Vanquish  
Weedone  
Chopper  
Pathway  
Tordon  
Arsenol

Figure 5a. Frill cut application.

Some of these techniques and herbicides used are illustrated in Figures 5a – 5f. The U. S. Department of Agriculture (SCS, now NRCS) published a useful methods, treatment points, and time of treatment guidelines for controlling trees and brush on dams, including some of the applications listed in Figure 4 (USDA, 1988). Table 4 summarizes the USDA recommendations. With the exception of Krenite, which is applied to the foliage, 2,4-D is the only approved herbicide for poisoning trees on dams. 2, 4-D is manufactured by several companies and is sold under several trade names. In all cases, the user is cautioned again to follow the manufacturer’s instructions and should consider the manufacturer’s label instructions to supercede recommended instructions in the USDA table.

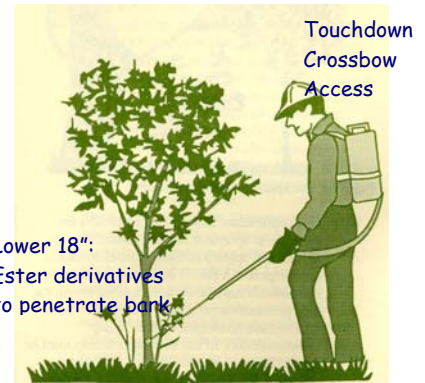
Touchdown  
Crossbow  
Access

Lower 18":  
Ester derivatives  
to penetrate bark

Figure 5b. Basal bark spraying.

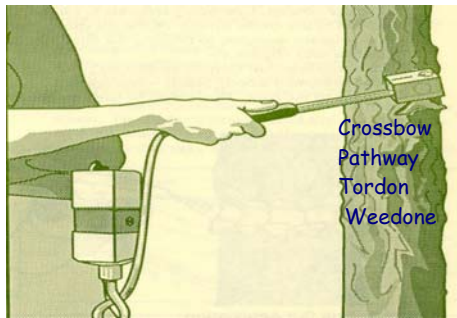
Crossbow  
Pathway  
Tordon  
Weedone

Figure 5c. Hypohatchet application.

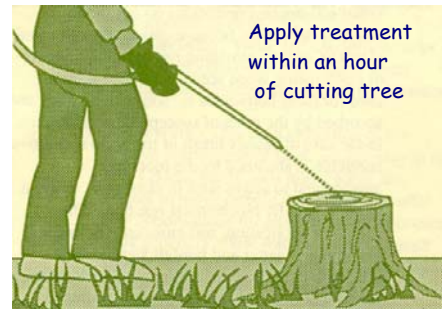
Apply treatment  
within an hour  
of cutting tree

Figure 5d. Cut-stump application.

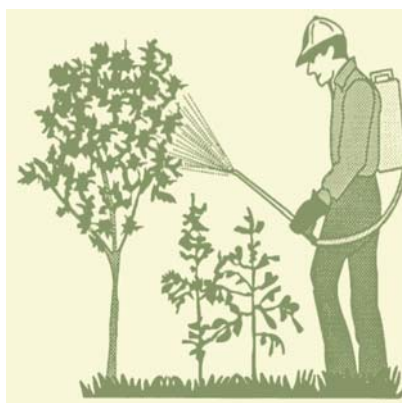
Vanquish  
Weedone  
Weedmaster  
Crossbow  
Banvel  
Roundup  
Accord  
Arsenol  
Chopper  
Pathway  
Tordon  
Touchdown  
Spike  
Garland

Figure 5e. Backpack foliar application on dam.

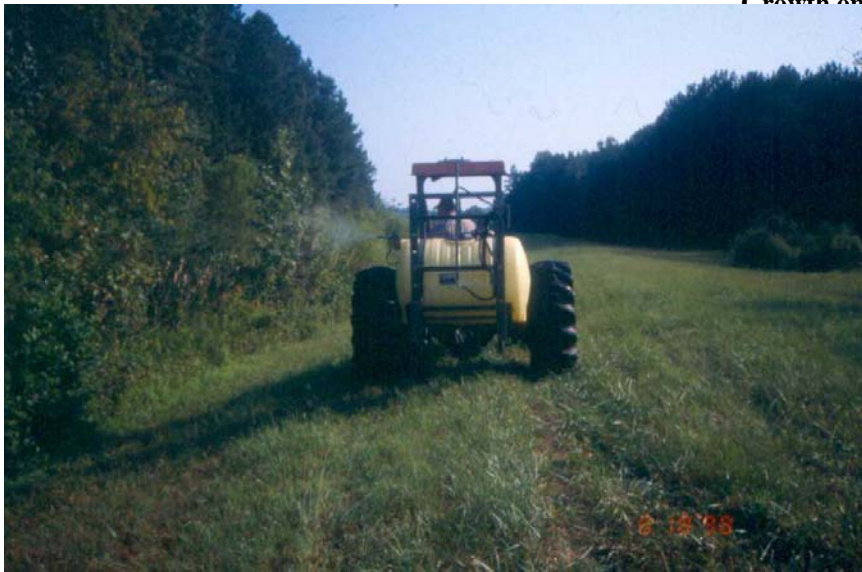
Figure 5f. Tractor spraying application on dam.

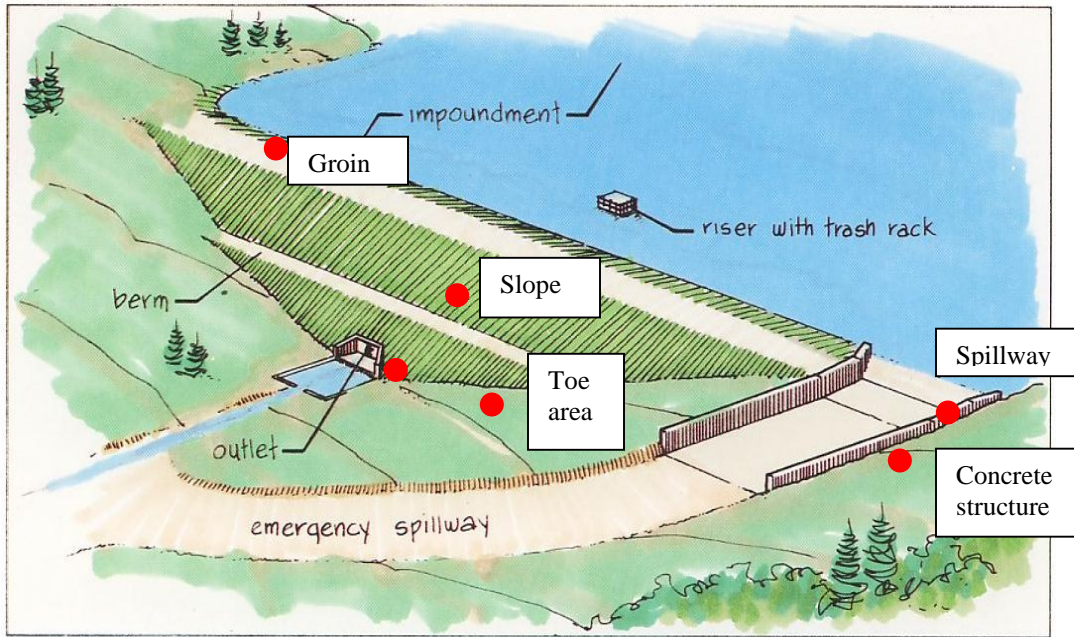
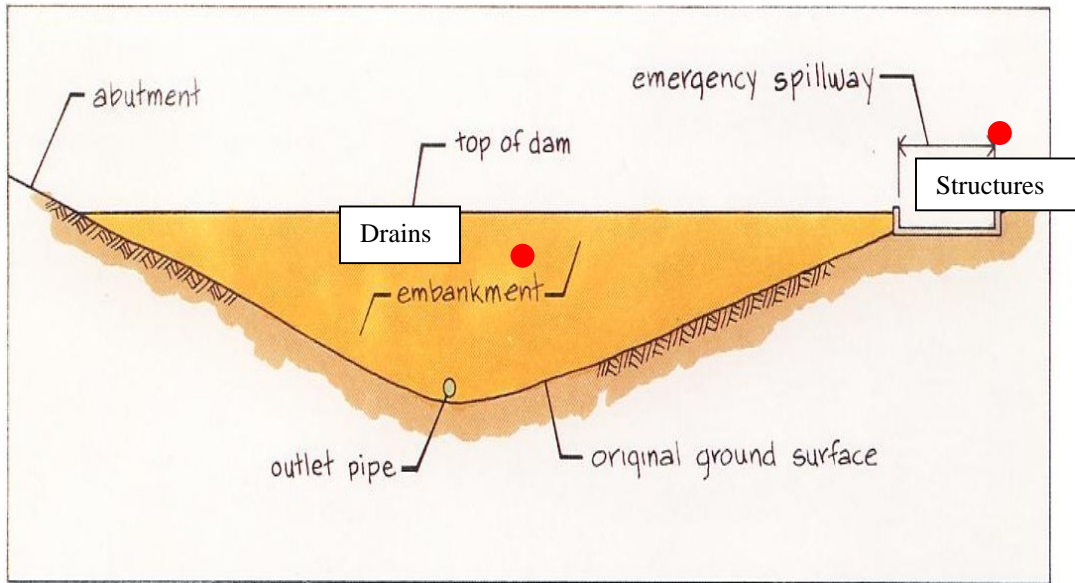
Figure 6. Tree clearance zones for embankment dams and dikes.

3. **Root exclusion zones** utilizing soil structure changes, soil compaction, water/aeration, stress, anaerobic conditions, soil injections and slurries, soil additives, and chemicals to prevent roots from colonizing the soil structure areas due to applied physical or chemical changes to the soil. Changing the soil structure, pore space volume or drainage/aeration matrices can generate a soil environment that roots cannot effectively grow and sustain. A variety of physical- or chemical-based soil altering materials (i.e., soil injected clay slurry or cement solutions) can be effective, at least over the short term if adequate soil volume is treated. Compacting soils appear to be a very good way to prevent root colonization. High density soils increase the resisting strength of these soils to root penetration and deprive the roots from needed oxygen and available water. Certain types of clay soils, freeze-thaw cycles, biological activity, and poor soil compaction can, over time, produce root-accessible pore space. Soil or infrastructure building material additives that neutralize or sterilize the available minerals and nutrients such as nitrogen gas, sulphur, sodium, zinc, borate, salts, or herbicides may produce serious environmental consequences, short-lived results, and non-targeted damage potential. Other methods or additives may be cost-prohibitive. See Figure 6 at end of chapter for root clearance zones.

8. **Creating avoidance zones** to separate tree growth from earthen dam embankments and dam appurtenances where root damage may be critical thus establishing biological-free zones that reduce potential problems. This method simply recognizes that there are places where trees are acceptable and other places, namely dams, where they are not (see Figure 6).

The reader is referred to the USDA guideline for detailed discussion on each of the six treatment methods listed in the above table. These methods can be applied to establish tree and woody plant clearance or avoidance zones on and around dams as illustrated in Figure 6.

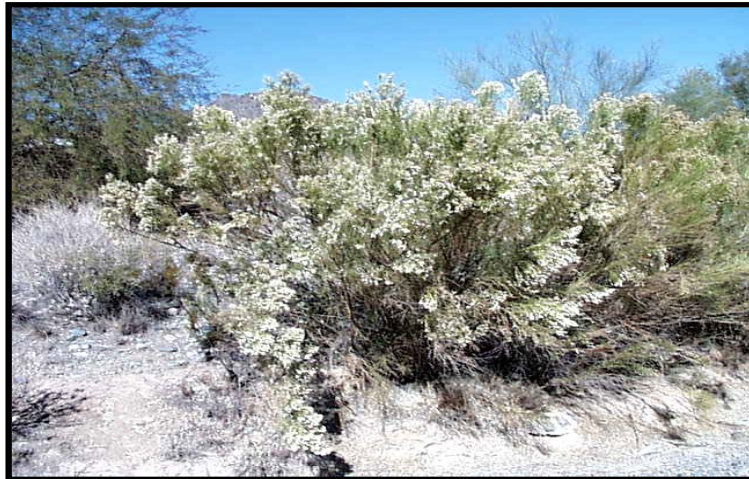
**Figure 7. Deep-rooting Desert Broom Plant**

Deep-rooted desert plants, when left unchecked, can propagate rapidly on earthen dams located in arid and semi-arid regions of the U. S. Some of these deep-rooted plants include Desert Broom shown in Figure 7, Salt Cedar, Mesquite, Cypress, Cottonwood and Paloverde. All of these species require considerable effort to control and should not be allowed to become established anywhere on dams. Palm trees can be a problem in that they are shallow-rooted, but develop a large root ball that can produce large cavities when toppled during high winds. Upstream and downstream access roads, in place at many dams, should be utilized to create a buffer zone between these species and the toe of dams.

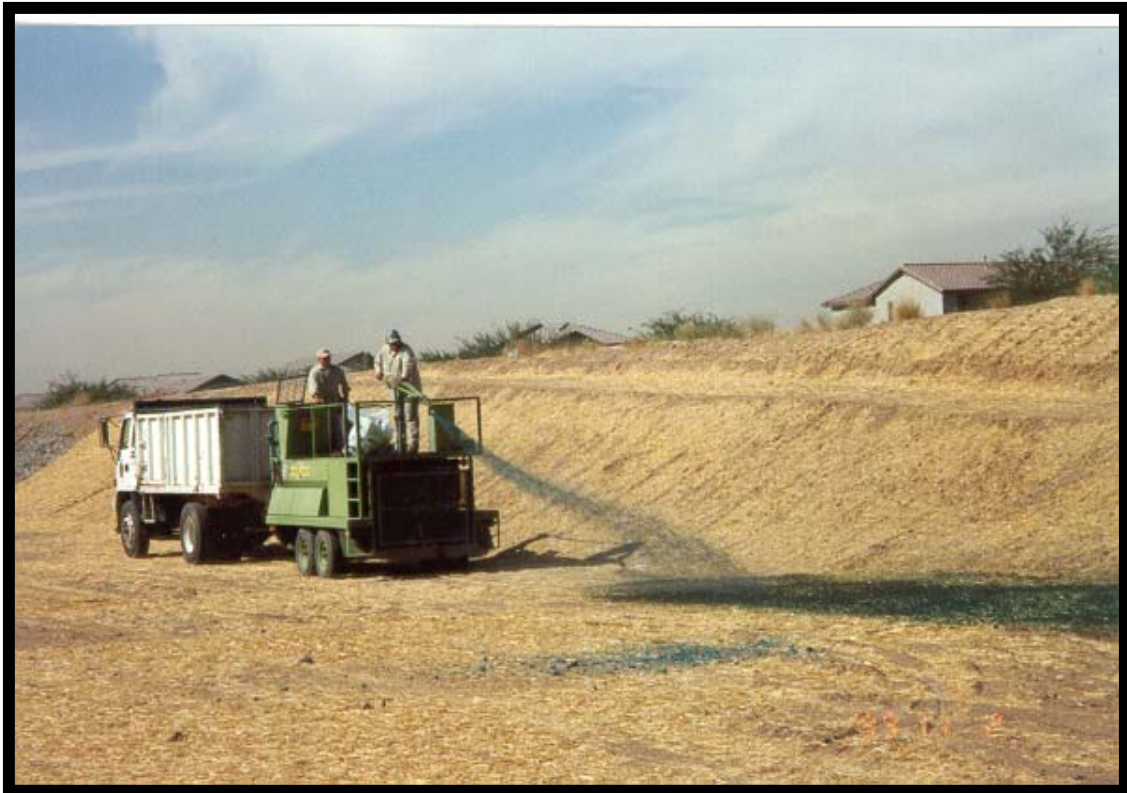
**Figure 8. Hydro-seeding operations on a floodway dam in Maricopa County, Arizona (Renckly & Drake, 1999).**

Revegetation on earthen dams is recommended to minimize erosion on the embankment slopes and to provide natural landscaping for earthen dams. MCFCD recommends hydro-seeding over labor-intensive hand-seeding to revegetate dam embankments. Figure 8 illustrates hydro-seeding operations on a floodway dam. Seed, water, tack material and a wood fiber or paper mulch are mixed in a hydro-seeder and sprayed directed onto the slopes. The seeds are encapsulated in the mulch and tack material until enough moisture is present to begin the germination process.

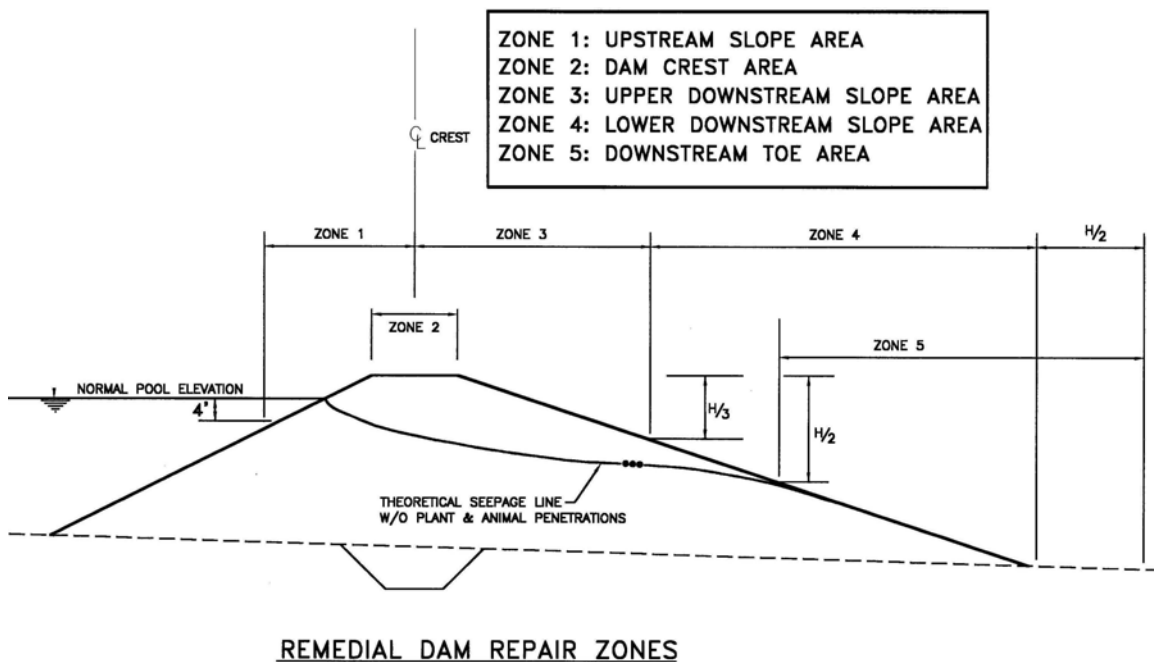
Specific dam remediation design considerations, procedures, and techniques will be considered for each of the previously identified dam safety inspection and evaluation zones. Figure 1 presents these zones as a review prior to discussion of potential dam remediation design considerations for each zone. Dam remediation design alternatives presented herein should be considered examples. These remediation design examples should not be considered the only alternatives for use in dam remediation design to correct deficiencies associated with tree and woody vegetation growth on earthen dams. Some additional dam remediation design alternatives presented for correction of tree and woody vegetation growth related deficiencies also provide positive correction of other deficiencies and protection against other types of earthen dam deterioration.

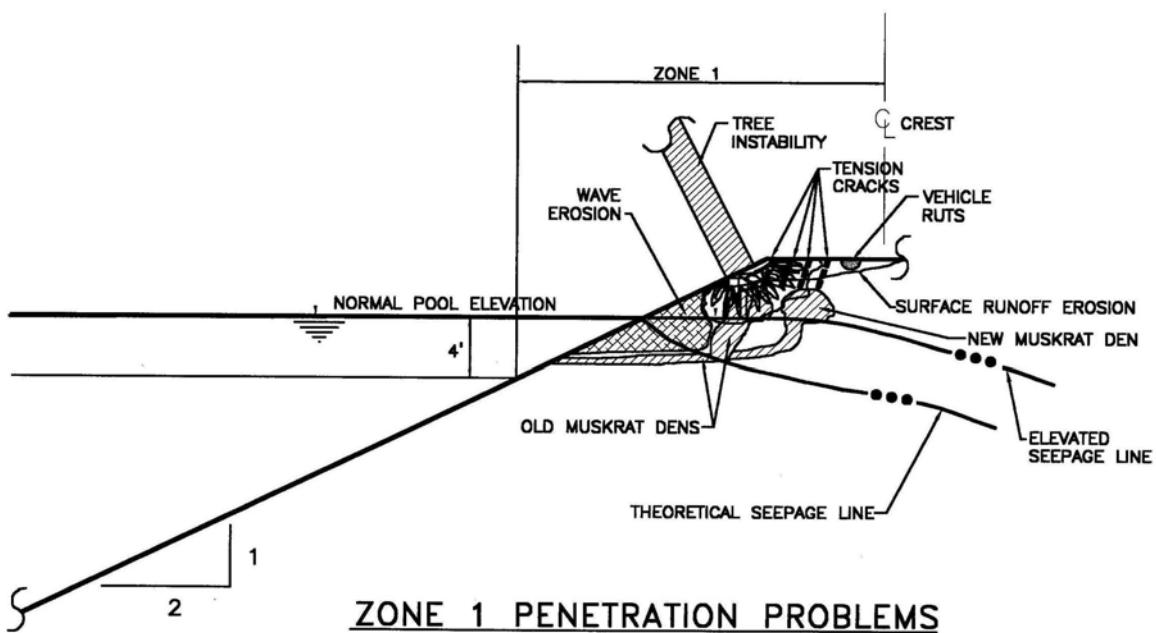
**Figure 2**

Figure 2 illustrates potential problems that can occur in Zone 1 with respect to tree and woody vegetation growth on earthen dams. This illustration also depicts the occurrence of wave erosion, vehicle access, and surface runoff erosion. Potential problems illustrated include instability of relatively large trees on the upstream slope and dam crest, and alteration of the seepage line as a result of wave erosion.

Dam remediation design techniques necessary to address potential problems illustrated in Figure 2 are illustrated in Figures 3 and 4. Dam remediation construction typically requires lowering of the normal pool elevation and/or complete drawdown of the retained reservoir. This is particularly true for dam remediation construction in Zone 1. The normal pool elevation should be lowered as far ahead of the scheduled dam remediation construction as practicable.

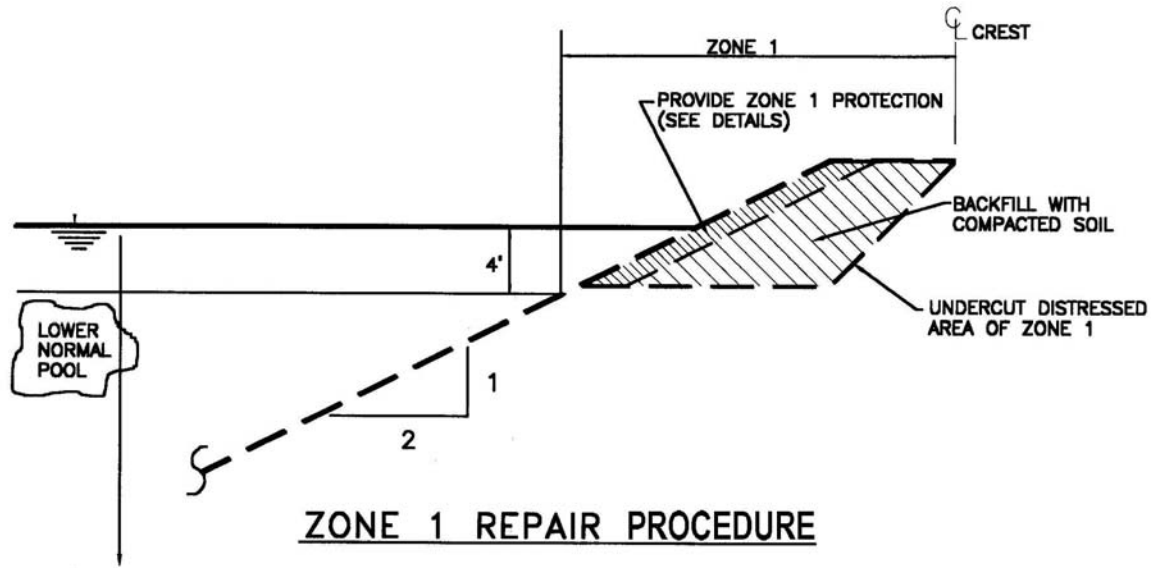
Figure 3

Tree and woody vegetation growth in Zone 1 must be undercut to remove all stumps, rootballs, and root systems developed by tree penetrations as illustrated in Figure 3. The required depth of undercutting typically extends to near the limits of Zone 1, which is about four feet below normal pool elevation. In the case of earthen dams with narrow crest widths, the backslope of the undercut area will typically extend to near the centerline of the dam crest or the downstream limits of Zone 1. Subsequent to undercutting affected areas of Zone 1, the undercut area must be thoroughly inspected to confirm that all major root systems (greater than about one-half inch in diameter) have been removed during the undercutting operation. Following inspection and approval of the undercut area by the engineer, suitable backfill should be placed in the excavation and properly compacted to the dam remediation design limits. Backfill should consist of approved embankment fill material and should be compacted to a minimum of 95 percent of the maximum dry density of the fill soil as determined by the standard Proctor compaction test (ASTM D-698). In conjunction with the undercutting and backfilling, the dam remediation design should include a slope protection system to deter future tree and woody vegetation growth and reduce the potential for wave and surface runoff erosion.

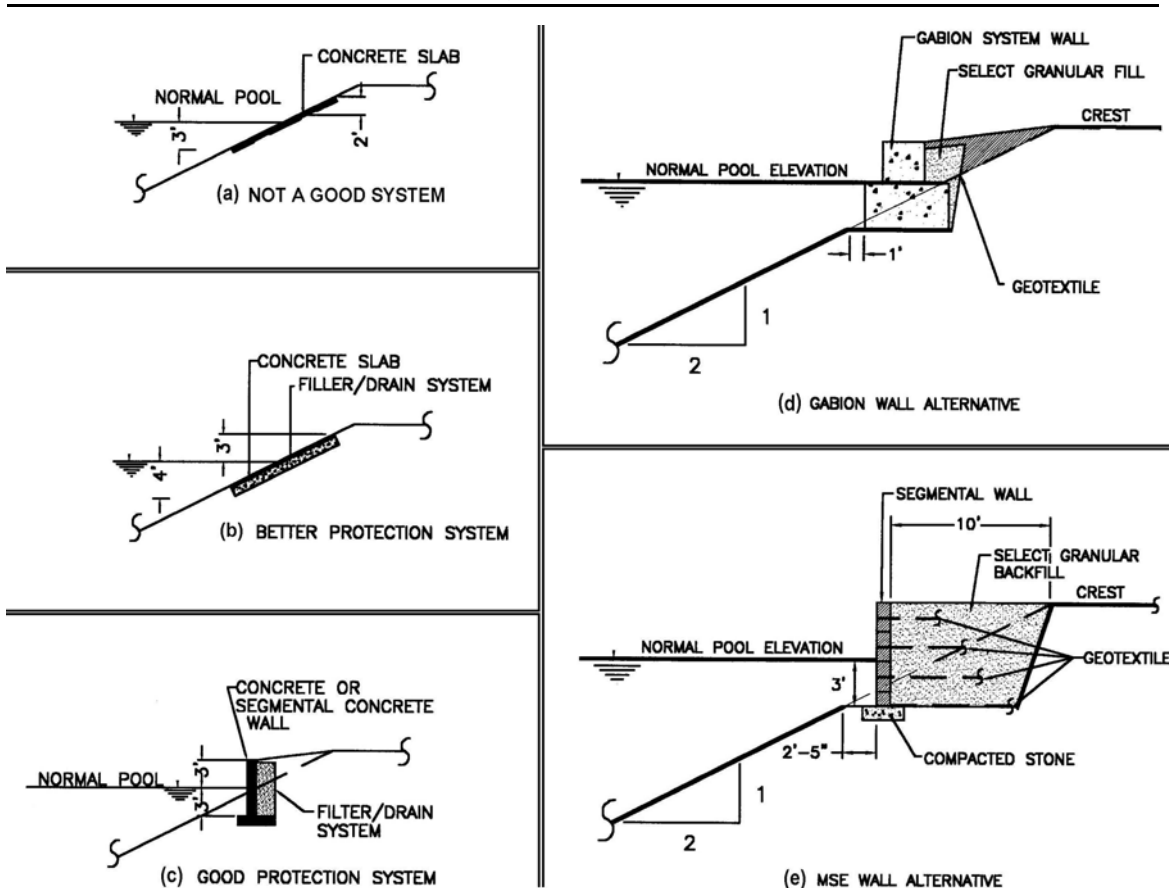
Figure 4

Figures 4(a) through 4(c) illustrate various configurations of rigid (concrete) upstream embankment slope protection systems. Figure 4(a) illustrates a concrete slab being placed directly on the upstream slope from about three feet below to about two feet above normal pool elevation. While this system is somewhat limited relative to the area of protection, the most critical aspect of this system is that it provides no filtration and/or drainage system beneath the concrete slab. Continual wave action and the buildup of hydrostatic pressures beneath the concrete slab will eventually result in downward movement of the slab. Figure 4(b) illustrates a better dam remediation design utilizing a concrete slab slope protection system. This slope protection system has been improved over the original system by covering a larger area of the upstream slope and by providing a filter system beneath the concrete slab protection system. The author is of the opinion

***NOTE: Reinforced concrete wall and slab systems constructed on the upstream slope must always be provided with filtration/drainage systems to reduce the potential for development of excessive hydrostatic pressures and internal erosion and scour of soil from beneath the structures. The referenced figures are presented for illustrative purposes and should not be used for actual dam remediation design without proper design analyses to confirm any indicated dimensions of the drawings.***

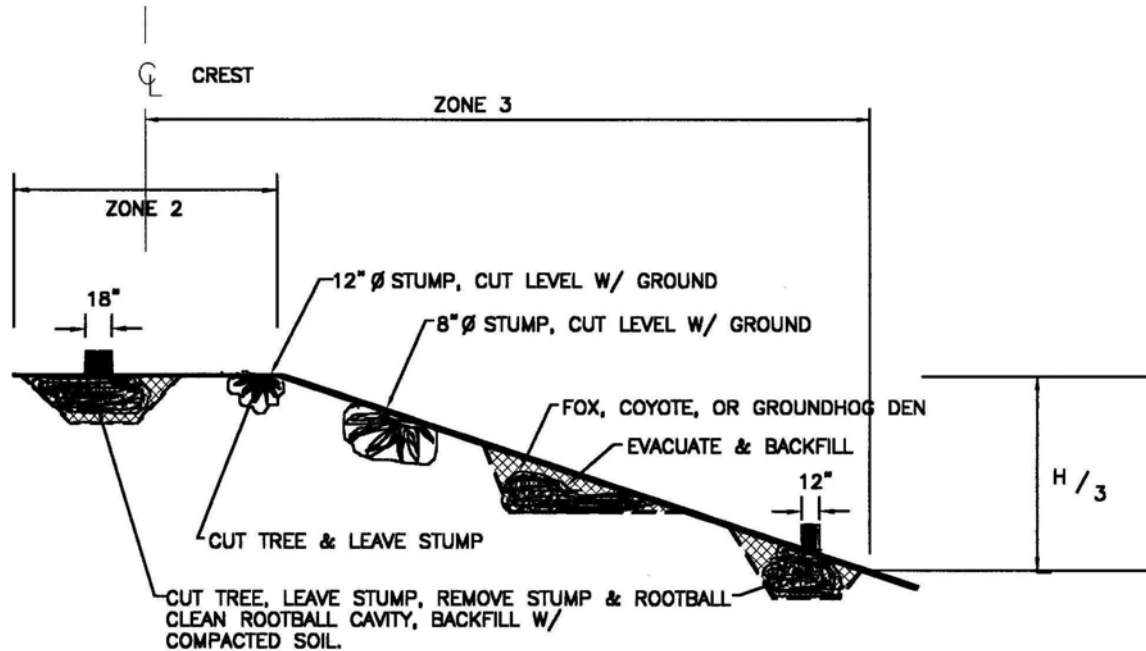
Potential problems associated with tree and woody vegetation growth on earthen dams in identified Zones 2 and 3 are illustrated with dam remediation design procedures in Figure 5. Potential problems illustrated for Zone 2 include the growth of mature trees having stump diameters greater than twelve inches. Mature trees having stump diameters greater than eight inches are illustrated at various locations throughout Zone 3 and in the overlap area of Zones 2 and 3.

### ZONE 2 & 3 REPAIR PROCEDURES

Two dam remediation design procedures are illustrated in Figure 5 for removal of trees of various sizes. This illustration implies that trees located in the overlap area of Zones 2 and 3 having stump diameters less than about twelve inches could be cut flush with the ground and left in place for future treatment of the decayed stump and rootball system. However, removal of all stumps, rootballs and root systems is always the better and more conservative approach to removal of mature trees. Subsequent to cutting of trees having stump diameter less than about twelve inches in the overlap area of Zones 2 and 3, the surface of the stump can be treated with a protective coating similar to polyurethane that will prolong the decaying process. Conversely, the referenced illustration indicates that any trees in Zone 2 upstream of the overlap area of Zones 2 and 3 having stump diameters of twelve inches or greater should be treated by total removal of the tree, stump, rootball, and root system. The suggested dam remediation design and construction procedure suggested for complete removal of trees, stumps, rootballs, and root systems in Zones 2 and 3 consists of the following activities:

Figure 5 further illustrates that trees located in Zone 3 that have stump diameters greater than about eight inches should be treated by total removal. The removal procedure should be the same as previously described for larger trees in Zone 2. Trees having stump diameter of less than about eight inches could be cut flush with the ground and treated with a waterproofing sealant similar to polyurethane to prolong the stump and rootball decaying process. Again, complete removal of the stumps, rootballs, and root systems of all mature trees is a better and more conservative method of remediation.

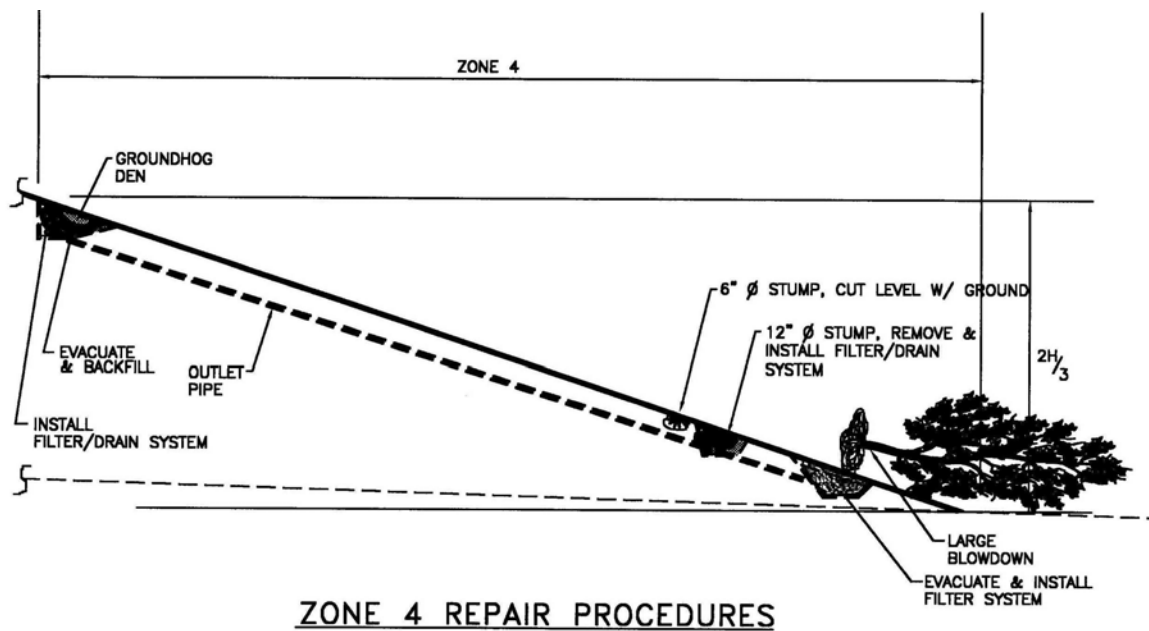
Figure 6 illustrates potential problems associated with tree and woody vegetation growth in Zone 4 of an earthen dam with suggested dam remediation design and construction procedures.

Young immature trees having stump diameters less than about six inches can be removed by cutting flush with the ground and treating the stump with a wood preservative and/or sealant to prolong the decaying process. This procedure is based upon the fact that immature trees of this size typically have not developed a rootball and/or root system that will significantly impact the zone of saturation or the seepage line in Zone 4.

1. **Cut** the tree approximately two feet above ground level leaving a prominent stump for use in the rootball extraction process;
2. **Remove** the stump and rootball by pulling the stump or extracting with a track-mounted backhoe after loosening the rootball by pulling on the stump from different directions;
3. **Clean** the rootball cavity to remove loose soil and the remaining root system by excavating the rootball cavity with maximum 1:1 (horizontal to vertical) side slopes and a horizontal bottom; and
4. **Install** a subdrain and/or filter system in the tree penetration excavation and backfill with compacted soil placed in maximum loose lifts of eight inches.

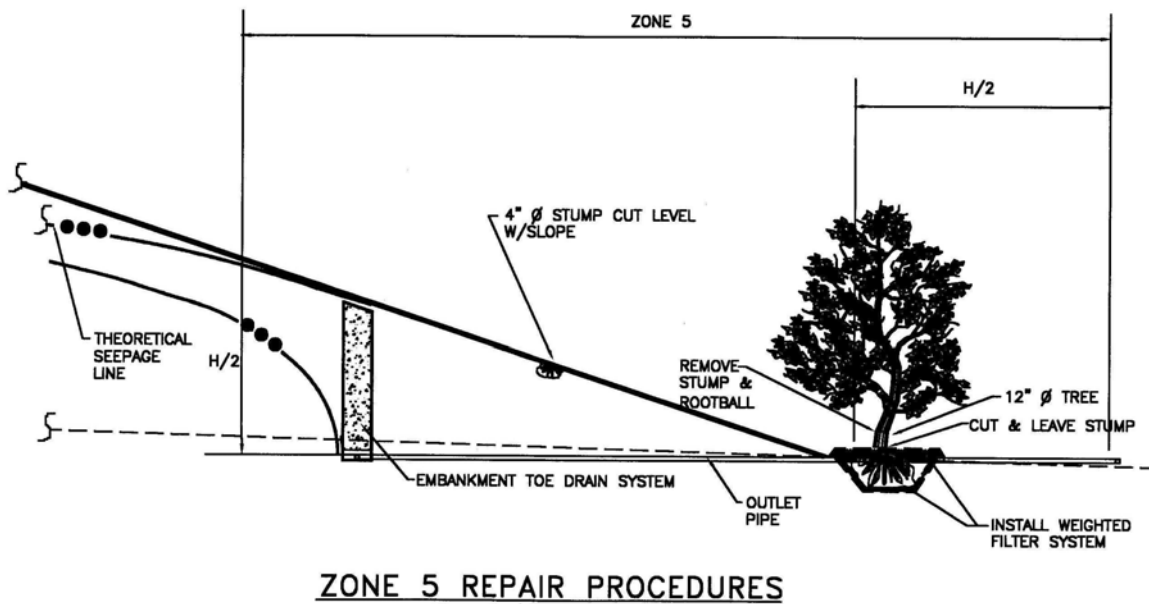
The author identified Zone 5 as one of the two most critical zones for tree and woody vegetation growth on an earthen dam. Figure 7 illustrates some of the problems that can occur with tree and woody vegetation growth in Zone 5. The major adverse feature in Zone 5 is typically the interception of the downstream embankment slope by the seepage line. The author is a strong advocate of the installation of embankment subdrain systems during dam remediation design and construction even though the earthen dam may have been provided with an embankment subdrain system during original design and construction.

One must understand the impact of tree removal in Zone 5 on the seepage line and the quantity of seepage that will occur subsequent to dam remediation in this zone. As indicated by Figure 7, trees in Zone 5 having stump diameters less than about four inches can be cut flush with the ground and the stump treated with a waterproof sealant to

prolong stump and rootball decay. Trees having stump diameters greater than about four inches must be removed completely. If the embankment toe drain or subdrain system is installed in advance of tree removal in Zone 5, the rootball cavity can be backfilled with compacted soil, provided seepage does not emerge from the excavation and/or the tree is located beyond the toe of the embankment slope. Tree rootball cavities existing beyond the toe of the downstream embankment slope generally require the installation of a filter system and in some cases a weighted filter system as indicated in Figure 7. The weighted filter system may be converted to a weighted drain system by installing a drain and outlet pipes connected to the outlet pipe of the embankment subdrain system.
