**A TECHNICAL MANUAL ON THE  
EFFECTS OF TREE AND WOODY  
VEGETATION ROOT PENETRATIONS  
ON THE SAFETY OF EARTHEN DAMS**

**Dr. B. Dan Marks, P.E.  
Dr. Bruce A. Tschantz, P.E.**

**December 2002**

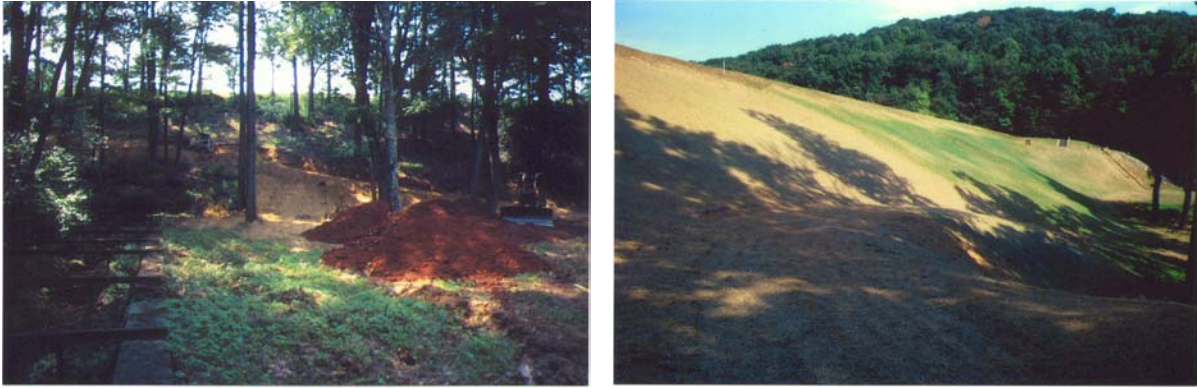
**Figure 1. Restored Downstream Slope on Fishing Creek Dam, Maryland (1991-92)**

State and federal dam safety officials and other dam safety experts agree that trees have no place on dams. Federal agencies and some states do not allow trees to grow on dams. However, it is estimated that about a third of the nation's 77,000 inventoried dams have sufficient woody vegetation to hinder effective dam safety inspections (ASDSO, 2000; Tschantz, 2000). Most states require dam owners to remove trees and undesirable vegetation, but the cost of clearing and grubbing trees and restoring the dam embankment slopes and crest is often cost prohibitive for many dam owners, usually running into thousands of dollars. It would seem that regular control of woody vegetation and maintaining the surface on an earthen is relatively inexpensive, compared to removing trees on and repairing damage from neglected dams such as shown in Figure 1.

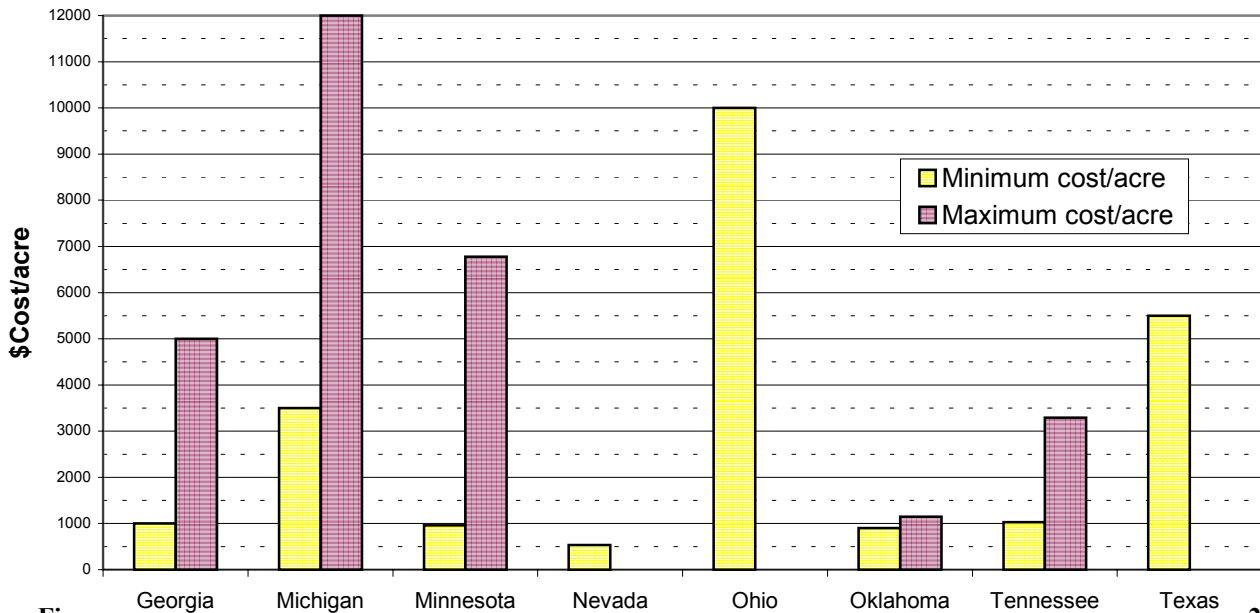
Figure 2. Comparison of tree removal costs per acre of dam surface area reported by 8 states.

The reader is referred to Table 1 in Chapter 2 and Figure 2 below for unit area tree removal cost comparison experiences reported in a survey by eight state dam safety officials in different regions of the country. The survey data shows that the cost of clearing and grubbing trees and other woody vegetation varies widely within and among states, but generally ranges from about \$1000 to \$5000 per acre, depending on site-specific conditions (Tschantz, 2000).

These data compare favorably with the \$1500 - \$3000 bid price data for three Southeastern states discussed earlier in Chapter 2 for cutting trees, removing stumps and rootballs, and grubbing the area to remove roots for different dam conditions. While not included in the above Figure 2 chart data, Massachusetts’ dam safety personnel reported in 2000 that, based on its own in-house experience, some local consultants and other sources, “broad area” tree removal costs ranged from \$5000 and \$6000 per acre or from about \$800 to \$1000 for individual 18-24 inch trees in their region. One dam safety official, from Tennessee, provided detailed cost data for clearing trees from seven dams in that state from 1995-1999. The cost for clearing and grubbing trees and for reseeding for one typical dam in 1998 is described for the reader in Table 1.

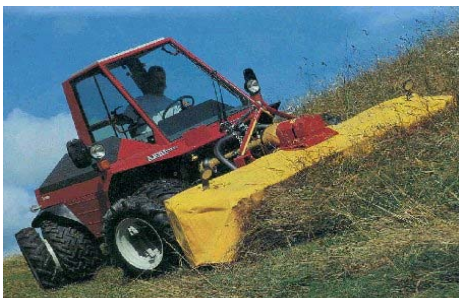
**Figure 3. Example of slope mower (Terratrac© photo used with permission from AEBI North America, Inc.)**

Figure 3 illustrates the use of a slope mower for easing the burden of maintenance for state and federal agencies and for other multiple or large dam owners.

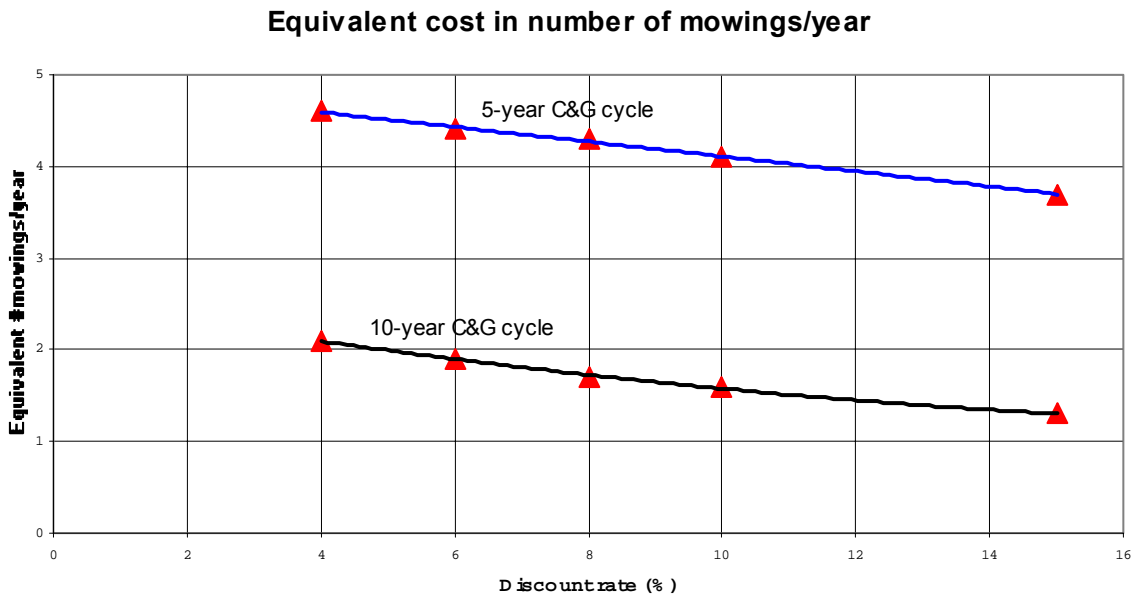
**Figure 4. Comparison of Annual Tree Clearing and Grubbing Costs for 5 and 10-Year \$2500/acre payouts.**

For a more conservative 5-year tree growth cycle and a \$2500 clearing and grubbing cost assumption, the annualized clearing and grubbing costs would be \$1523, \$1464, \$1406, \$1351, and \$1224 for the same discount rates, respectively. The corresponding justifiable mowings would be 4.6, 4.4, 4.3, 4.1, and 3.7 per year. Similarly, justifiable mowings for an assumed \$5000 clearing and grubbing cost would double the justifiable mowings to 9.2, 8.9, 8.6, 8.2, and 7.4 per year. Figure 4 compares 5 and 10-year annualized costs for \$2500/acre clearing and grubbing payouts.

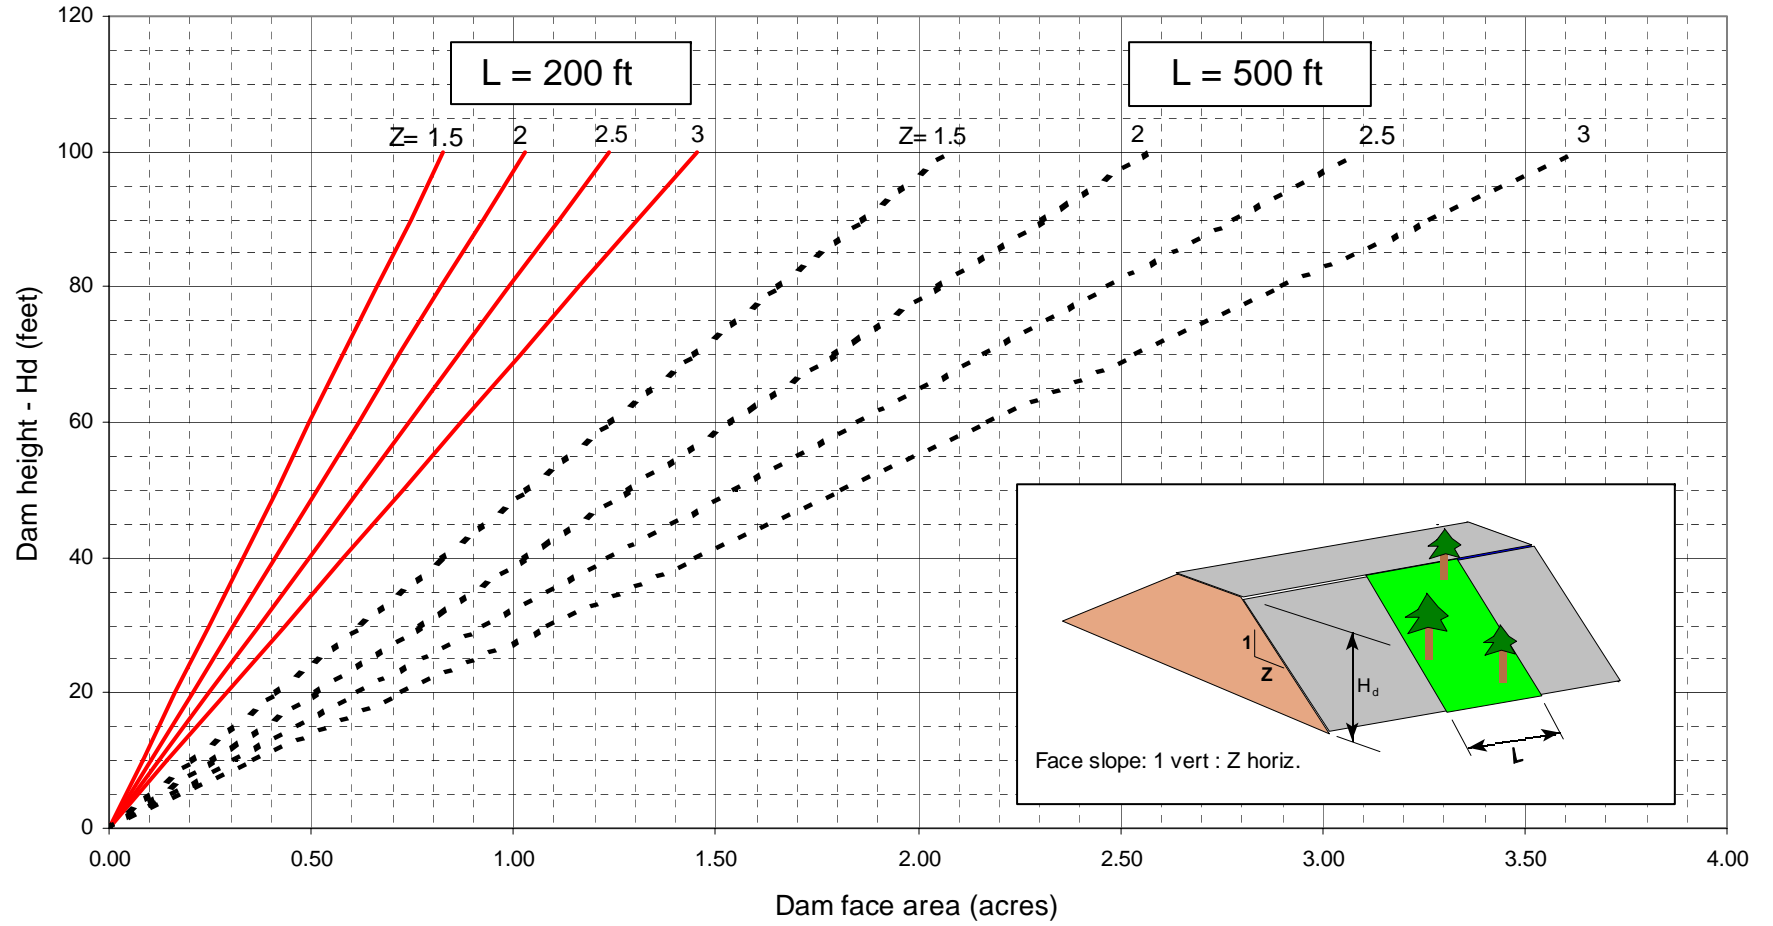
Chart 1. Dam face area for different geometries

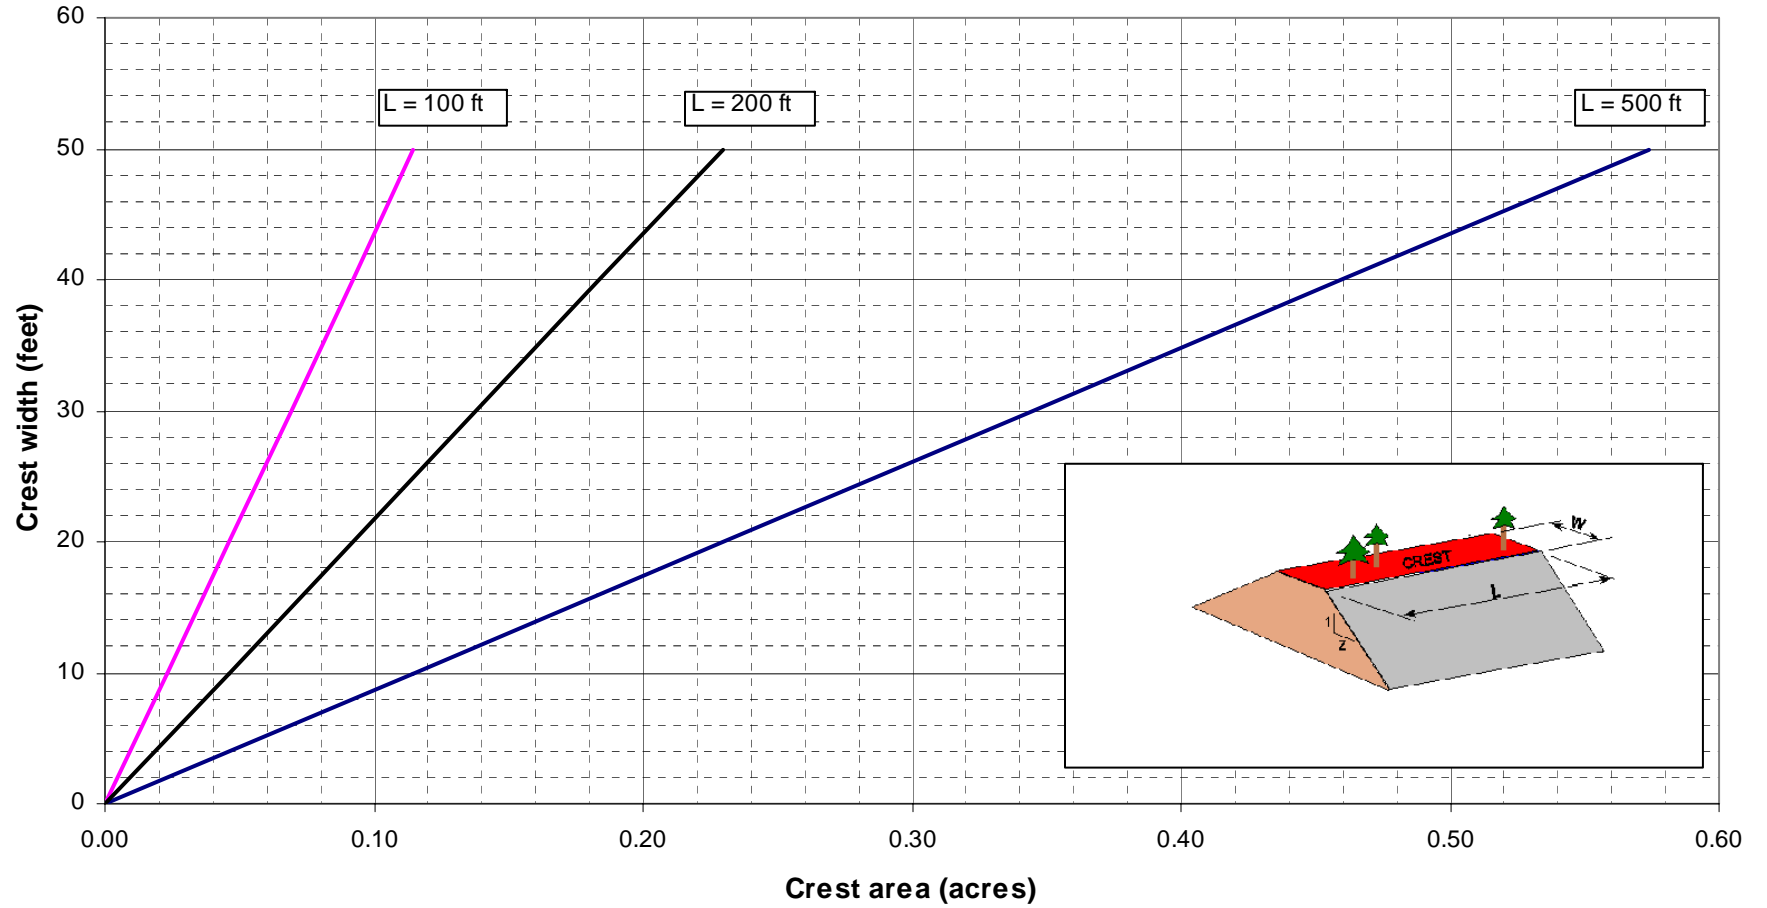
Chart 2. Dam crest area by width and length

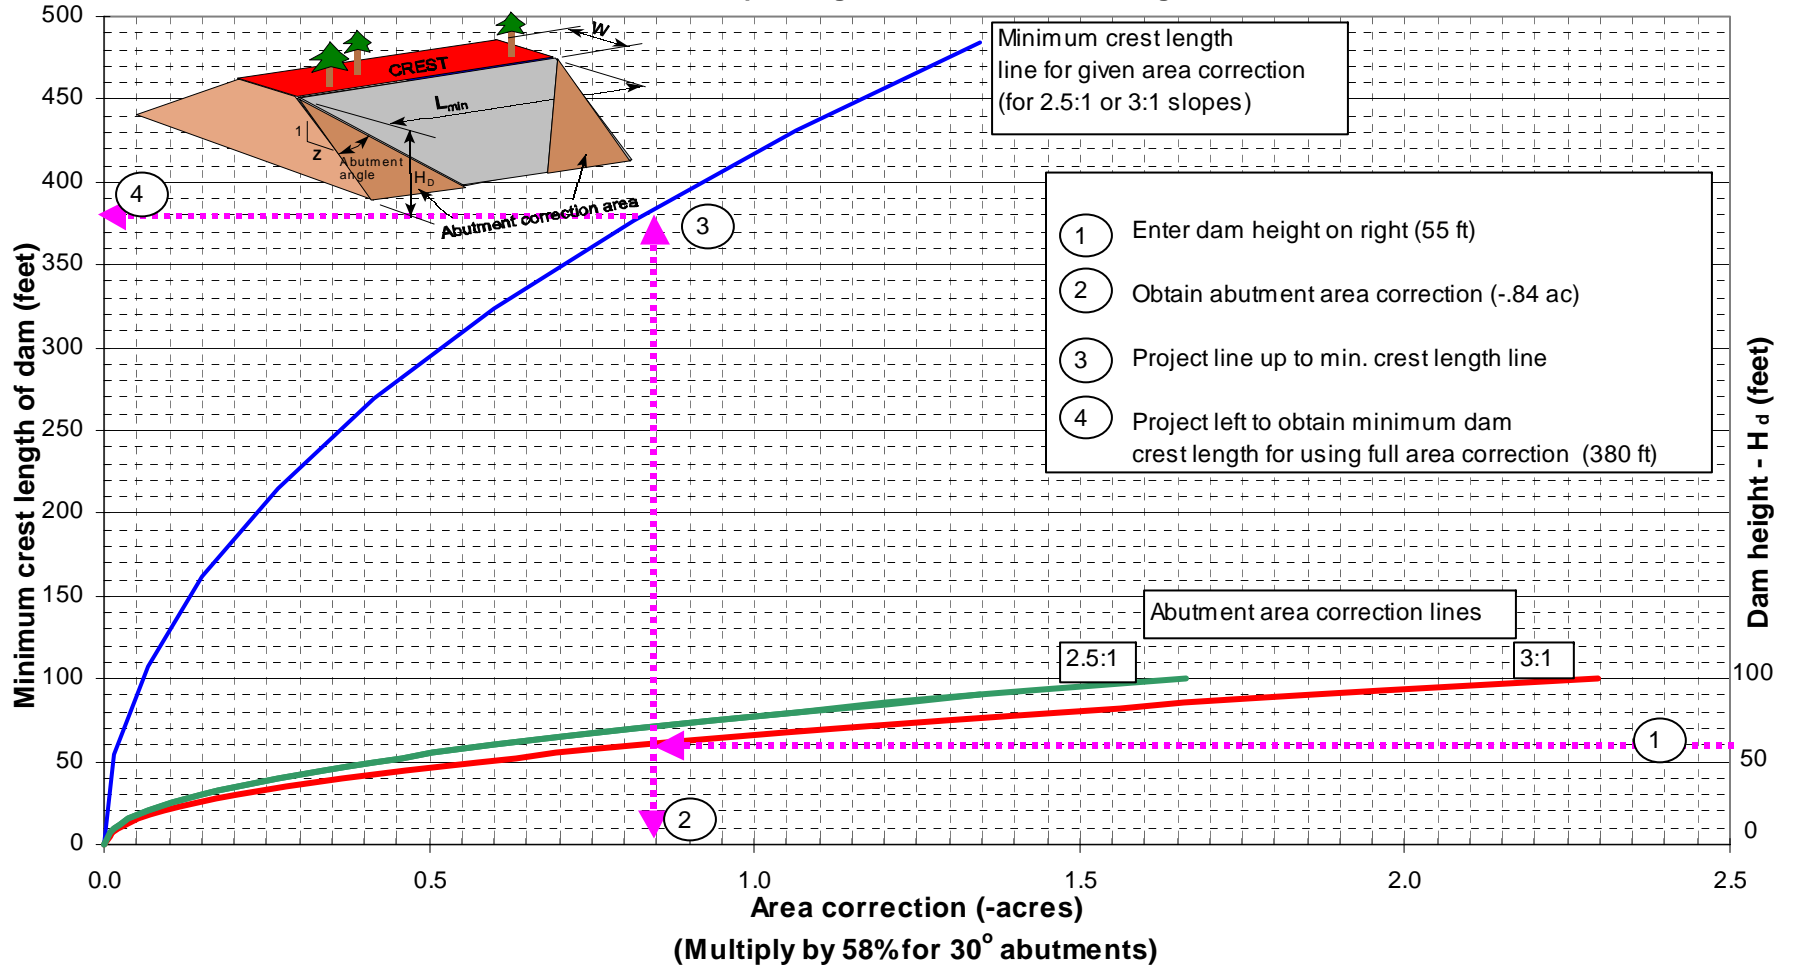
Chart 3. Abutment area corrections vs. dam height for 2.5H:1V & 3H:1V side slopes, with 45° abutment angle and corresponding minimum dam crest length
