ARM Group LLC

Re: Comment Response Letter:
Rod and Wire Mill 2022 IM Report
Area A: Parcel A3
Tradepoint Atlantic
Sparrows Point, MD 21219

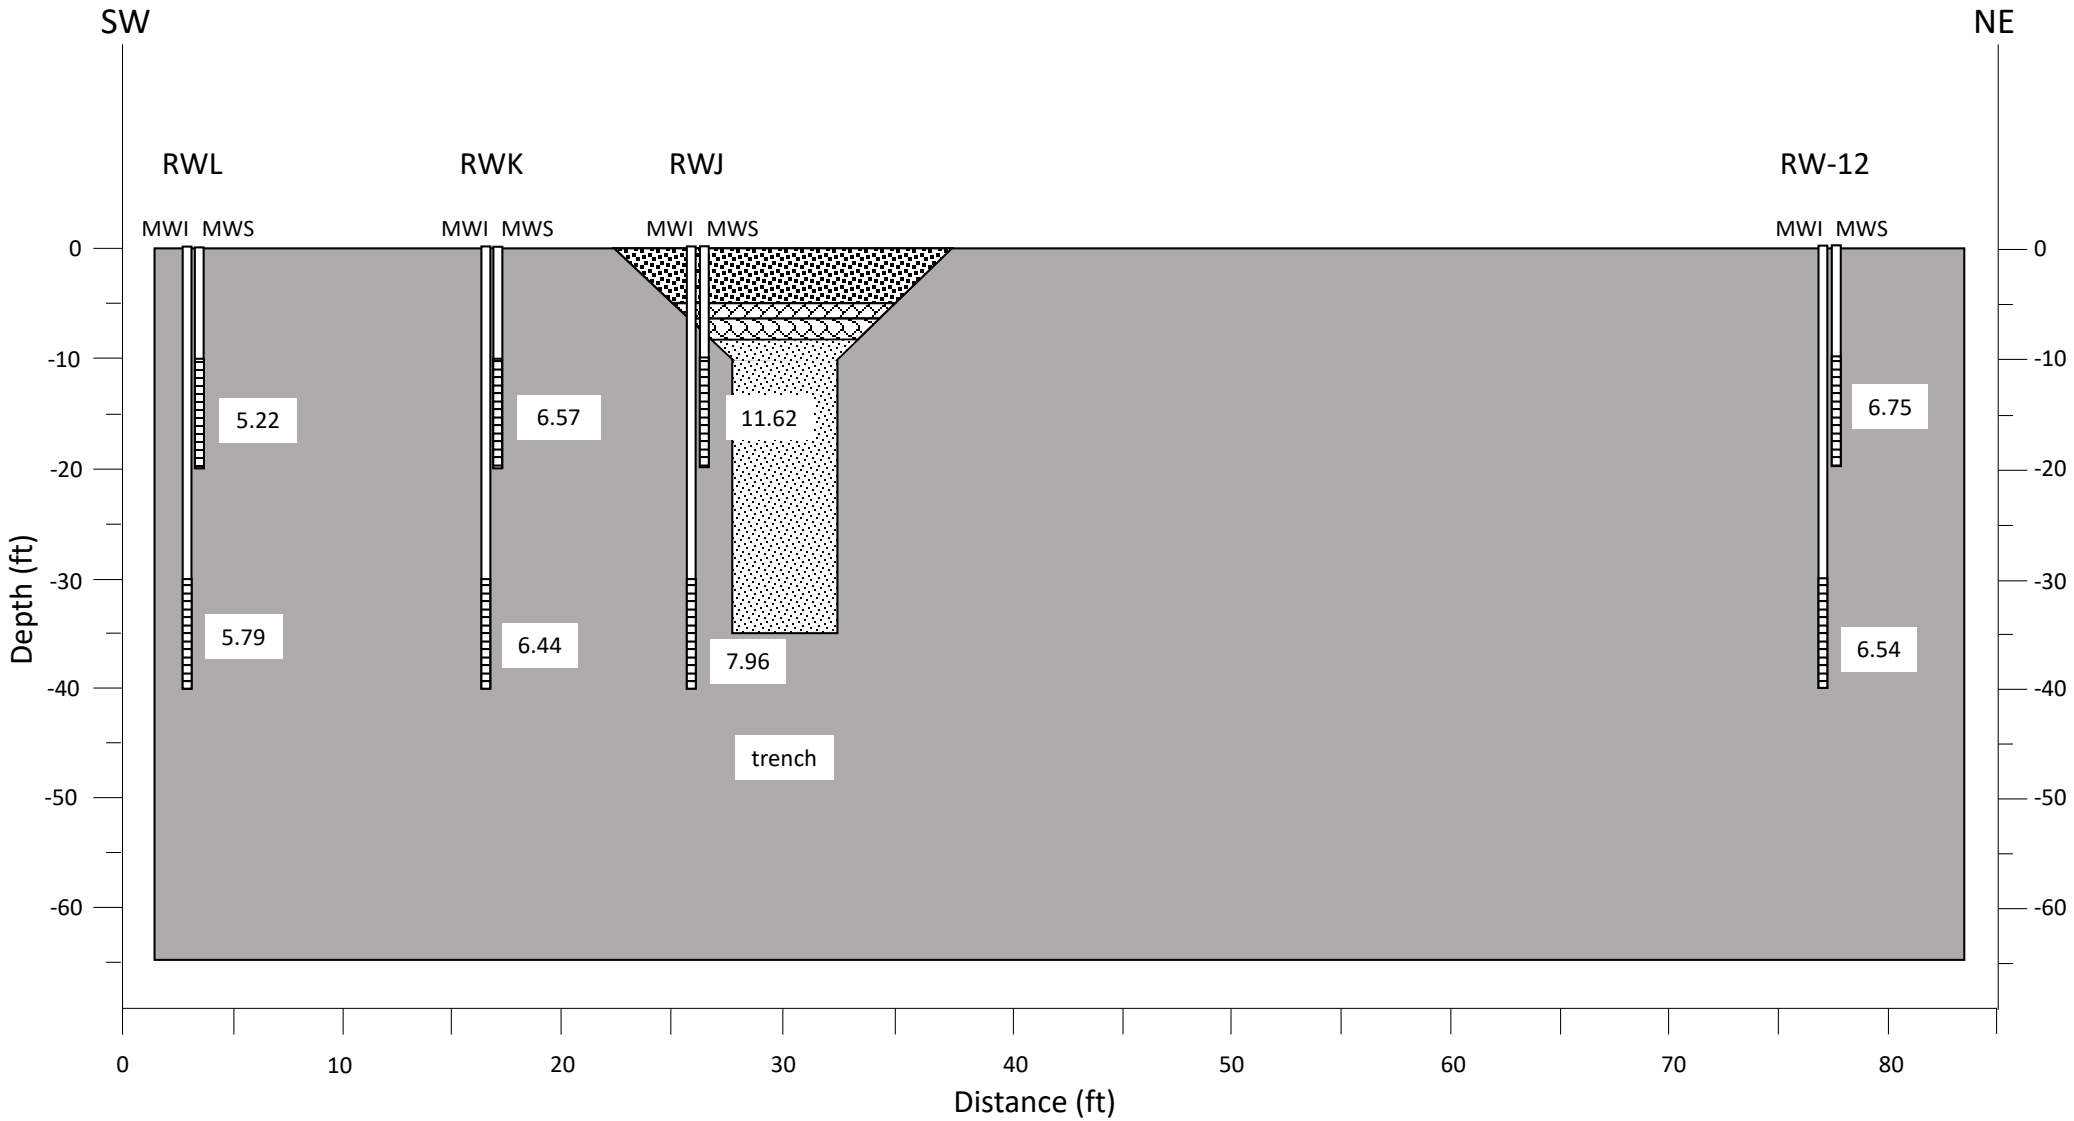
Figure 2 - Rod and Wire Mill Cross Section - pH Values

- Assumption of flat ground surface; actual ground surface varies by a few feet
- Diagram is horizontally exaggerated

Response: Please note that the remediation trenches are wider at the top than at the base, so RWJ was installed through the top of the remediation trench but is screened adjacent to the remediation trench. Refer to the attached Figure 2 showing a cross section (previously included in the 2020 IM Report). A formal survey of the trench extent is not available.

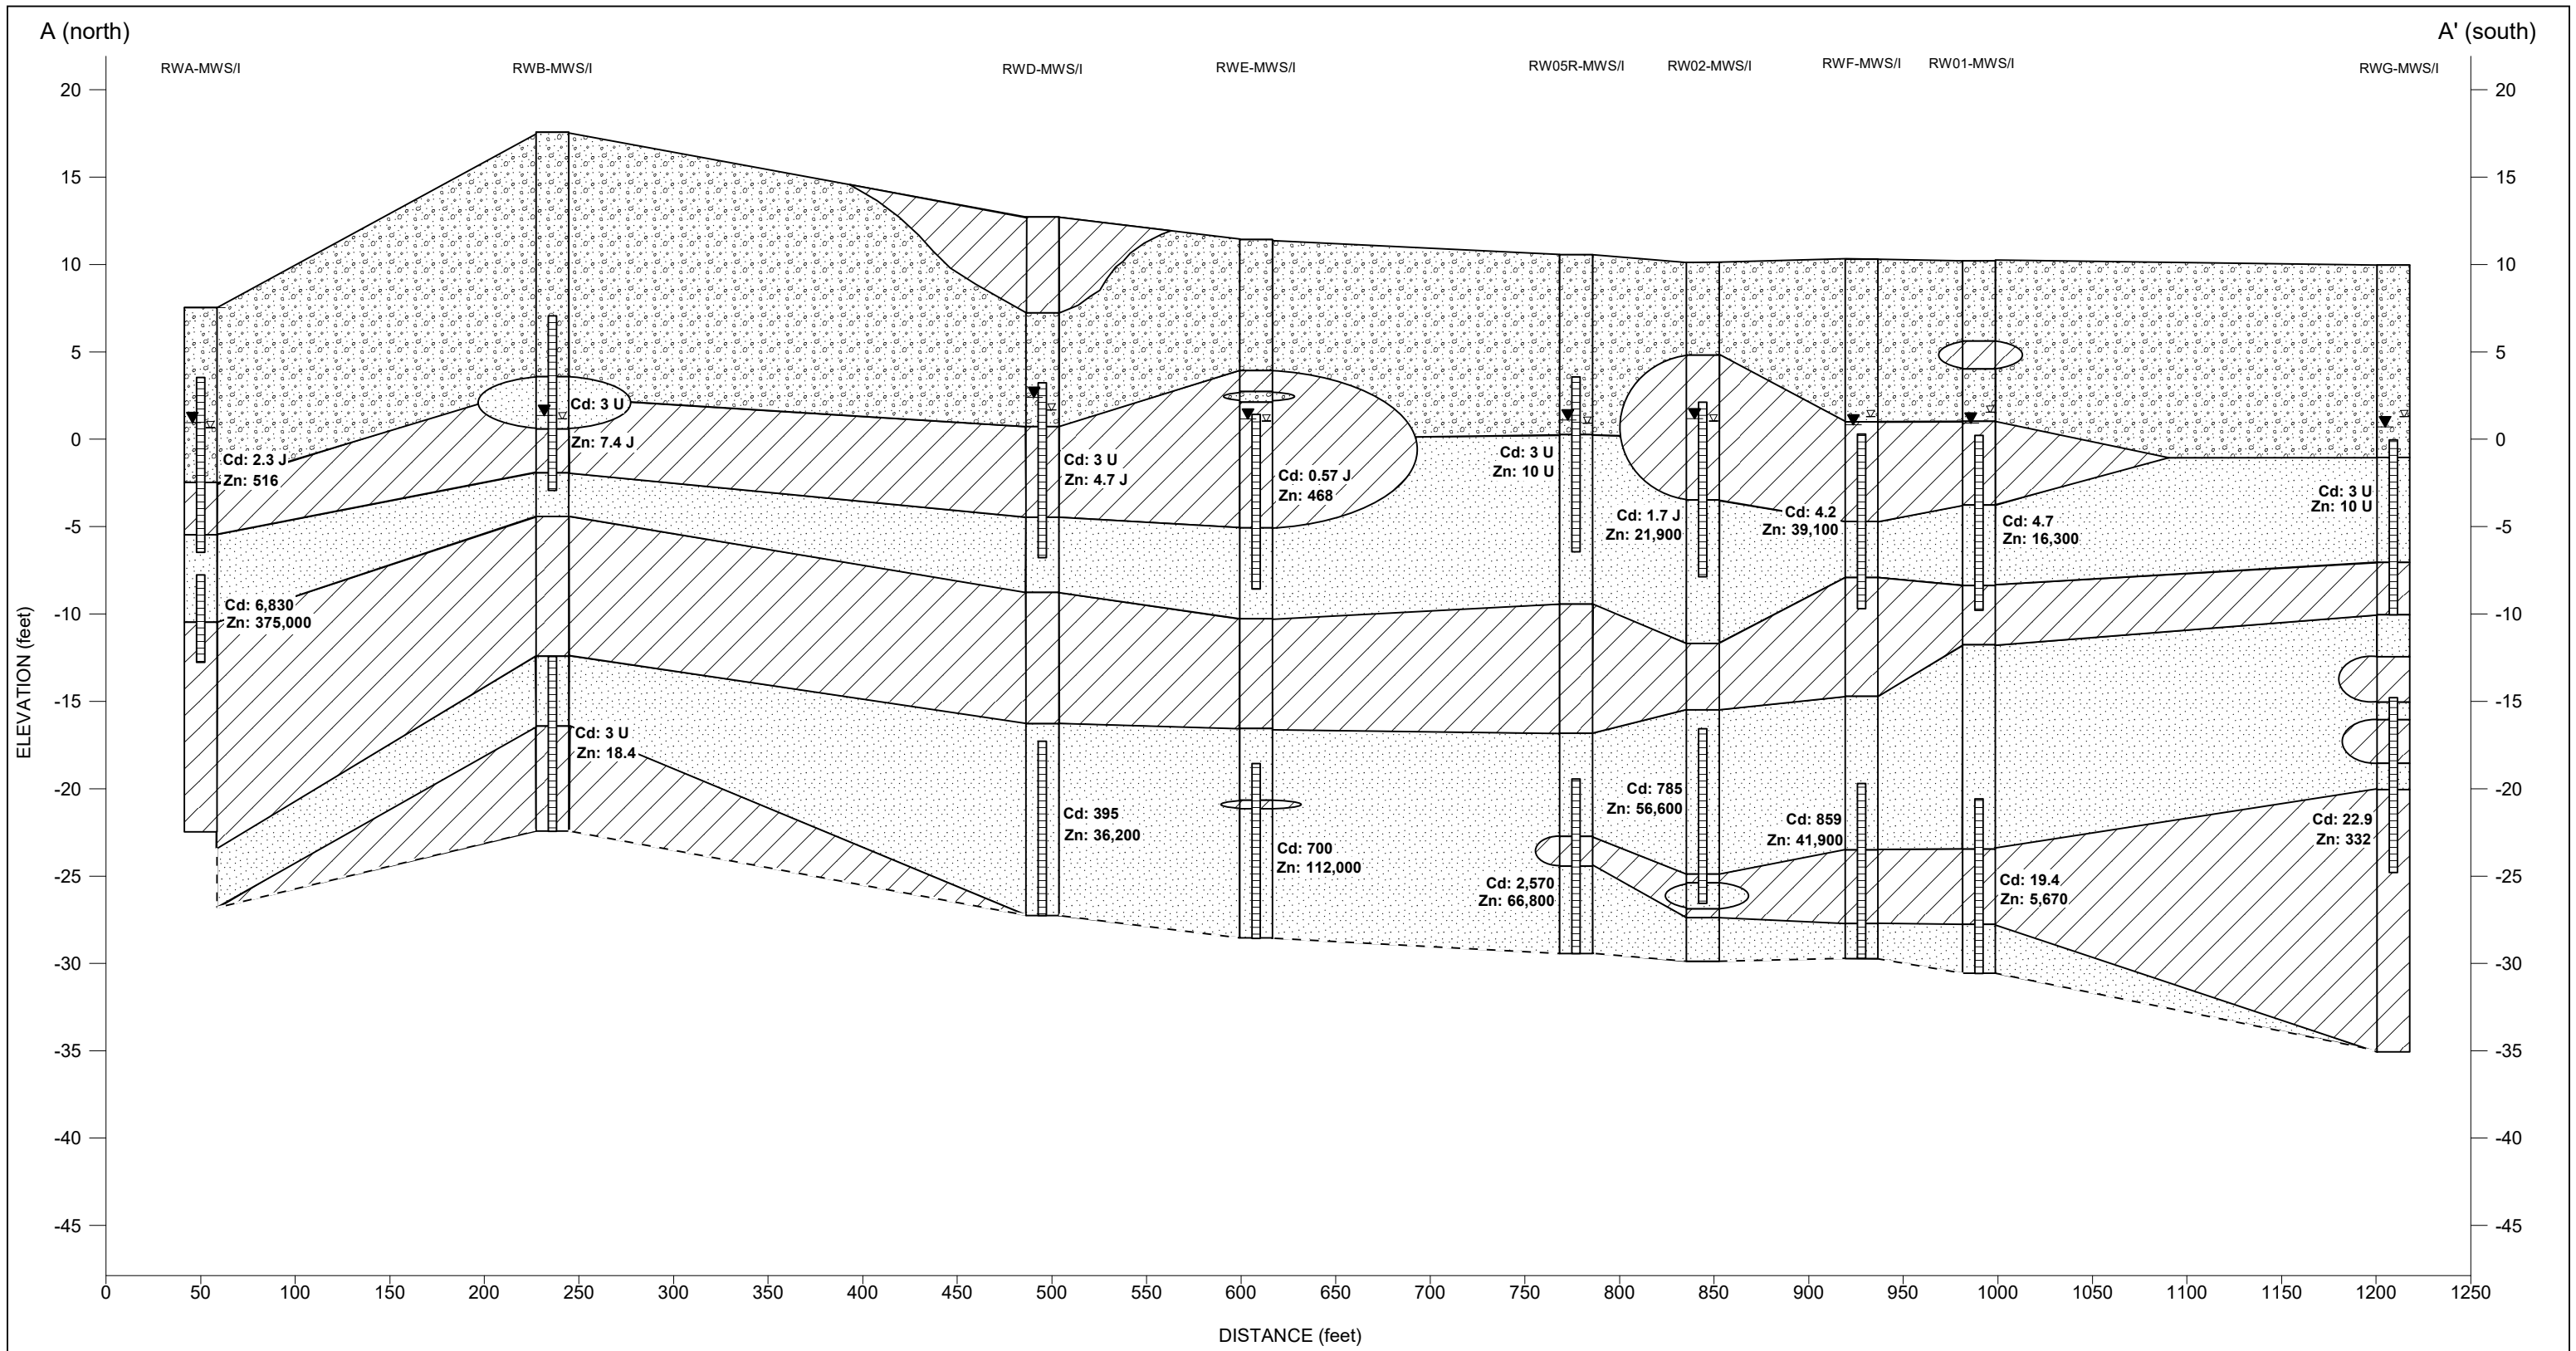
Figure 20
 Cross Section A-A'
 (Revision 1)

Slag
 Sand
 Silt/Clay

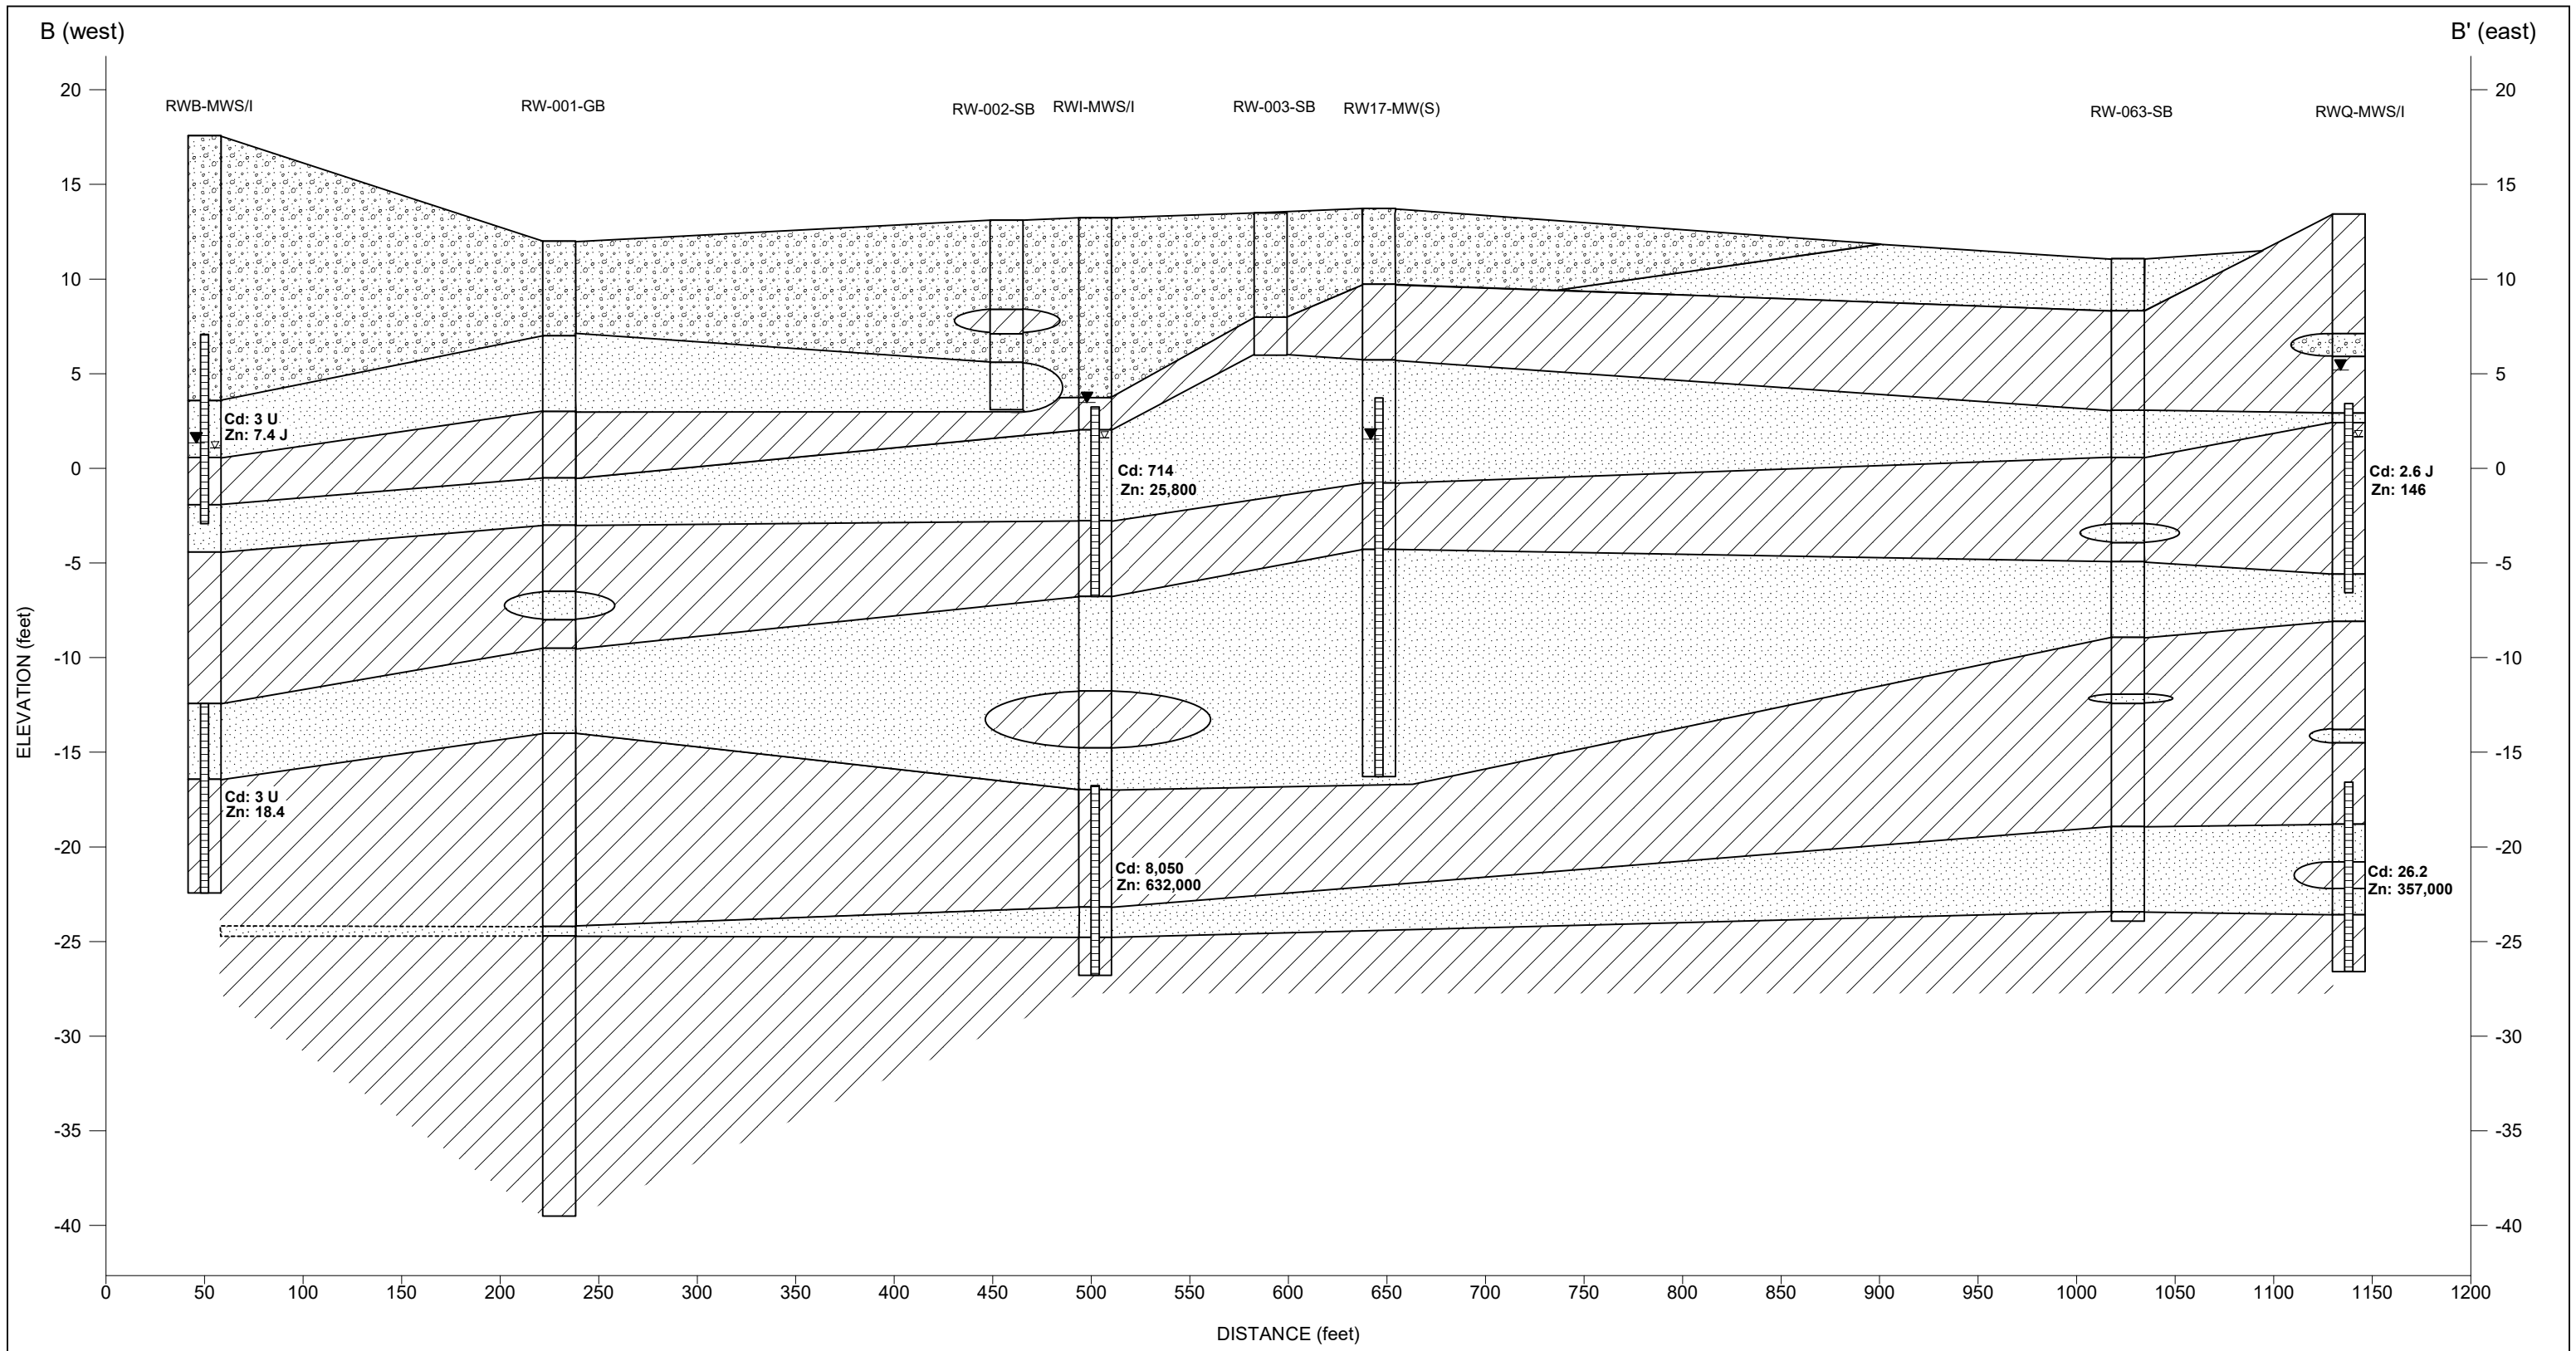
Cross-Section B-B'
 (Revision 1)

- Slag
- Sand
- Silt/Clay
- Shallow Well Groundwater Elevation
- Intermediate Well Groundwater Elevation

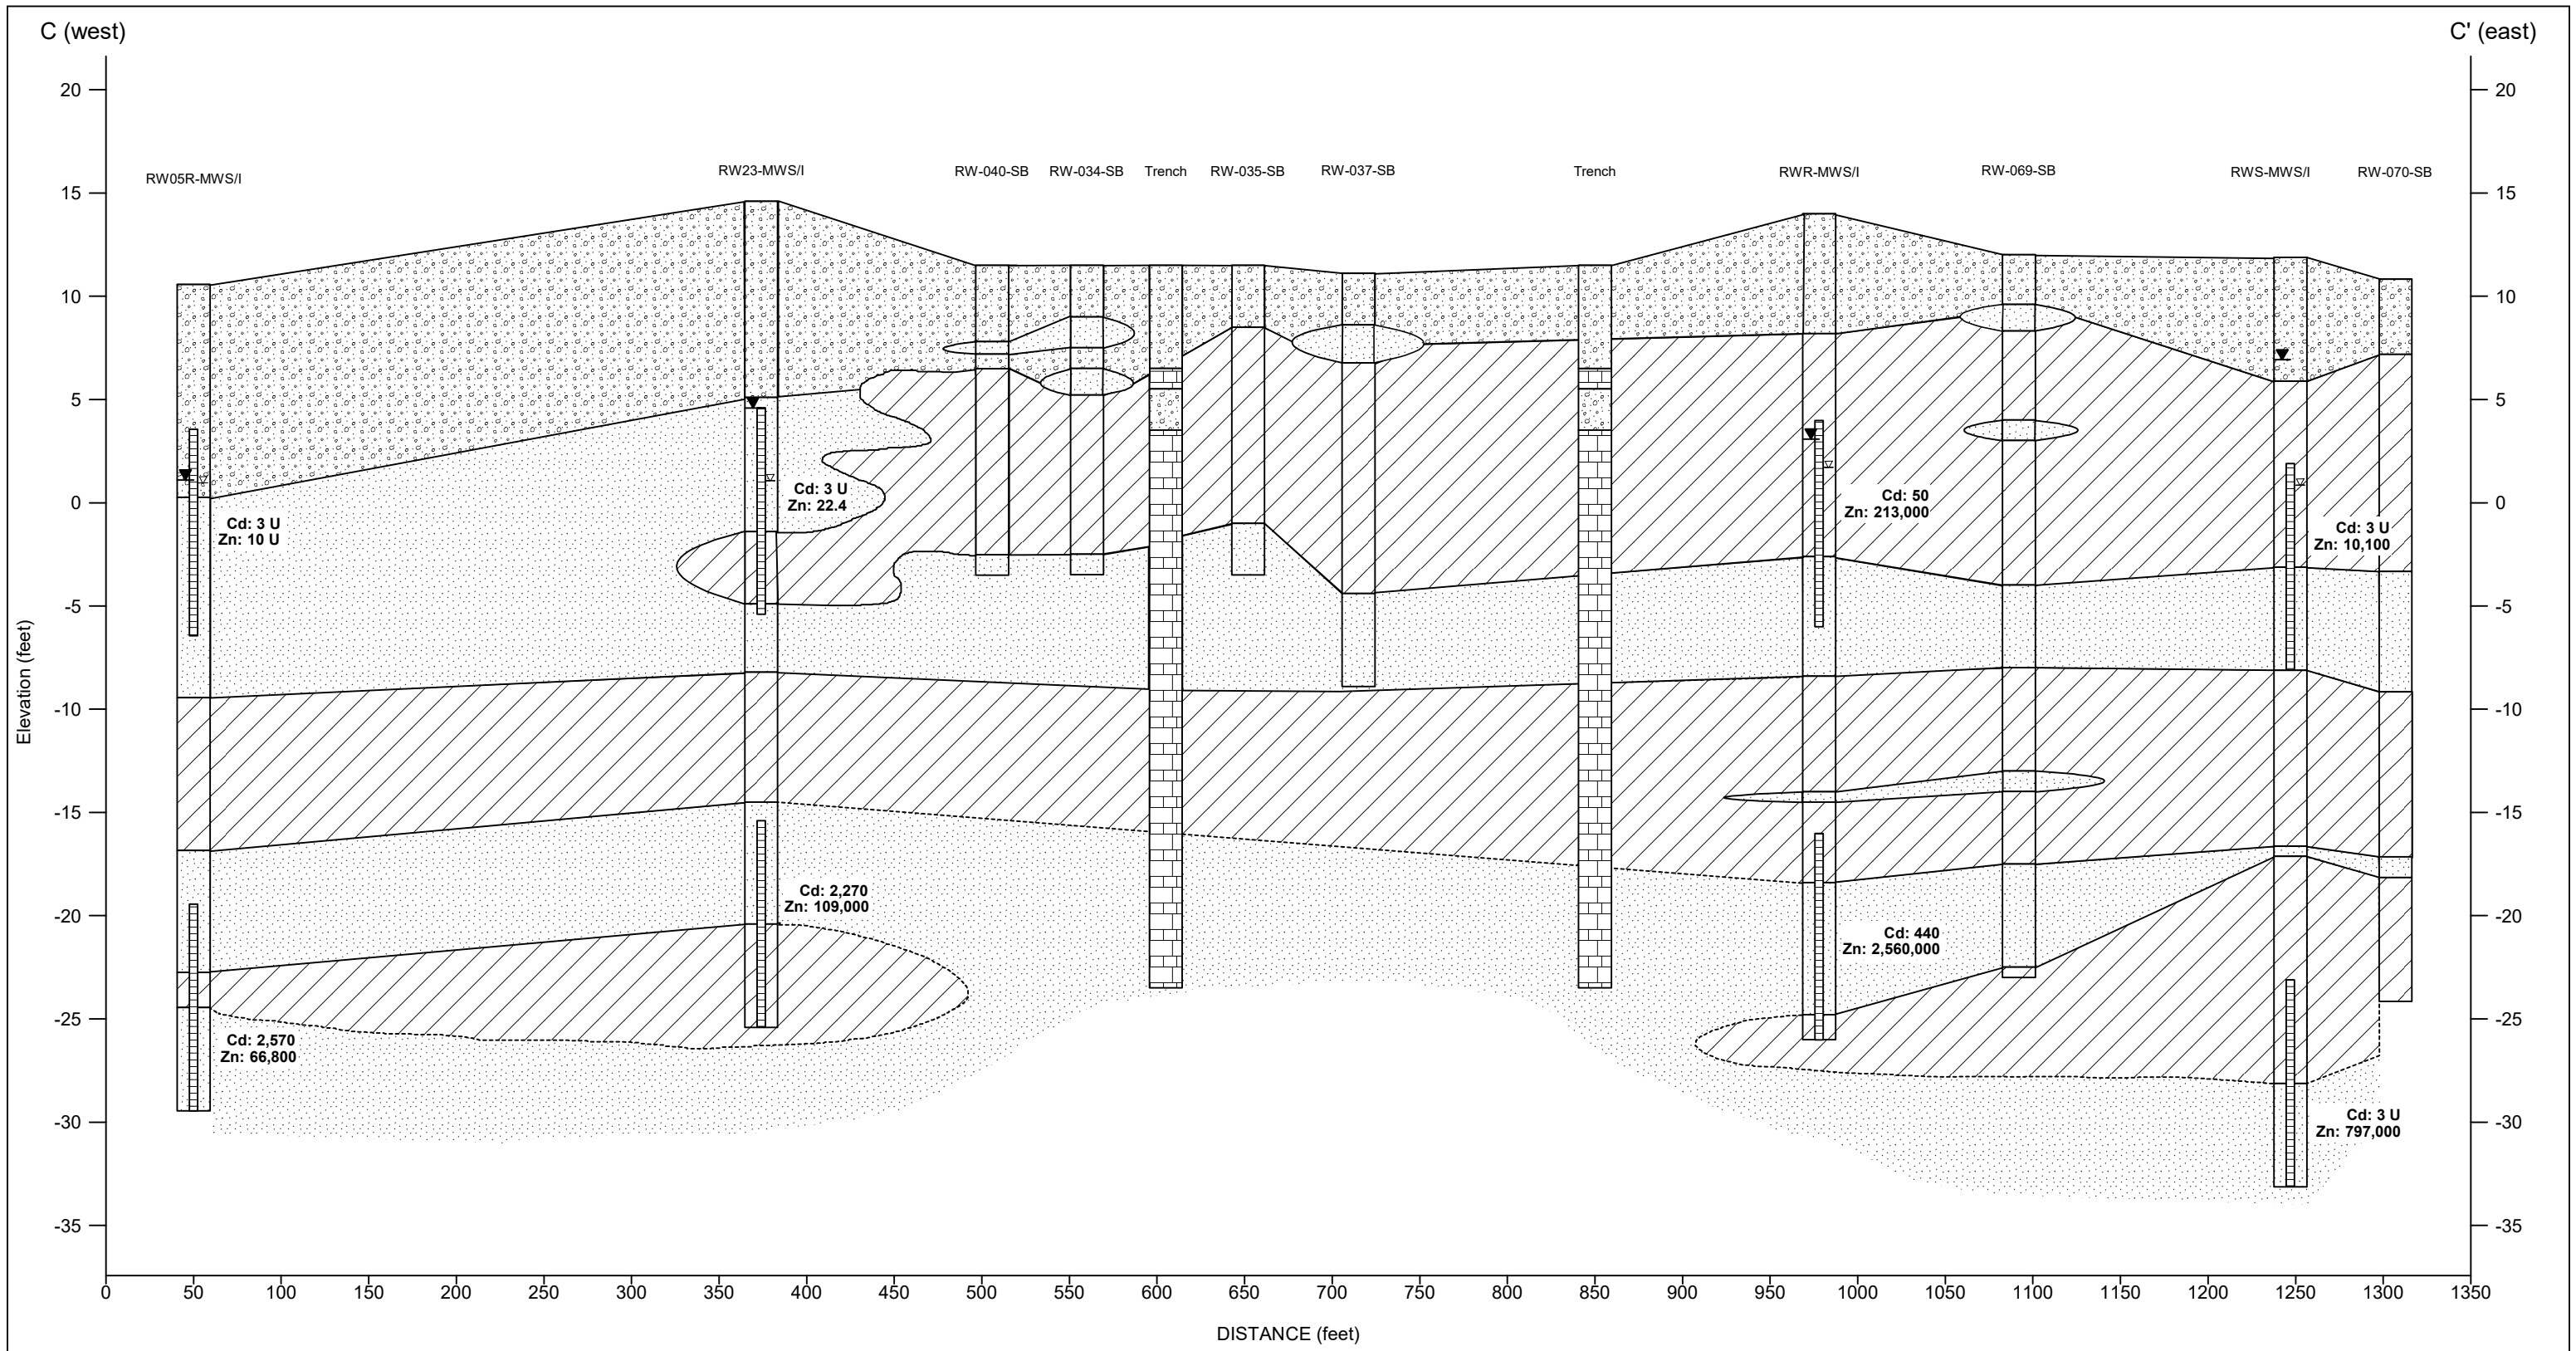
Figure 22
 Cross-Section C-C'
 (Revision 1)

- Slag
 - Sand
 - Silt/Clay
 - Trench Alkaline Charge Material
 - Shallow Well Groundwater Elevation
 - Intermediate Well Groundwater Elevation
- Notes:**
 No geologic data below bottom of boreholes.
 All concentrations are dissolved fraction in micrograms per liter.

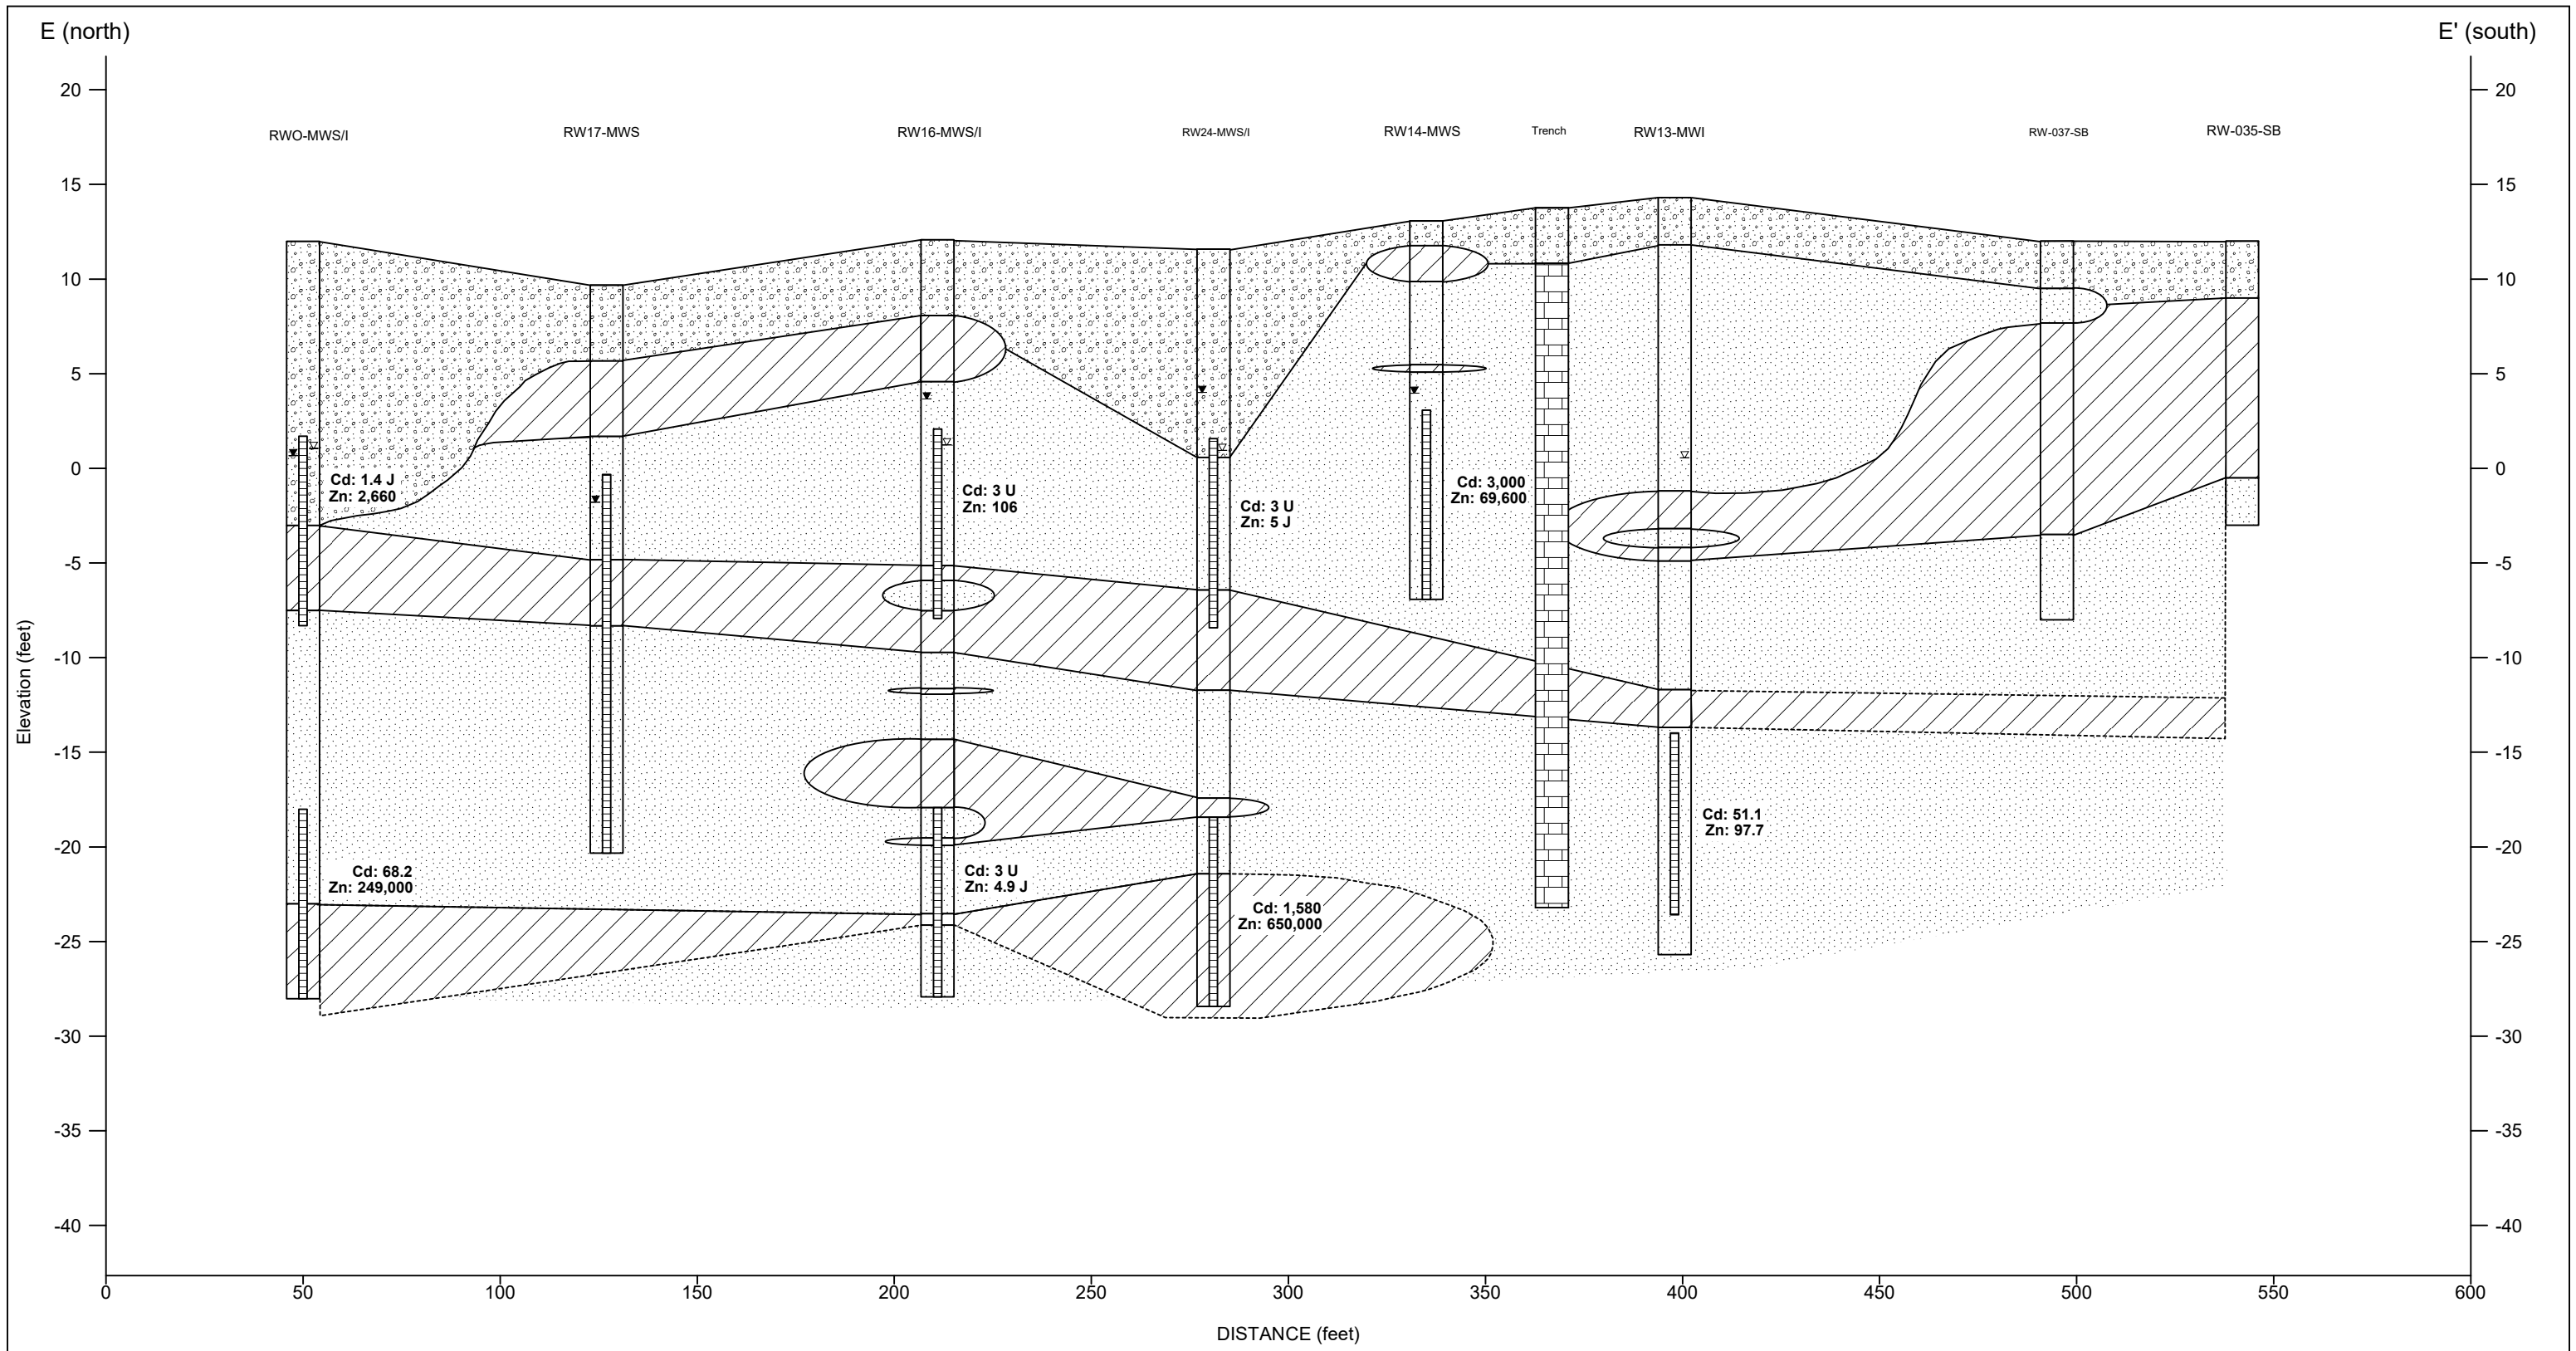
Cross-Section E-E'

- Slag
- Sand
- Silt/Clay
- Trench Alkaline Charge Material

Response: Figure 24 and Figure 25 have been updated with contour intervals of 0.5 feet.
