SOURCE WATER ASSESSMENT

FOR THE TOWN OF THURMONT FREDERICK COUNTY, MD

Prepared By
Maryland Department of the Environment
Water Management Administration
Water Supply Program
February 2000

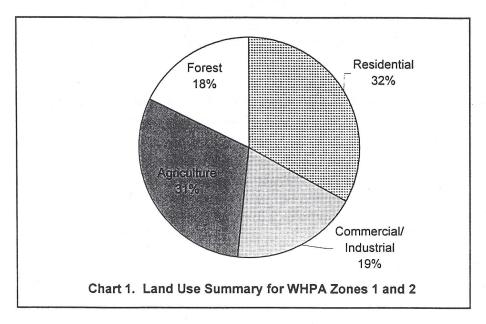
Based on the Maryland Office of Planning's 1997 Land Use map, the land use within WHPA Zones 1 and 2 is split evenly between residential, commercial and agricultural, and forest (Chart 1). WHPA Zone 3 is predominantly forested with small pockets of residential, commercial, and agricultural areas (Fig 3.). Table 3 outlines the distribution of land use within the WHPA Zone 3.

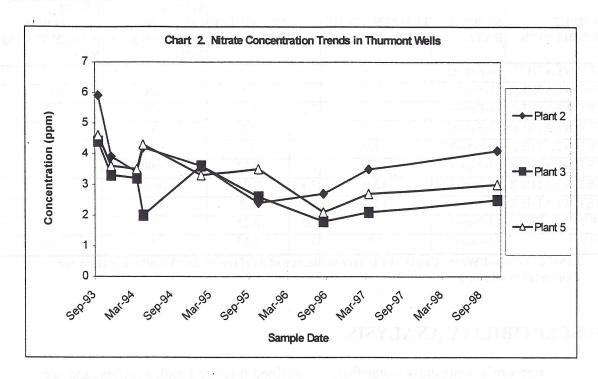
Nitrate is present in all of Thurmont's wells below the MCL. Sources of nitrate can generally be traced back to land use. Fertilization of agricultural fields and residential lawns, and septic systems are two non-point sources that are generally associated with nitrate loading in ground water. Nitrate is also found in precipitation throughout Maryland, which is the primary recharge of unconfined aquifers, due to reactions with atmospheric nitrogen (Bolton, 1996). Agricultural land makes up 31% (Table 3a) and non-sewered residential and commercial areas make up approximately 7% of WHPA Zones 1 and 2 based on 1997 land use. Trends in nitrate concentration in Thurmont's wells show that they peaked in 1993, were on a decline until 1996 and have been slowly on the rise since (Chart 2).

The fluctuations in nitrate concentration may be attributable to many factors including residential development, changes in agricultural practices, and seasonal variations in nitrate concentration in ground water recharge. Samples are collected annually, however they have not been consistently collected during the same time of year (Table 4). Currently, it appears that nitrate concentration is on the rise in Thurmont's water supply. Due to this and the numerous potential sources of nitrate the water supply is considered susceptible to this contaminant.
