Maryland Department of Environment

Inspector: AI ID:	Samantha Coffman 8449
Site Name: Facility Address:	Back River WWTP 8201 Eastern Ave, Baltimore, MD 21224
County: Start Date/Time: End Date /Time:	Baltimore County April 26, 2023 10:30 AM April 26, 2023 02:30 PM
Media Type(s):	NPDES Municipal Major Surface Water
Contact(s):	Ronald Turner, Plant Superintendent, Back River WWTP Andrea Buie-Branam, Chief of ERCS, Baltimore City DPW Michael Hallmen, Chief of Wastewater Facilities Division, Baltimore City DPW Betty Jacobs, Back River WWTP Dan Latova, Back River WWTP Dana Gams, Back River WWTP Rayford McEachern, Back River WWTP Herbert Bell, Atkins Vel Subramanian, Atkins

NPDES Municipal Major Surface Water

Permit / Approval Numbers: 15DP0581 NPDES Numbers: MD0021555 Inspection Reason: Follow-up (Non-Compliance), Initial Quarterly Site Status: Active Compliance Status: Noncompliance Site Condition: Noncompliance Recommended Action: Additional Investigation Required Evidence Collected: Photos or Videos Taken, Visual Observation Delivery Method: Email Weather: Partly Cloudy

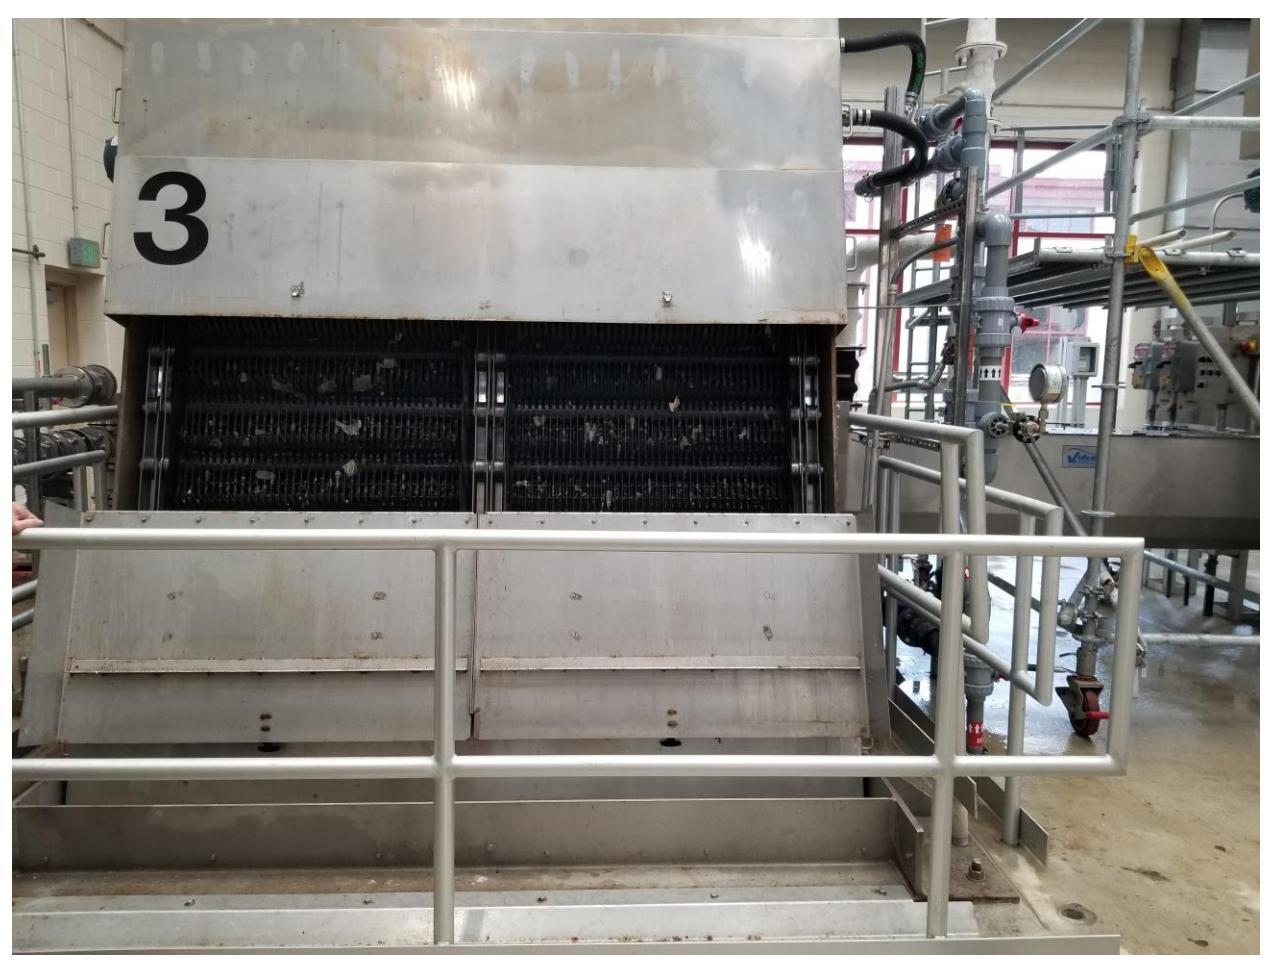
During this inspection, no problems were observed at the fine screening units area. The floor by the fine screening units was observed to be free of debris/rags.

4/26/23 Fine screening unit #3 was observed to be operating during inspection.

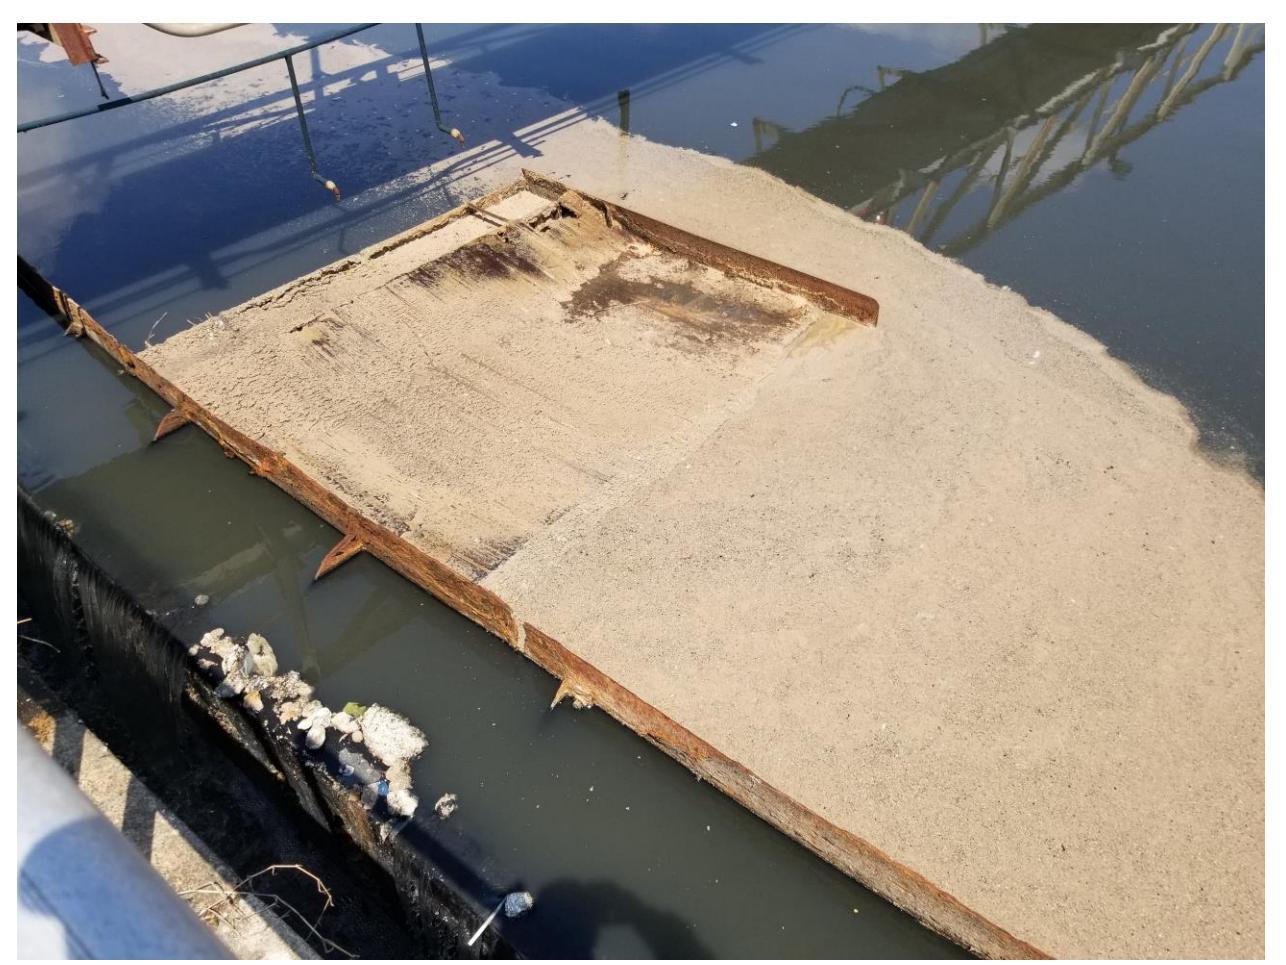
The next area of evaluation was at the PSTs. No issues were observed during inspection of PSTs #8, 11, and 7. The scum trough at PST #1 was observed to be clogged with scum and requires routine maintenance.

4/26/23 PST #1 – scum trough was observed to be clogged with scum.

- 6. The scum trough on PST #1 is clogged with scum and requires routine maintenance. This is a violation of General Condition B3 of the NPDES permit.
- 7. The scum troughs on secondary clarifiers 13B and 14B are clogged with scum and require routine maintenance. The skimming arm on secondary clarifier 12A is missing the skimming flap. This is a violation of General Condition B3 of the NPDES permit.

- F. With respect to item #6 above, the Back River WWTP should maintain the PSTs as required to keep them functioning properly to comply with the requirements under General Condition B3 of the NPDES permit. The scum pit should be pumped out as necessary and the scum trough should be cleaned. Going forward, the scum troughs on the PSTs should be routinely inspected and the scum pits pumped out as necessary to keep the scum trough openings clear.

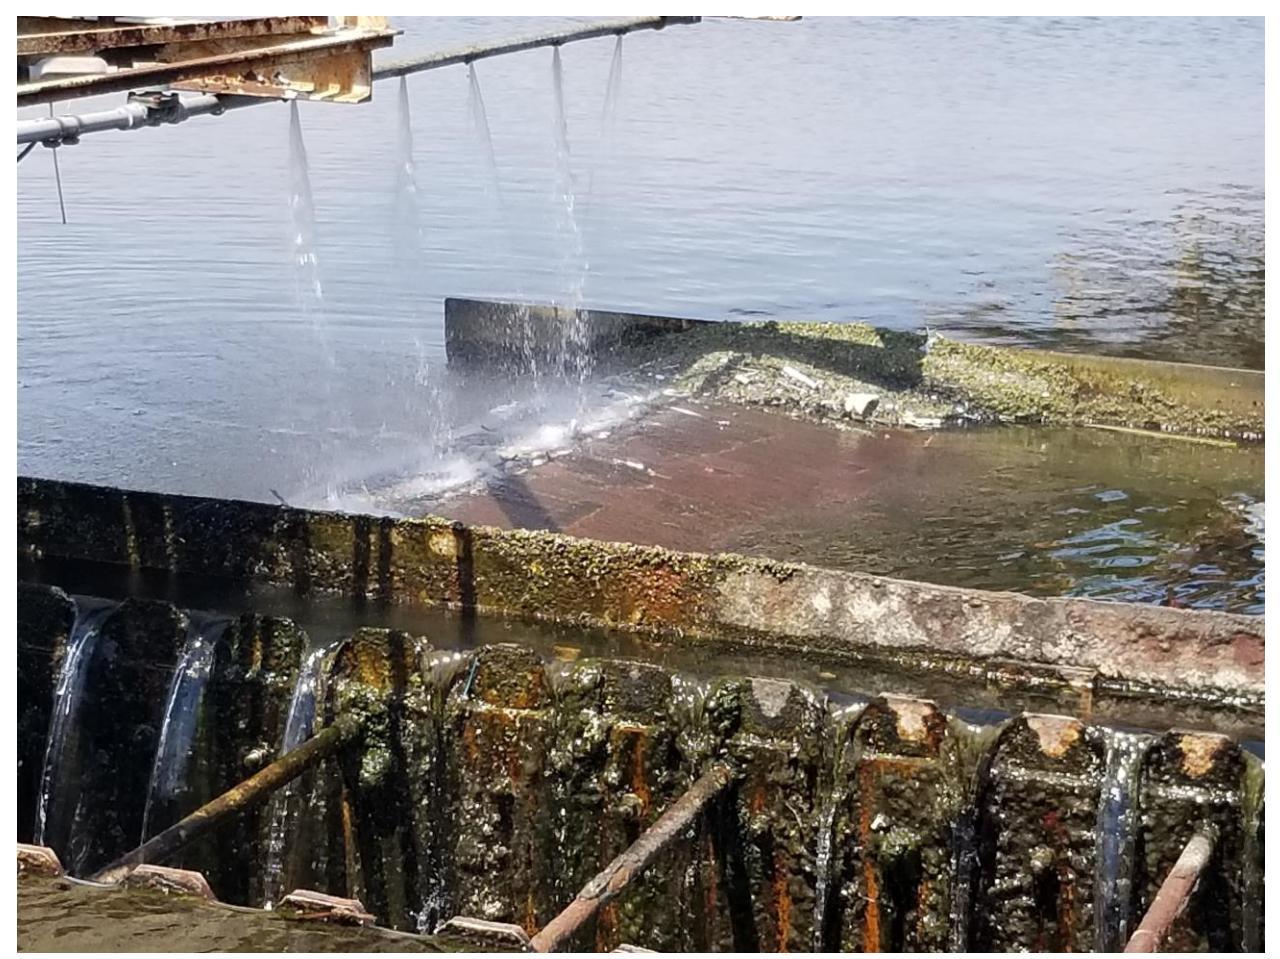
Secondary clarifiers 13B, 12A, 12B, and 14B were observed during inspection. The scum trough at secondary clarifier 13B was observed to be clogged with scum and requires routine maintenance. The skimming arm on secondary clarifier 12A was observed to be missing the skimming flap. According to Betty Jacobs at the time of inspection, secondary clarifier 12B is most likely being taken down for maintenance. The scum trough at secondary clarifier 14B was observed to be clogged with scum and requires routine maintenance.

4/26/23 Secondary clarifier 13B – scum trough was observed to be clogged with scum.

- G. With respect to item #7 above, the Back River WWTP should maintain the secondary clarifiers as required to keep them functioning properly to comply with the requirements under General Condition B3 of the NPDES permit. The scum pits should be pumped out as necessary and the scum troughs should be cleaned. The skimming flap for the skimming arm on secondary clarifier 12A should be installed. Going forward, the scum troughs on the secondary clarifiers should be routinely inspected and the scum pits pumped out as necessary to keep the scum trough openings clear.

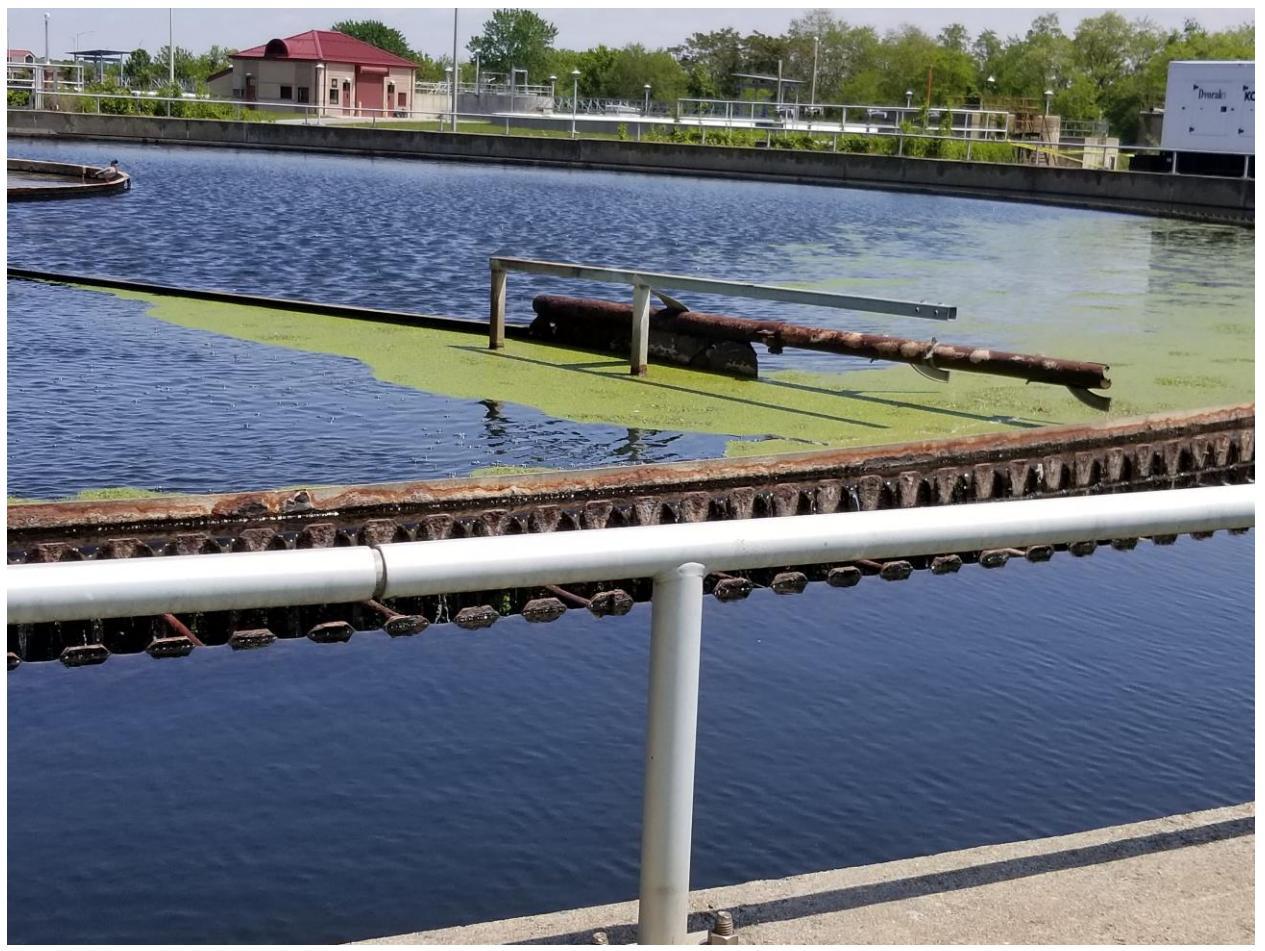
4/26/23 Secondary clarifier 12A – the skimming arm on secondary clarifier 12A was observed to be missing the skimming flap.

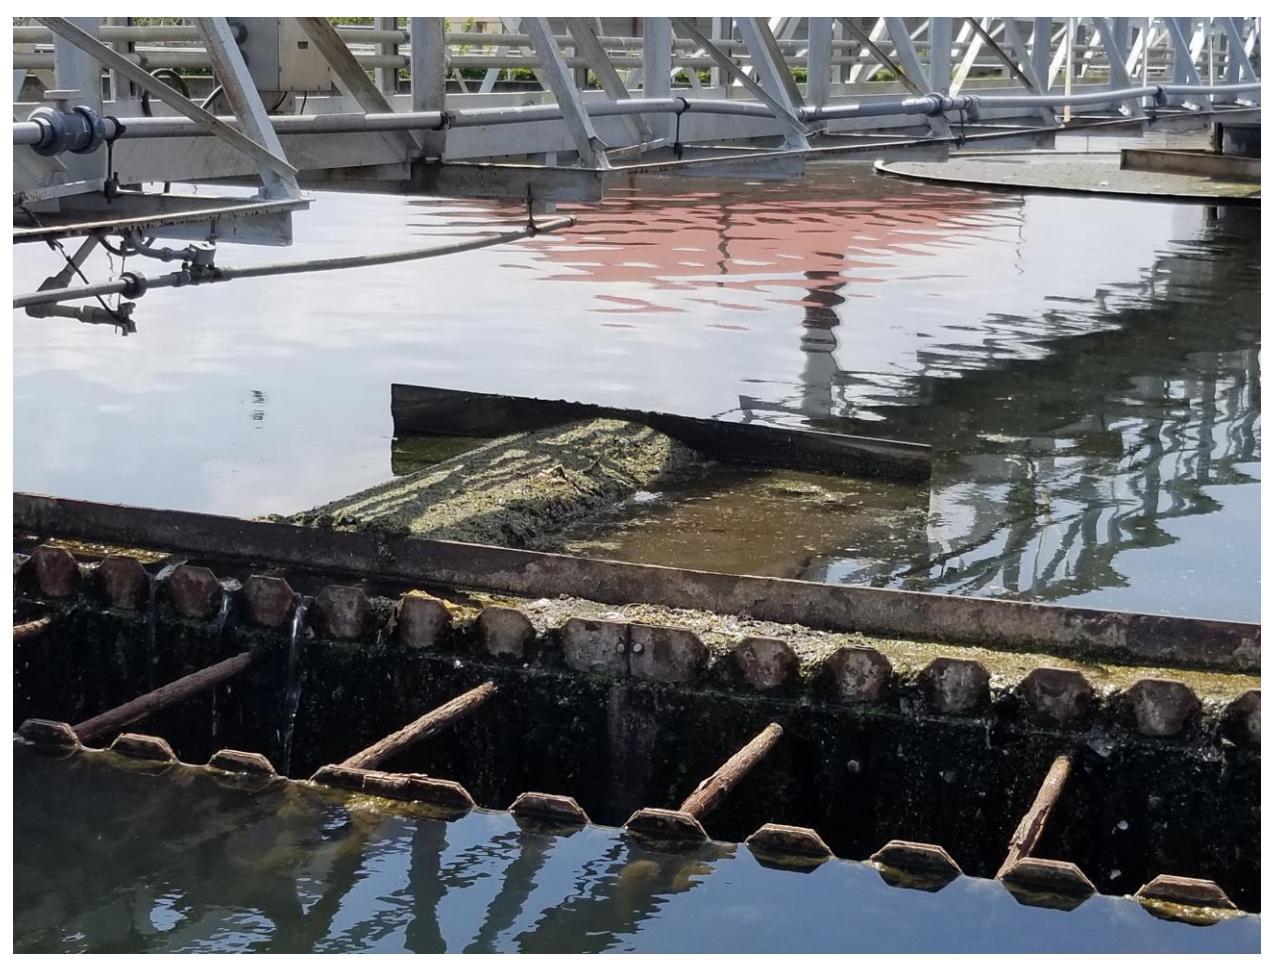
4/26/23 Secondary clarifier 14B – scum trough was observed to be clogged with scum.

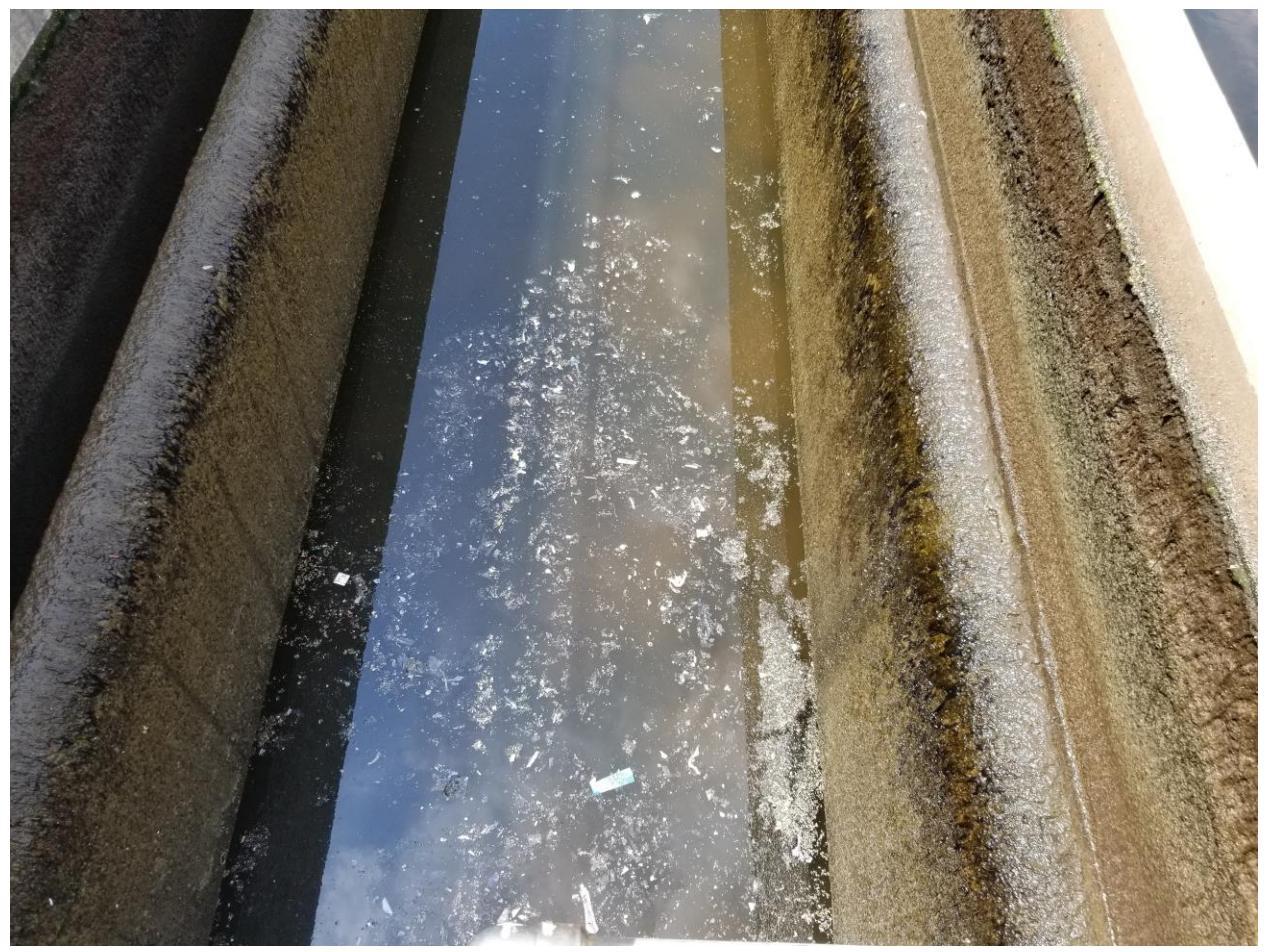
During an inspection of the filters in quads #1 and #2, there were still floating solids observed in the filter at the end of the quad (also observed during inspection on 1/26/23 and 2/24/23).

4/26/23 Solids and trash observed to be floating on water surface in the DNFs.

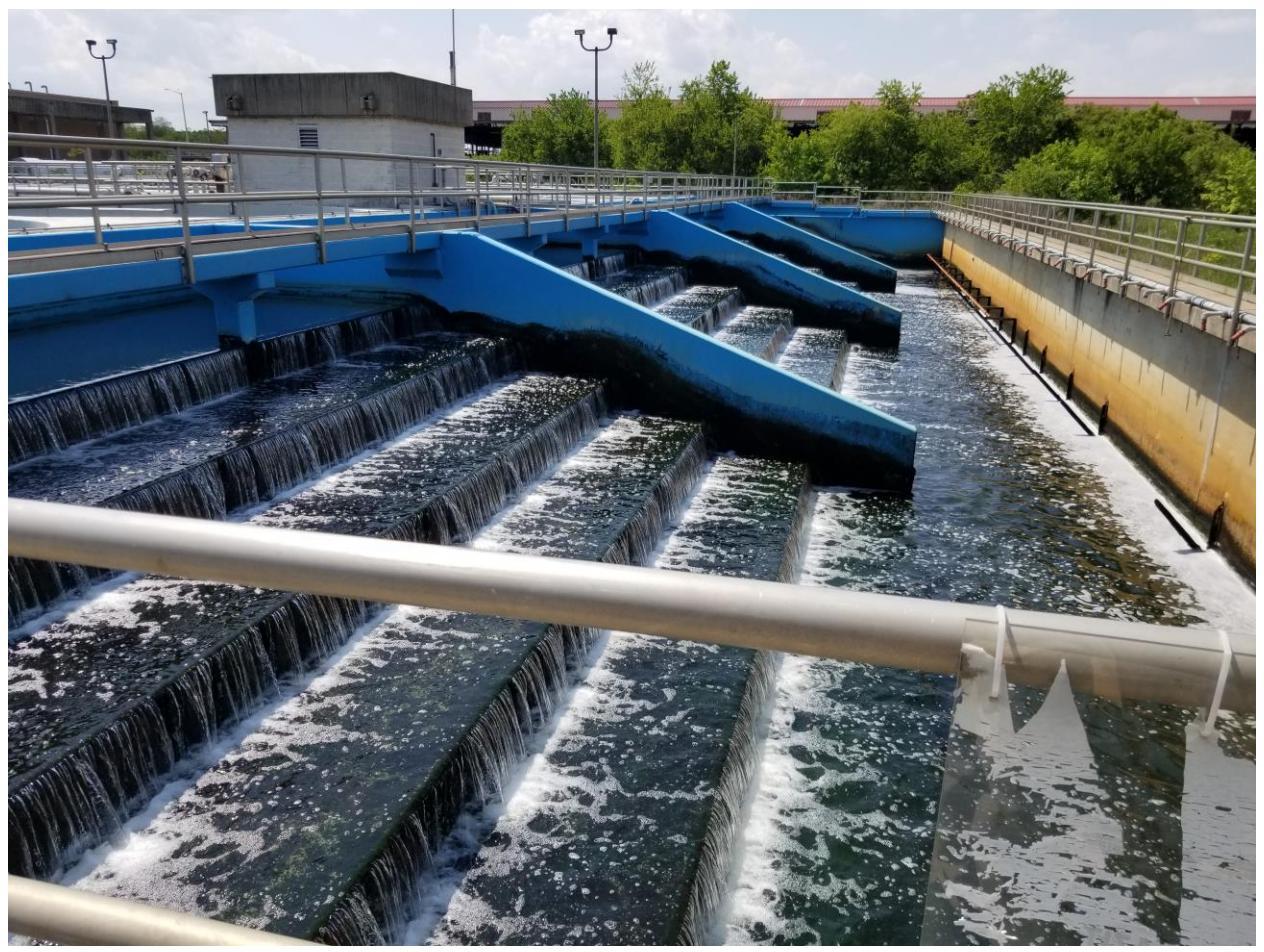
Next, I inspected the final effluent at the step aeration system. During an evaluation of the final effluent, I observed that the effluent was clear with no visible particulates. Much less flow was observed today than observed in previous inspections. According to Timothy Simmons, they are most likely taking it down to scrape the algae off.

4/26/23 Final Effluent at the step aeration system.
