Conduits through Embankment Dams

Best Practices for Design, Construction, Problem
Identification and Evaluation, Inspection,
Maintenance, Renovation, and Repair

L-266/September 2005

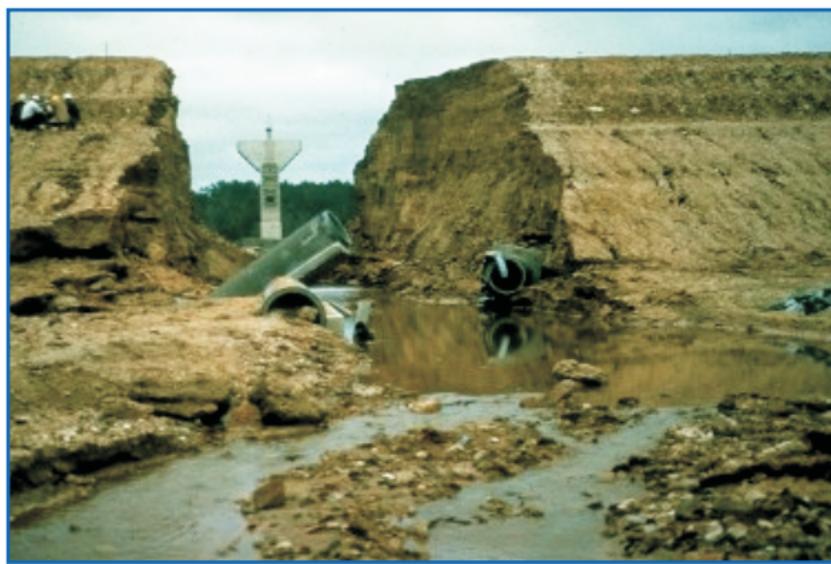
Failure of an embankment dam due to the discontinuity represented by the conduit.

A conduit represents a discontinuity through an embankment dam and its foundation. This discontinuity can cause settlement to be different adjacent to the conduit than it is in the rest of the embankment dam. Earthfill may also be compacted differently around a conduit than for the rest of the embankment dam. These factors can cause cracking of the earthfill and lead to other consequences. Failures of embankment dams caused by the uncontrolled flow of water through the dam or foundation are a common problem.

A conduit can develop defects from deterioration, cracking from foundation compressibility, or joint separation due to poor design and construction. Water leaking from defects in conduits can contribute to seepage pressures exceeding those that occur solely from flow through soils in the embankment dam from the reservoir. When preferential flow paths develop in the earthfill through which water can flow and erode the fill, severe problems or breaching type failures often result.

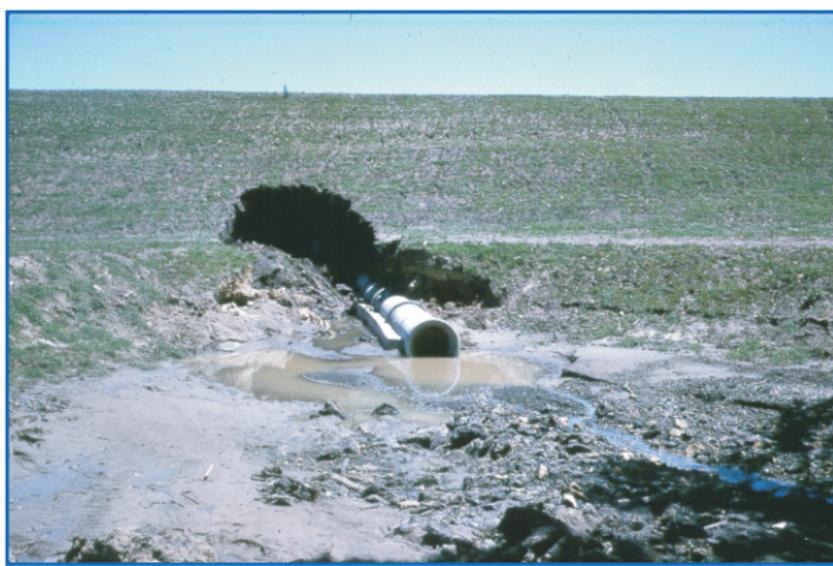
A failure due to internal erosion often leaves a tunnel-shaped void along the conduit.

“Internal erosion” describes the more common way that water can damage embankment dams, as it flows through cracks, discontinuities at the interfaces between conduits and earthen embankments or their foundations, or other preferential flow paths. Seepage flow for internal erosion is typically concentrated.

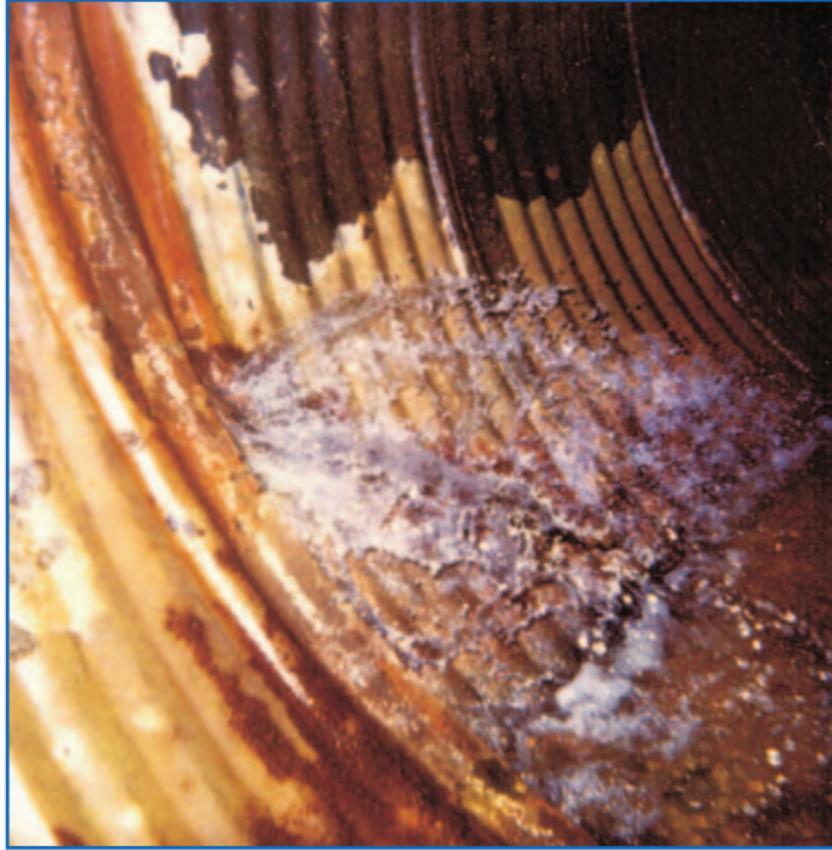
Leakage through a defective joint in a corrugated metal pipe outlet works conduit.

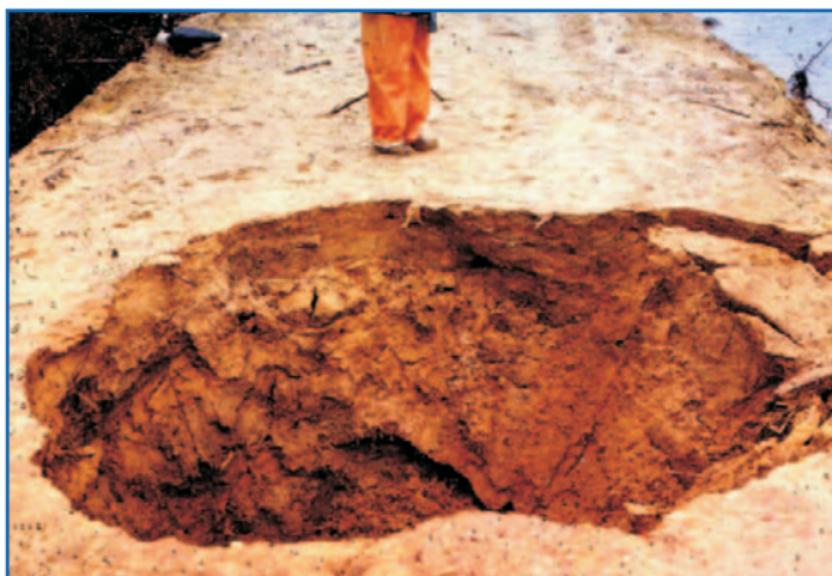
Sinkhole which developed over a spillway conduit.

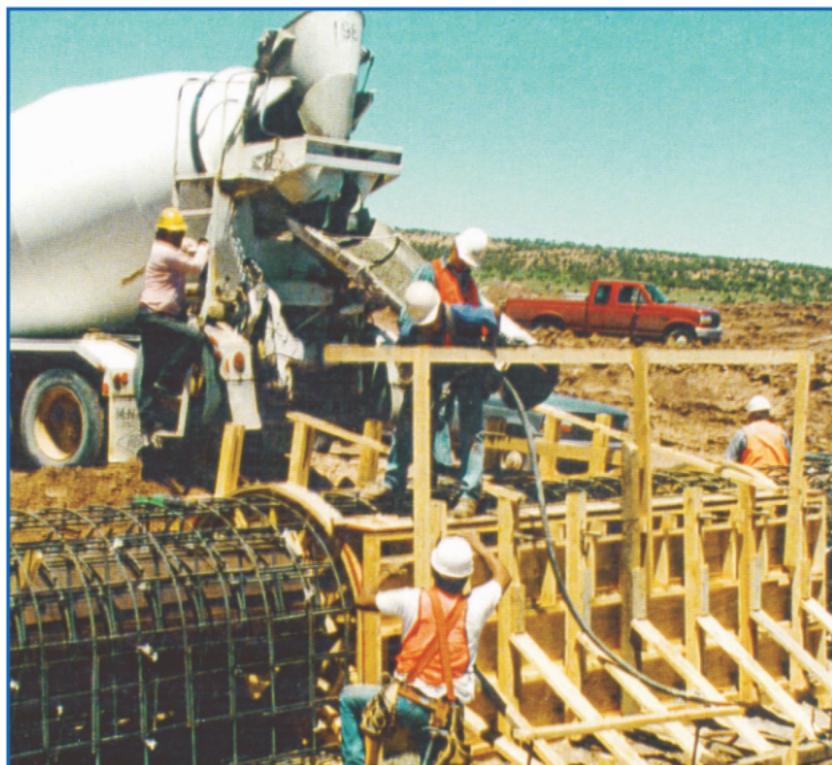
Concrete placement for a reinforced cast-in-place conduit.

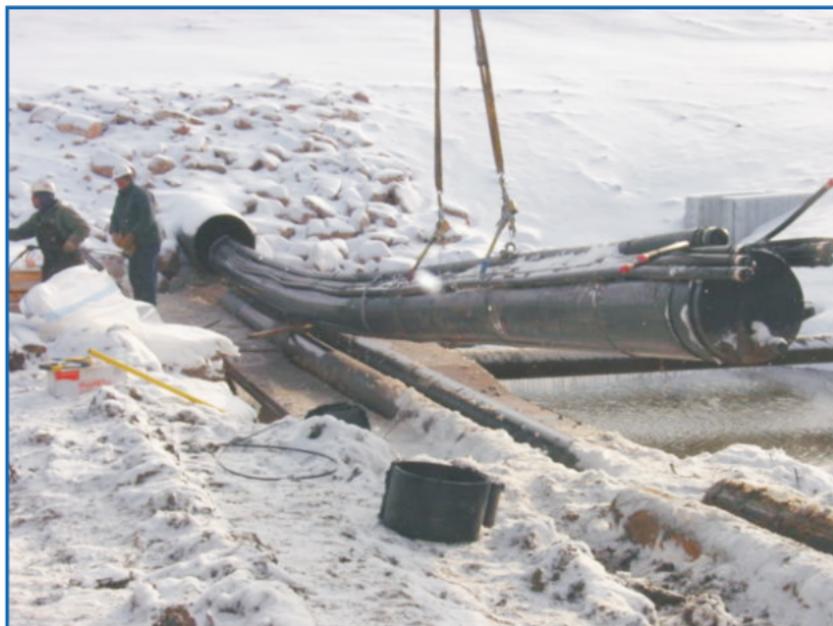
Insertion of a high density polyethylene (HDPE) slipliner into an existing outlet works conduit.
