Phase II Investigation Work Plan

Area A: Parcel A5, Parcel A9, and Greys Rail Yard Tradepoint Atlantic Sparrows Point, Maryland

Revision 0
August 23, 2017

ARM Projects 150298M-6, 150298M-4, and 150298M-17

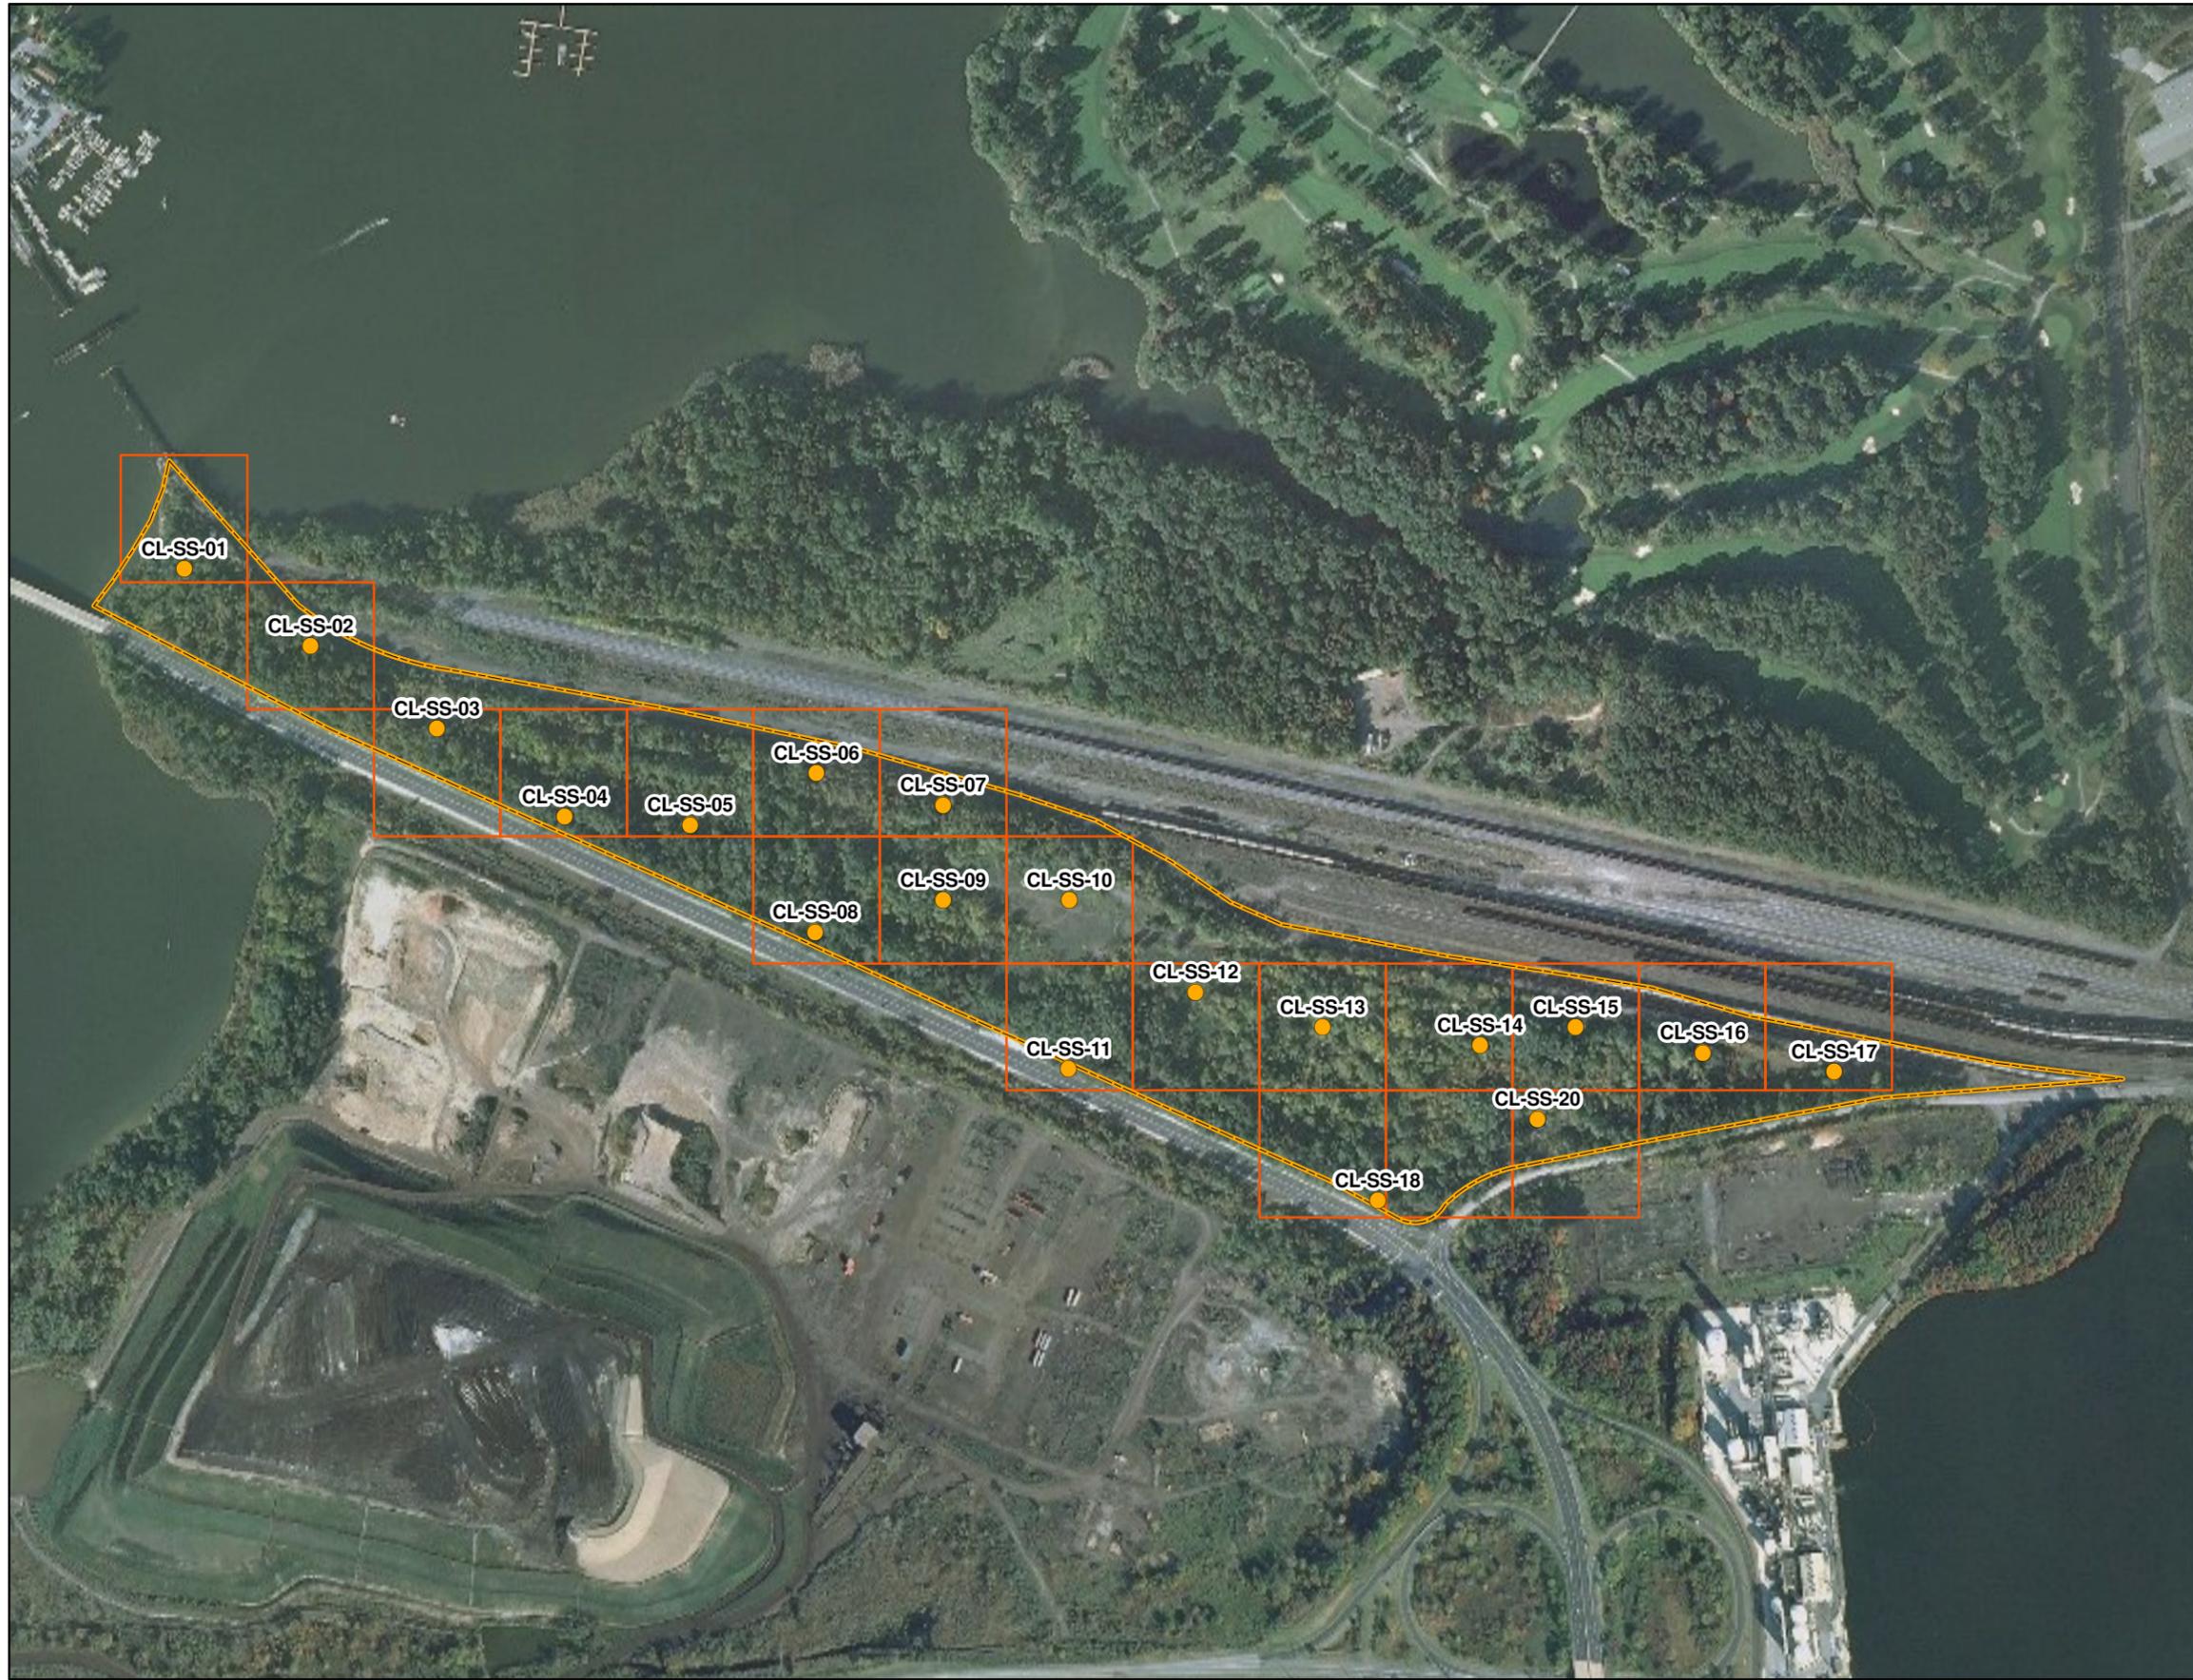
- Surface Soil Sample Location
- CL1B Parcel
- Sampling Grid

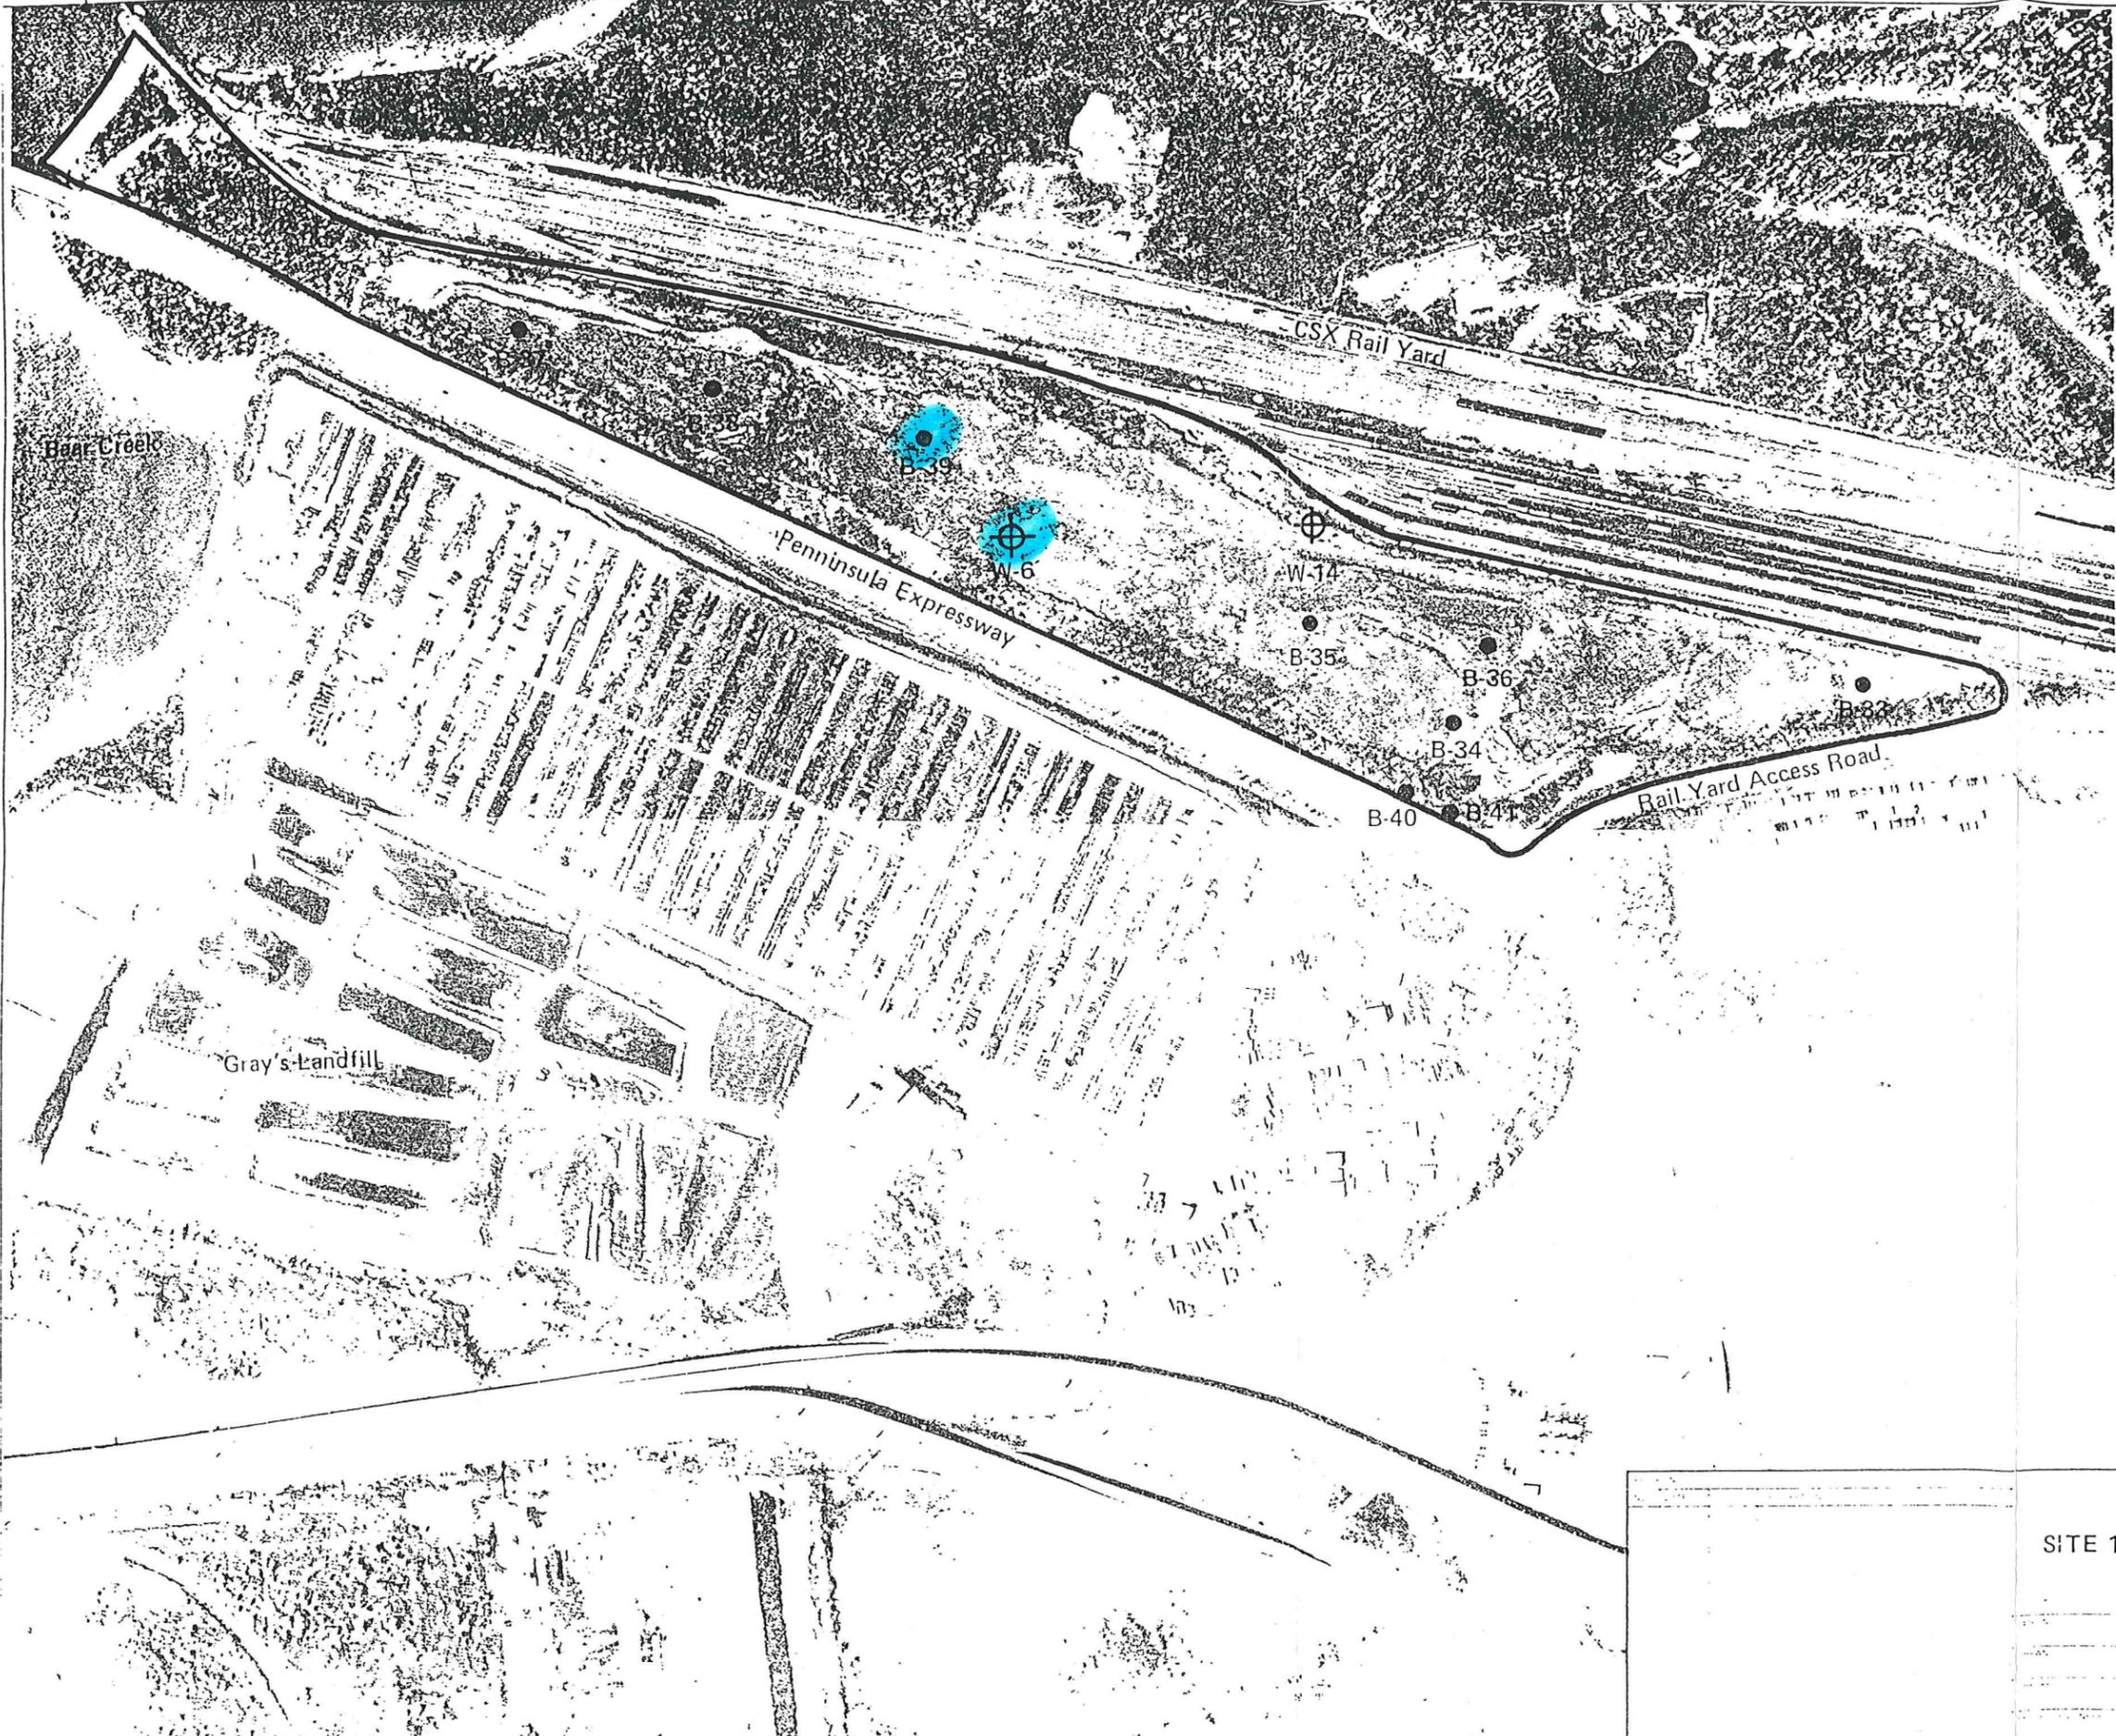
Figure 2-1. Well location and surface water sampling locations Site 1B.

NOTE: Locations approximate for presentation purposes only.
For boring and well coordinates see Appendix E.

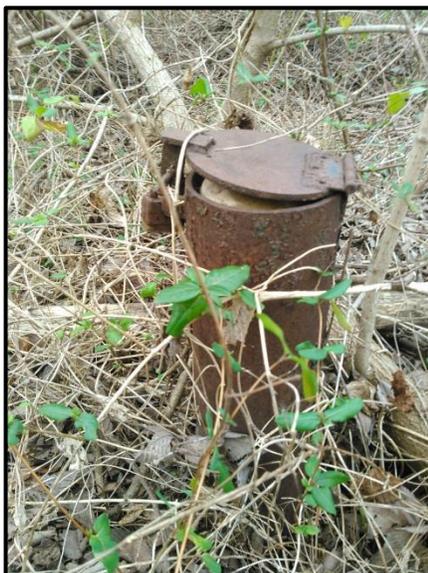
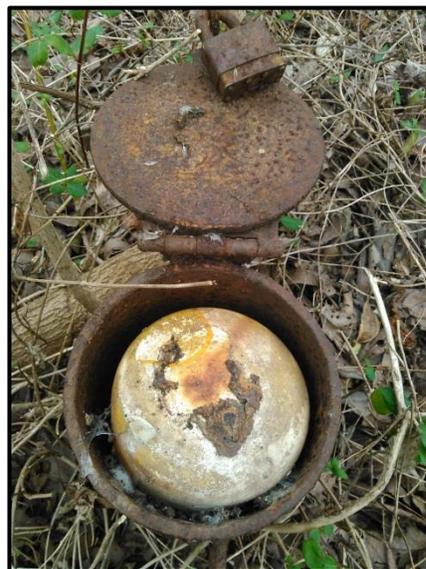
PICTURE OF WELL DURING INSPECTION

Condition of pad and/or cover: Good Flush Mount or Stick-Up? Stick-up

Additional Comments: Rubber cap on PVC; does not have a handle. Water between PVC and outer metal case – depth to water between PVC and casing was 2.3' TOC.

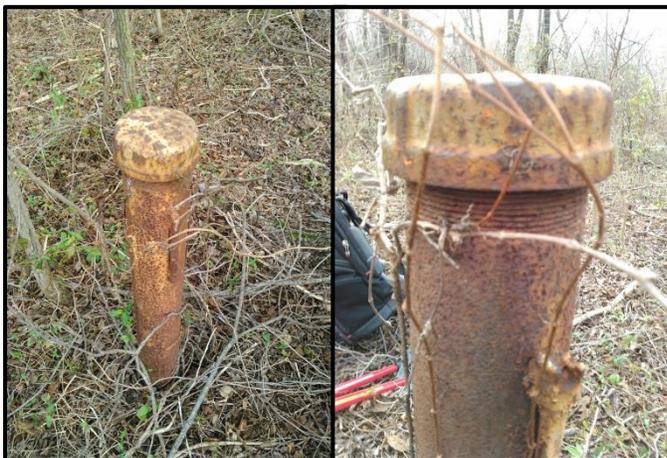
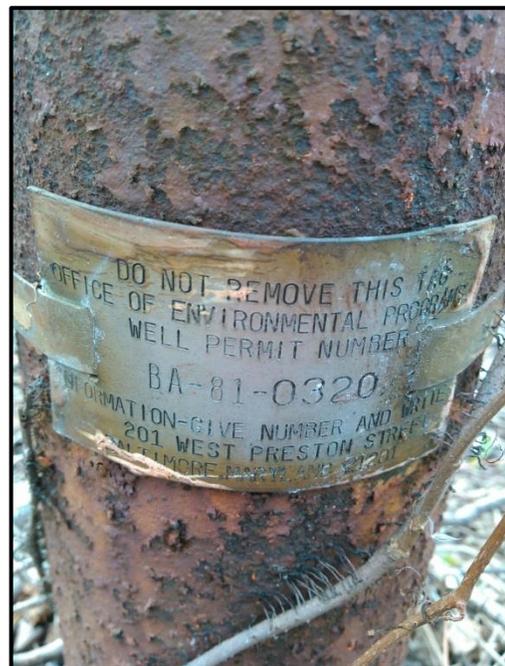
PICTURE OF WELL DURING INSPECTION

Condition of pad and/or cover: Good Flush Mount or Stick-Up? Stick-up

Additional Comments: Outer metal case was rusted and screwed on. Could not remove or access the well. N/D = No Data

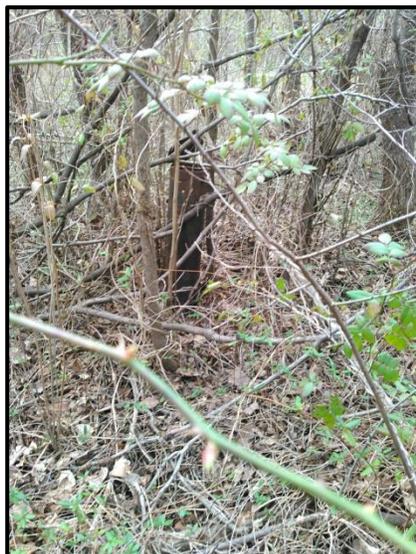
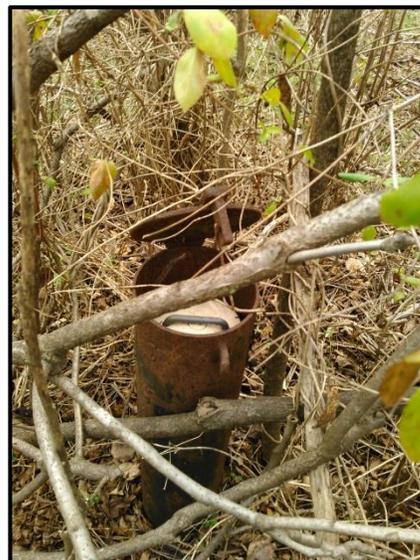
PICTURE OF WELL DURING INSPECTION

Condition of pad and/or cover: Good Flush Mount or Stick-Up? Stick-up

Additional Comments: Rubber plug cap on PVC. Difficult to locate due to dense vegetation and trees. Outer metal case cover does not move, but is approximately ¾ of the way opened. Total depth is significantly shallower than other wells investigated on this date, indicating possible damage. (No known historical depth)

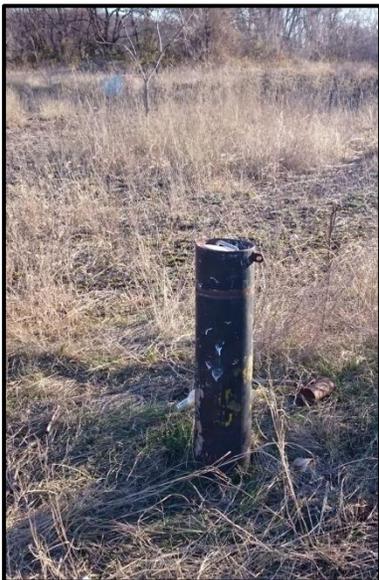
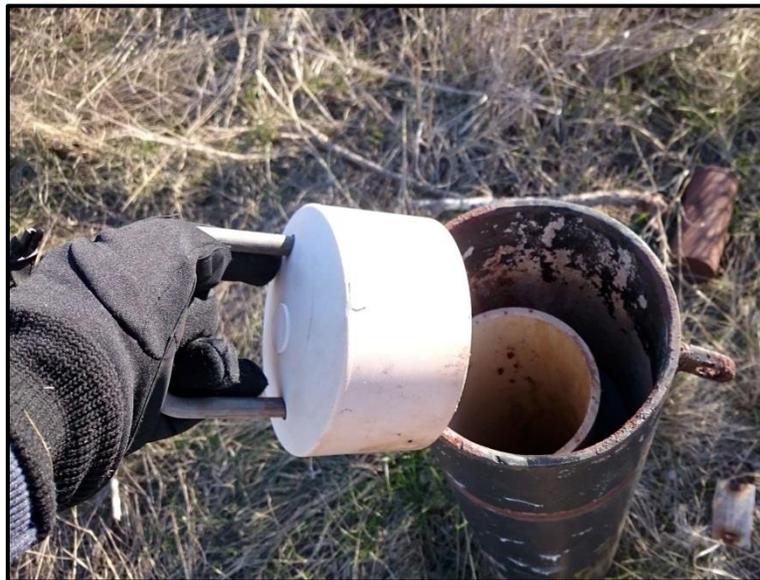
PICTURE OF WELL DURING INSPECTION

Condition of pad and/or cover: See comments Flush Mount or Stick-Up? Stick-up

Additional Comments: Missing locking lid. Well permit tag found on ground next to well. Rubber cap over PVC casing.

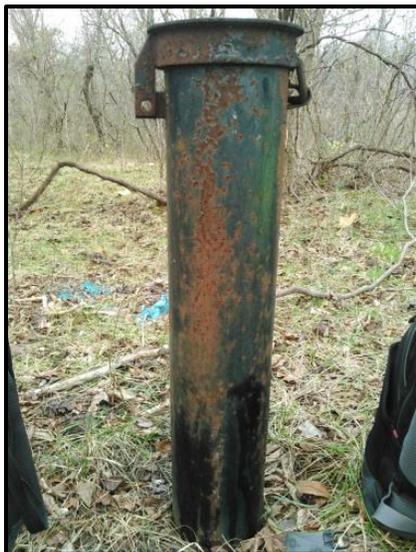
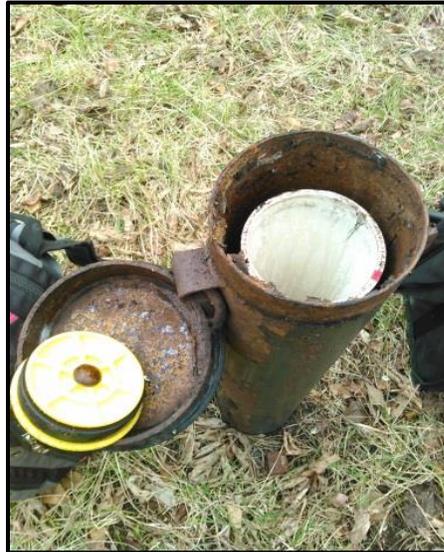
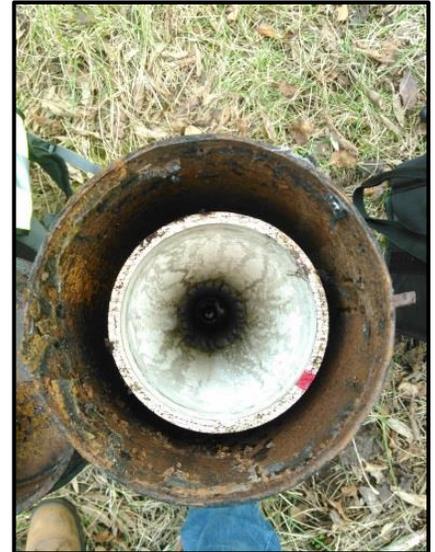
PICTURE OF WELL DURING INSPECTION

Condition of pad and/or cover: Good Flush Mount or Stick-Up? Stick-up

Additional Comments: Historical GIS coordinates were inaccurate. Sediment was attached to probe when it came up from the bottom. Outer metal case was locked; lock was cut.

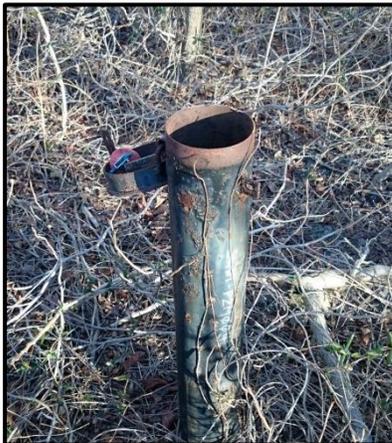
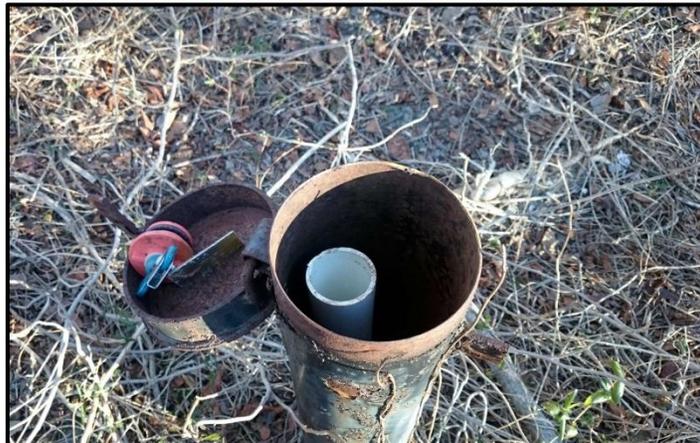
PICTURE OF WELL DURING INSPECTION

Condition of pad and/or cover: Good Flush Mount or Stick-Up? Stick-up

Additional Comments: CH2MHill tag on locking cap.

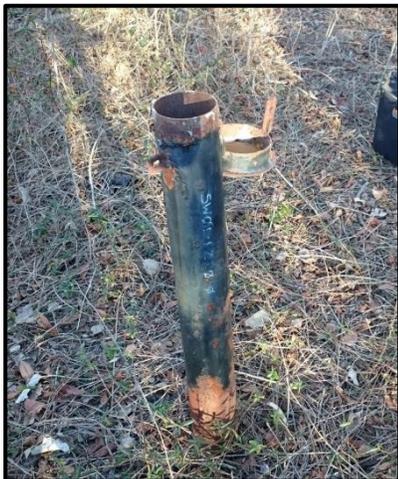
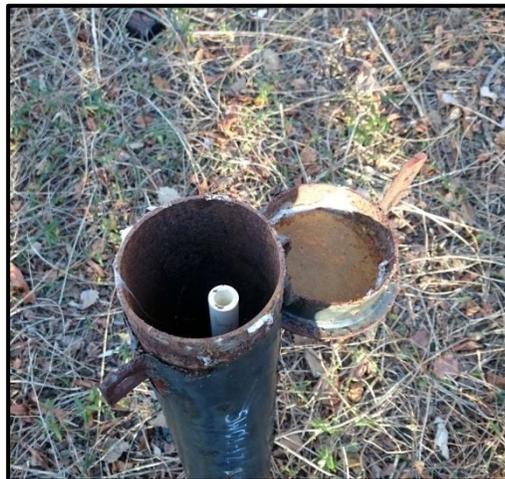
PICTURE OF WELL DURING INSPECTION

Condition of pad and/or cover: Good Flush Mount or Stick-Up? Stick-up

Additional Comments: CH2MHill Tag on locking lid. Could not measure with wide probe. Needs narrower meter to measure. (Revisit if added to the sampling plan).
