Phase II Investigation Work Plan

Area B: Parcel B7 and Parcel B25 Tradepoint Atlantic Sparrows Point, Maryland

Revision 1
May 22, 2018

ARM Project 150300M-8 and 150300M-26

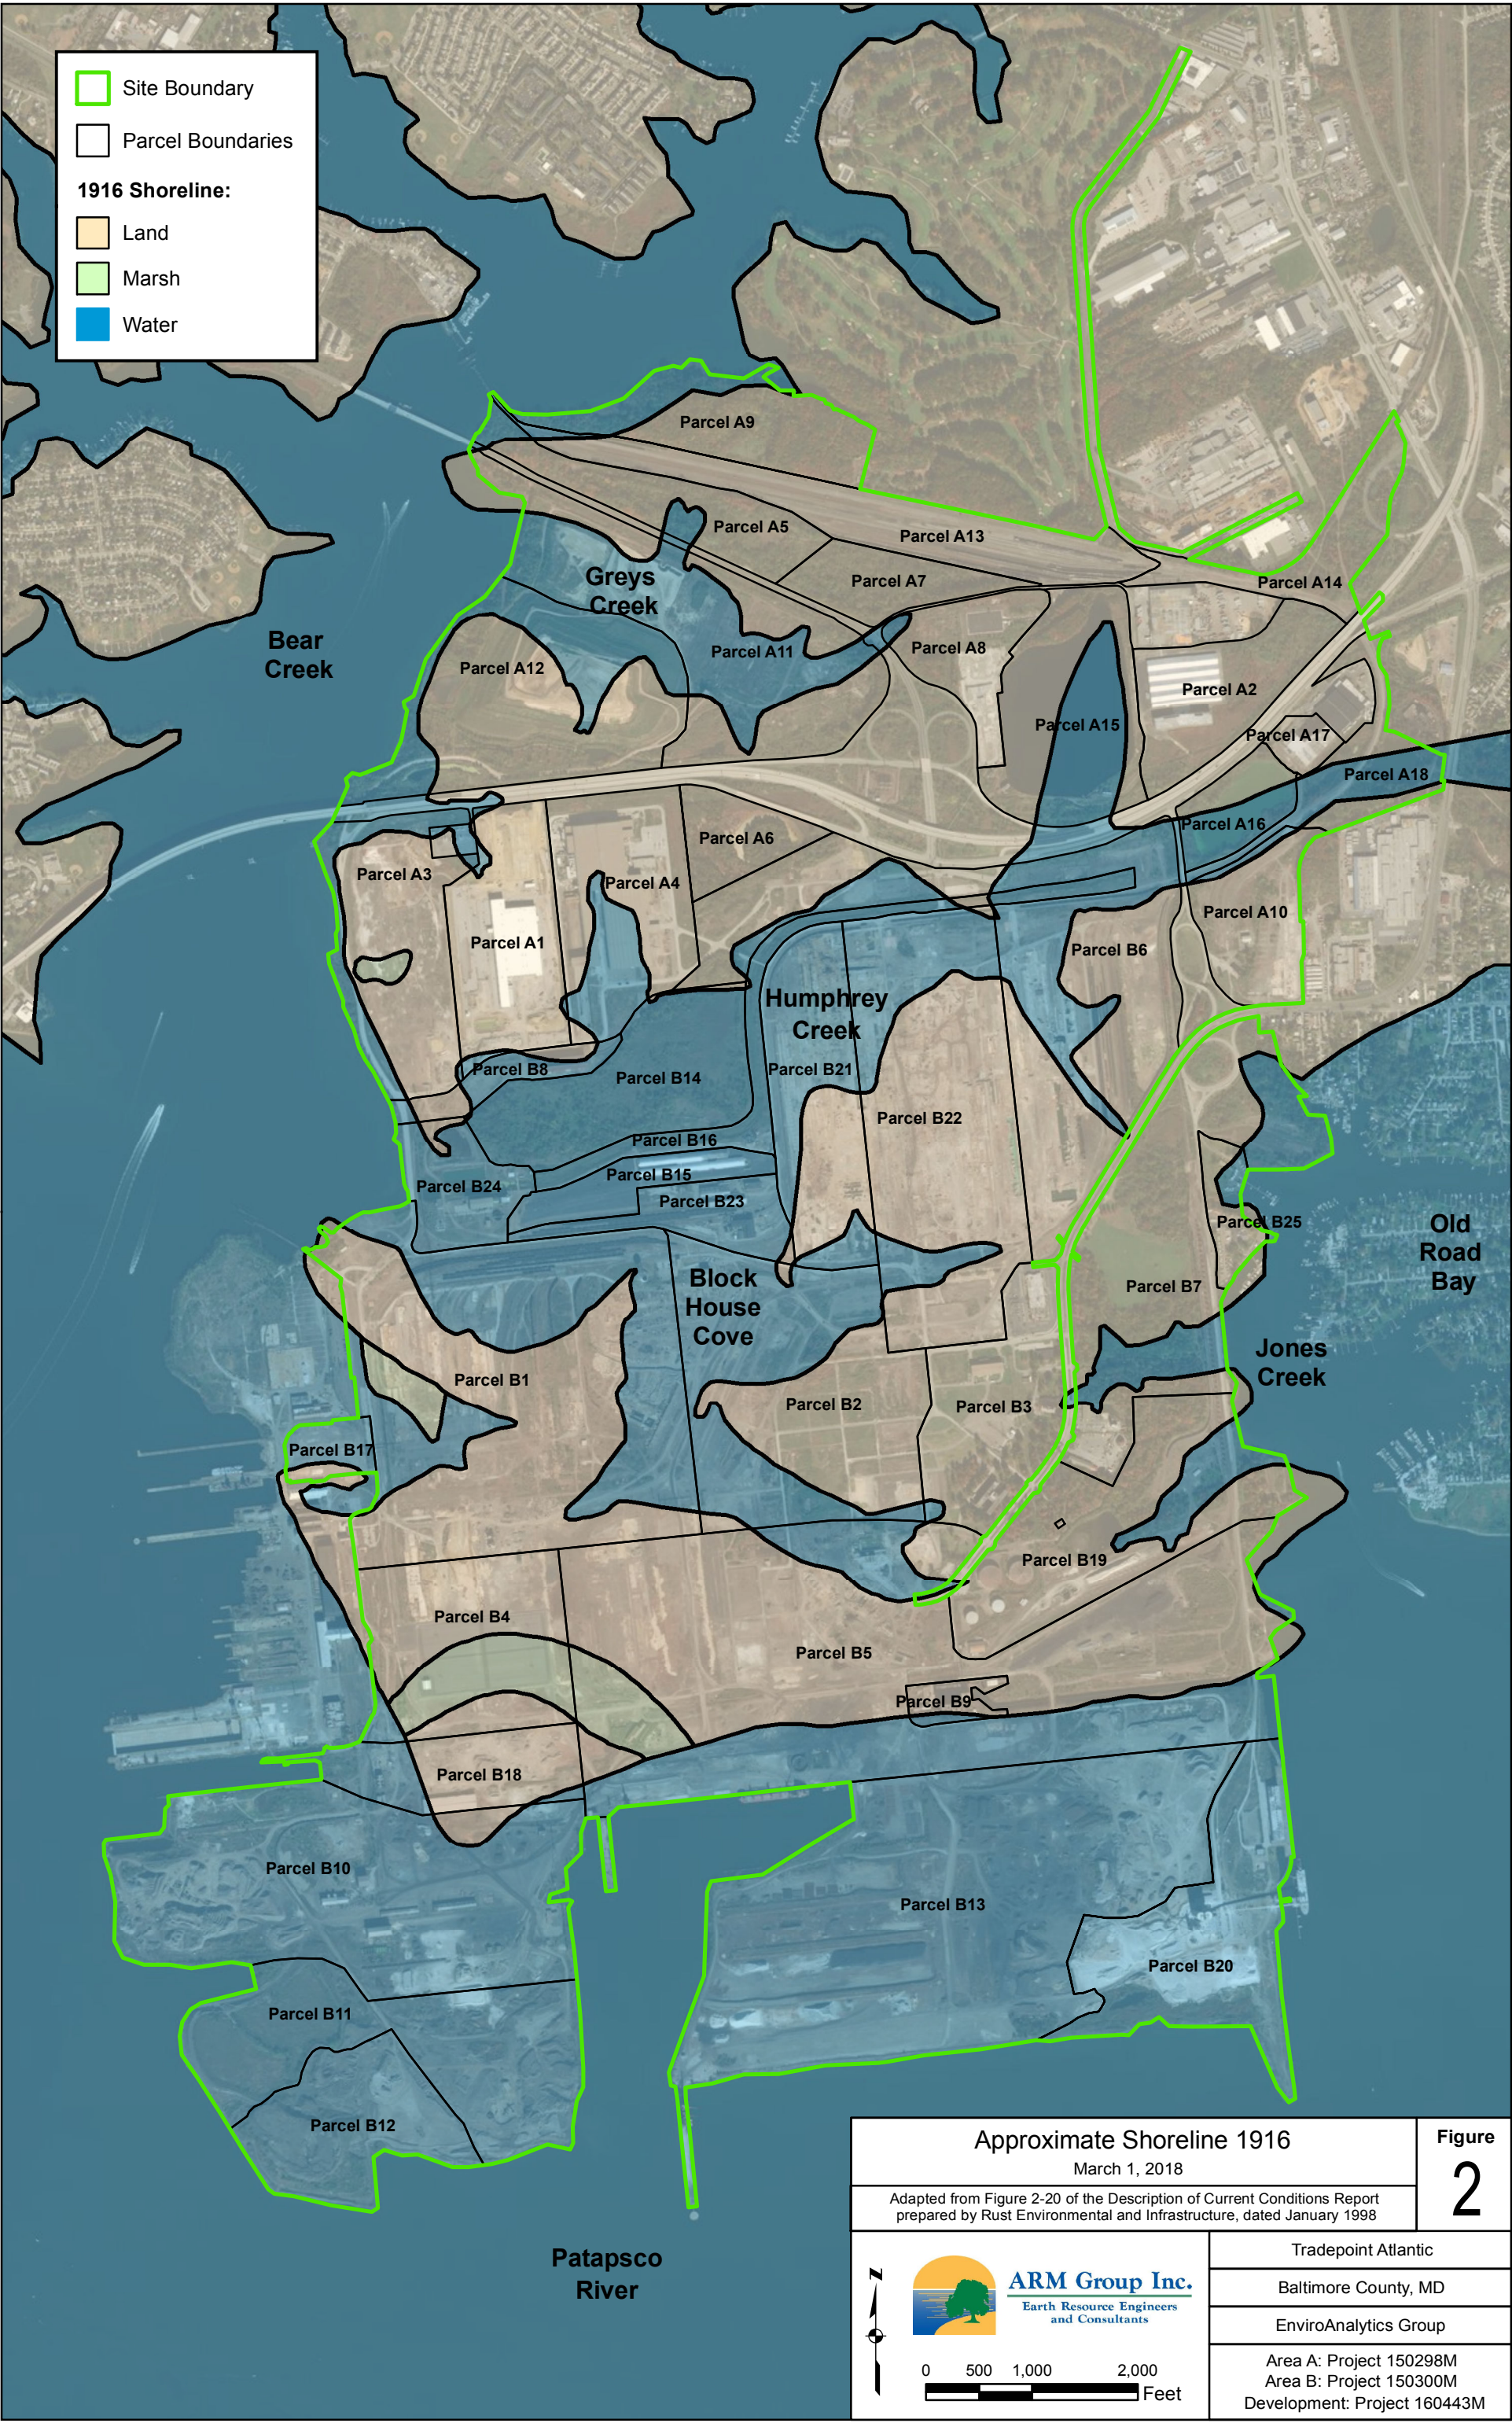
Approximate Shoreline 1916 March 1, 2018		Figure 2
Adapted from Figure 2-20 of the Description of Current Conditions Report prepared by Rust Environmental and Infrastructure, dated January 1998

Groundcover at the Site is comprised of approximately 76% natural soils and 24% fill materials based on the approximate shoreline of the Sparrows Point Peninsula in 1916, as shown on **Figure 2** (Adapted from Figure 2-20 on the Description of Current Conditions (DCC) Report prepared by Rust Environment and Infrastructure dated January 1998). Parcel B7 is comprised of approximately 75% natural soils and 25% fill materials. Parcel B25 is comprised of approximately 79% natural soils and 21% fill materials.

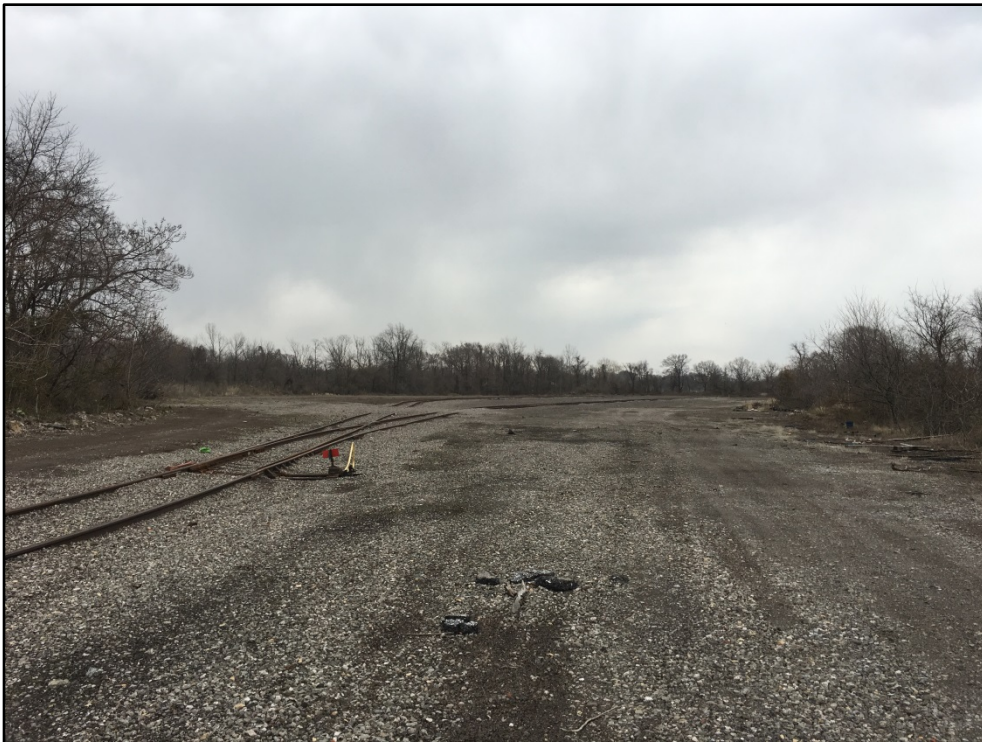
031518-4: View of REC-12B, Finding 247 located along the eastern portion of Parcel B7.

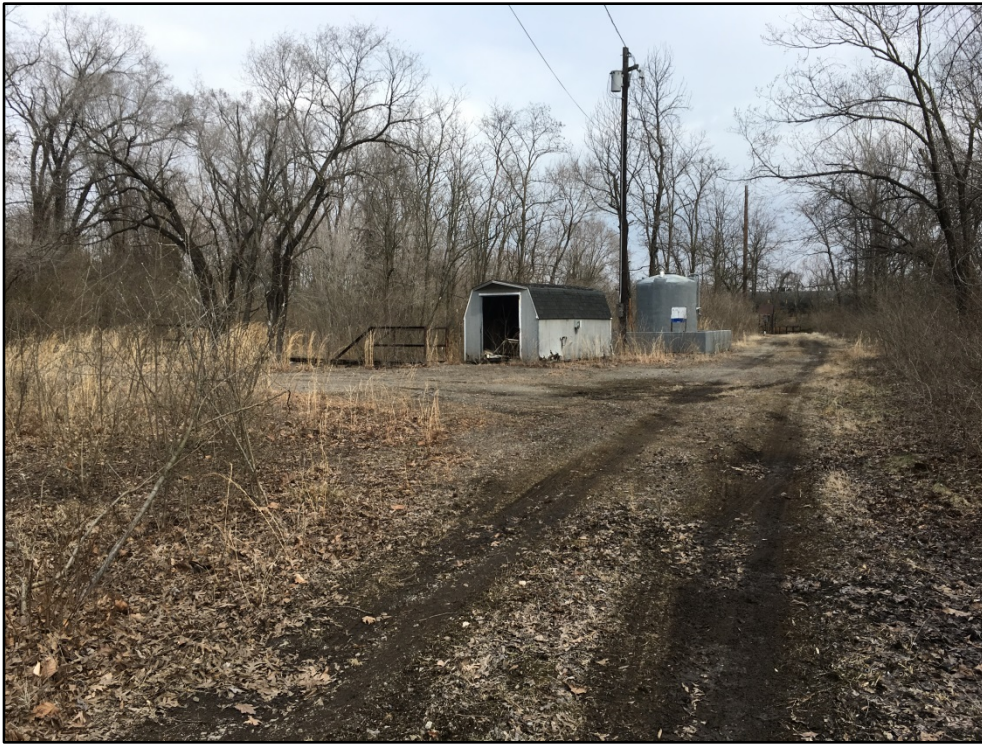
031518-5: View of a stormwater treatment area located along the middle portion of Parcel B7 facing east.

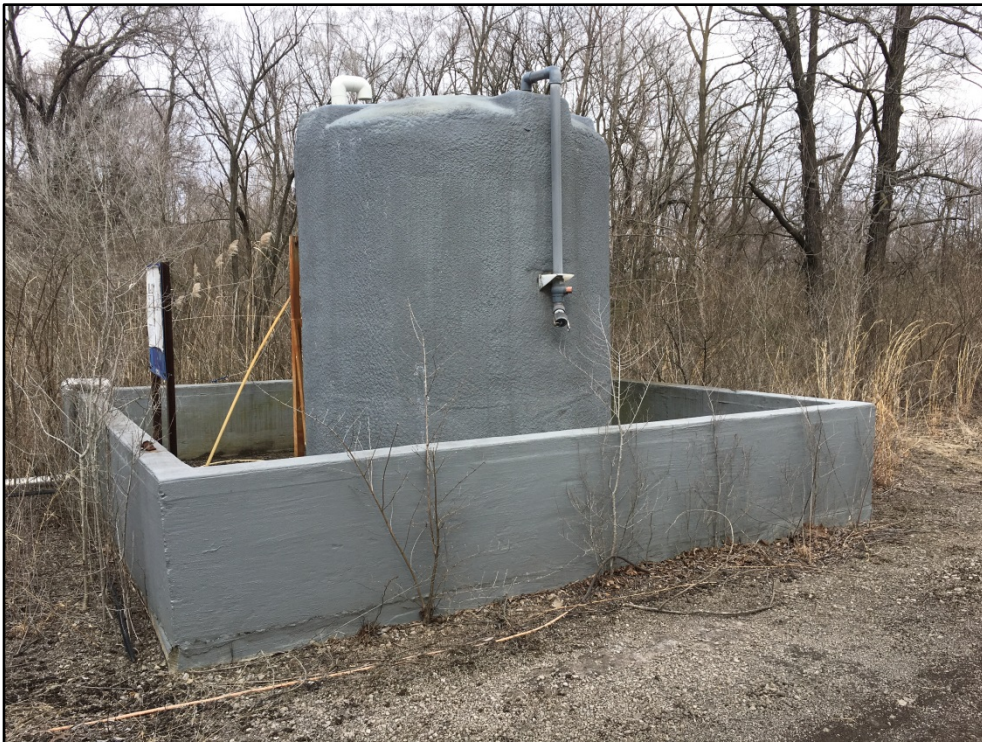
During the site walk of Parcel B7, ARM personnel identified an aboveground storage tank (AST) within a secondary containment unit which was labelled as containing sodium bisulfate. This AST was located along a stormwater conveyance channel in the southern portion of Parcel B7. Further along the stormwater conveyance, an oil weir with evidence of apparent petroleum impacts was observed. ARM attempted to locate an historic pumping station within a densely wooded area near the southern boundary of Parcel B7 (bordering Parcel B19). A cluster of abandoned buildings was observed to be vacant and in disrepair at the expected location. At the Baltimore County Vehicle Maintenance Facility, modern ASTs containing diesel and gasoline fuels were observed to be present. A pesticide storage shed was also present at the Vehicle Maintenance Facility. Two fire training areas were observed at the Baltimore Fire Academy, one of which contains a five-story building. Both of the fire training areas are constructed with concrete pads. A stormwater pond is located adjacent to the fire training areas.

031518-6: View of a sodium bisulfate AST located within secondary containment.

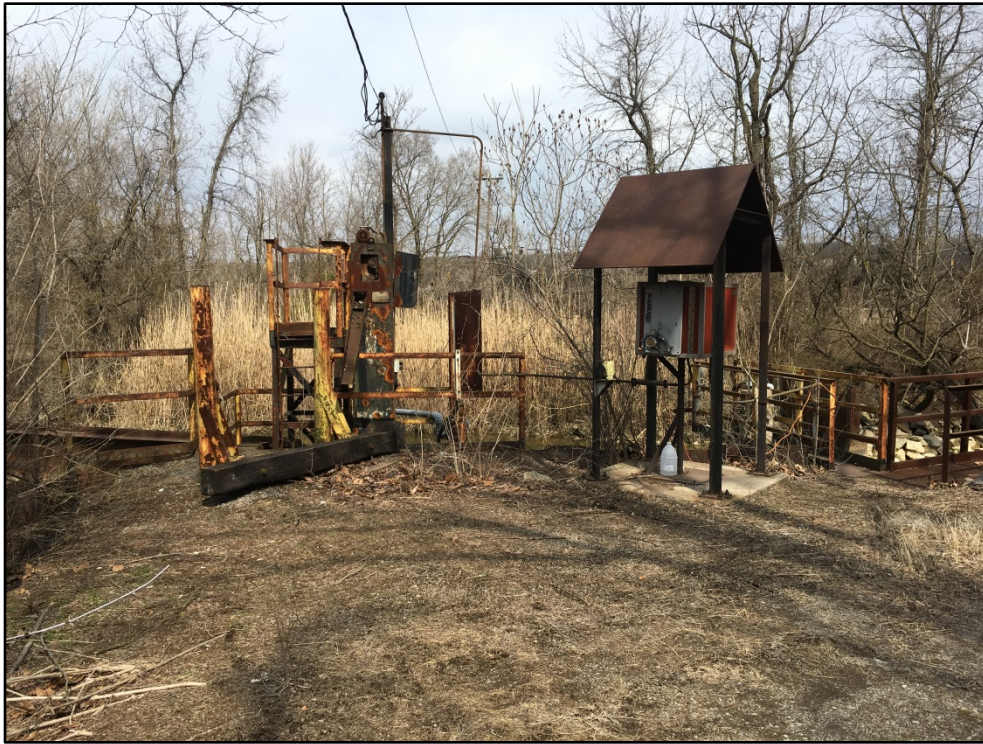
031518-7: View of former oil skimming operations located along the stormwater basin running east/west through Parcel B7.

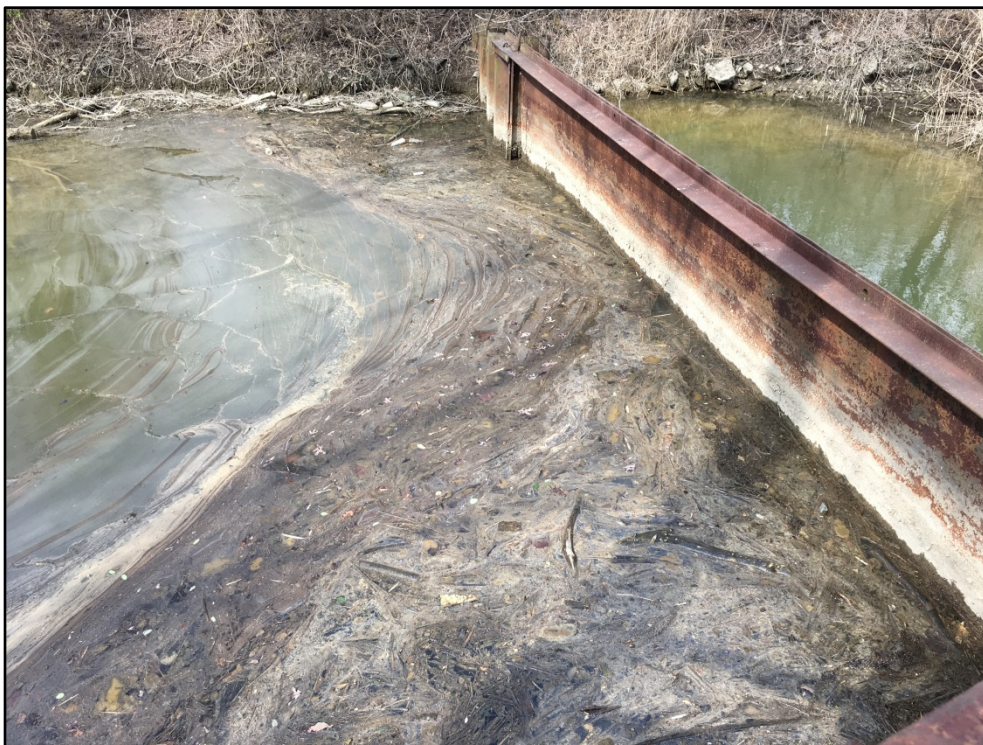
031518-8: View of potential petroleum impacts located at the oil skimming weir.

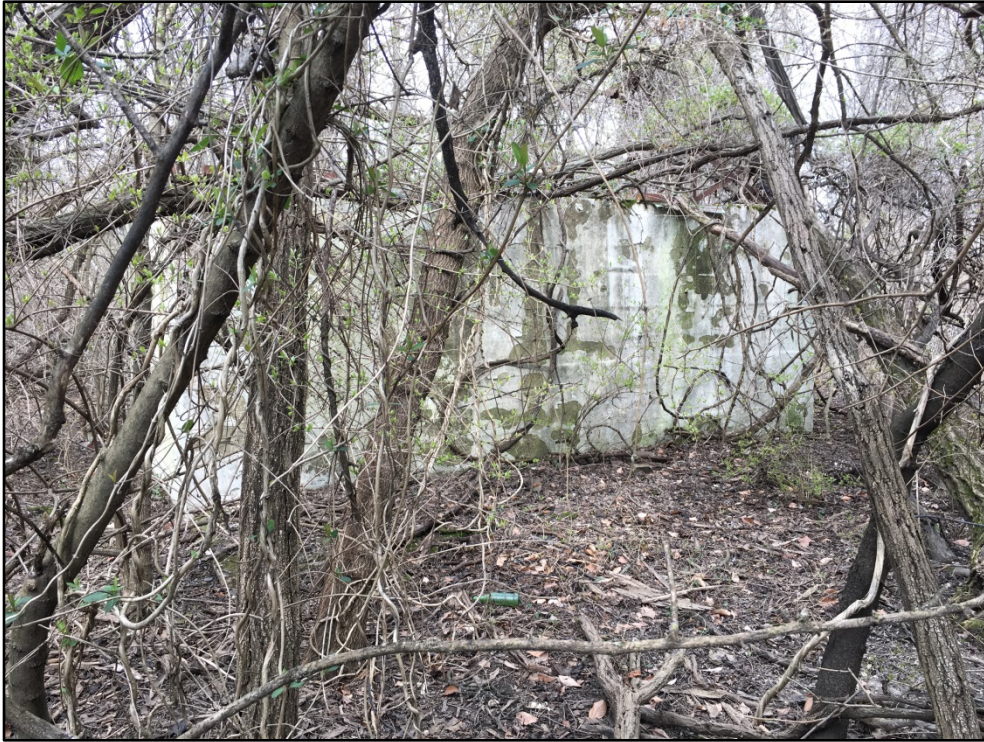
031518-9: View of former pump house located in the middle of heavily vegetated area.

Source Area Description	REC & Finding/ SWMU/ AOC	Figure or Drawing of Reference	RATIONALE	Number of Locations	Sample Locations	Boring Depth	Sample Depth	Analytical Parameters: Soil Samples
Pump House		Drawing 5030	Investigate potential impacts related to any historical activities which may have occurred in the vicinity of the Pump House (potential leaks or releases).	2	B7-012 and B7-013	Total depth of 20 feet or groundwater.	0-1', 4-5', 9-10' bgs. 4-5' interval may be adjusted in the field based on observations or field screening.	VOC [^] , SVOC, Metals, DRO/GRO, O&G, PCBs (0-1')
Scrap Storage Yard		Drawing 5042	Investigate potential impacts related to any historical activities which may have occurred in the vicinity of the Scrap Storage Yard (potential leaks or releases).	2	B7-014 and B7-015	Total depth of 20 feet or groundwater.	0-1', 1-2', 4-5', 9-10' bgs. 4-5' interval may be adjusted in the field based on observations or field screening.	VOC [^] , SVOC, Metals, DRO/GRO, O&G, PCBs (0-1'), Pesticides (0-1' and 1-2')

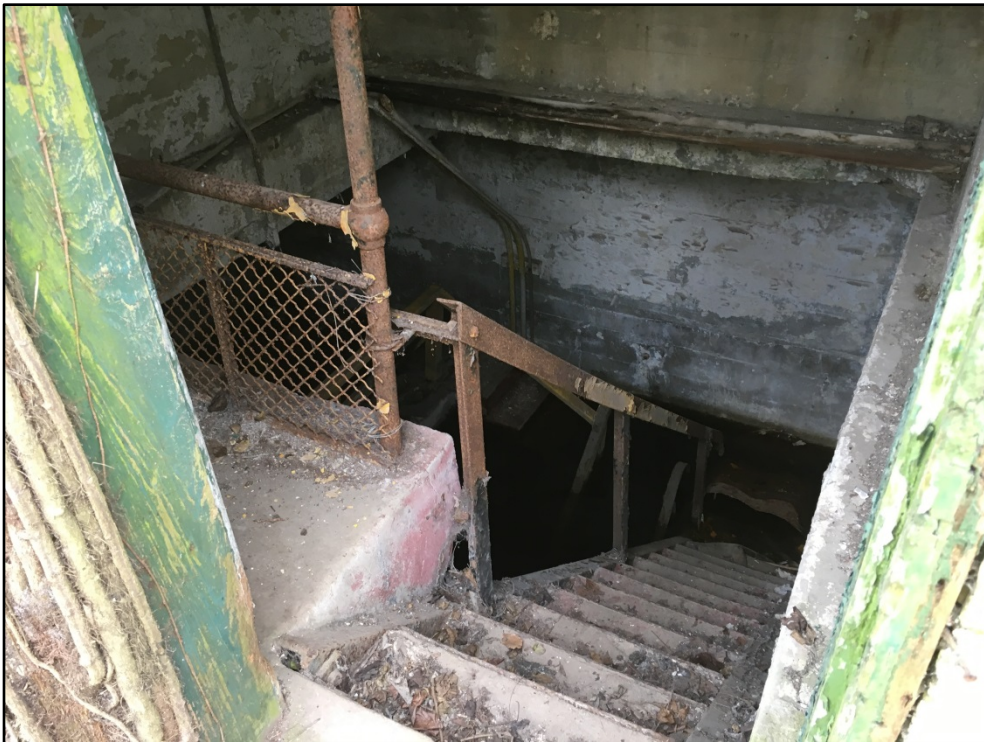
031518-10: View of the interior of the former pump house.

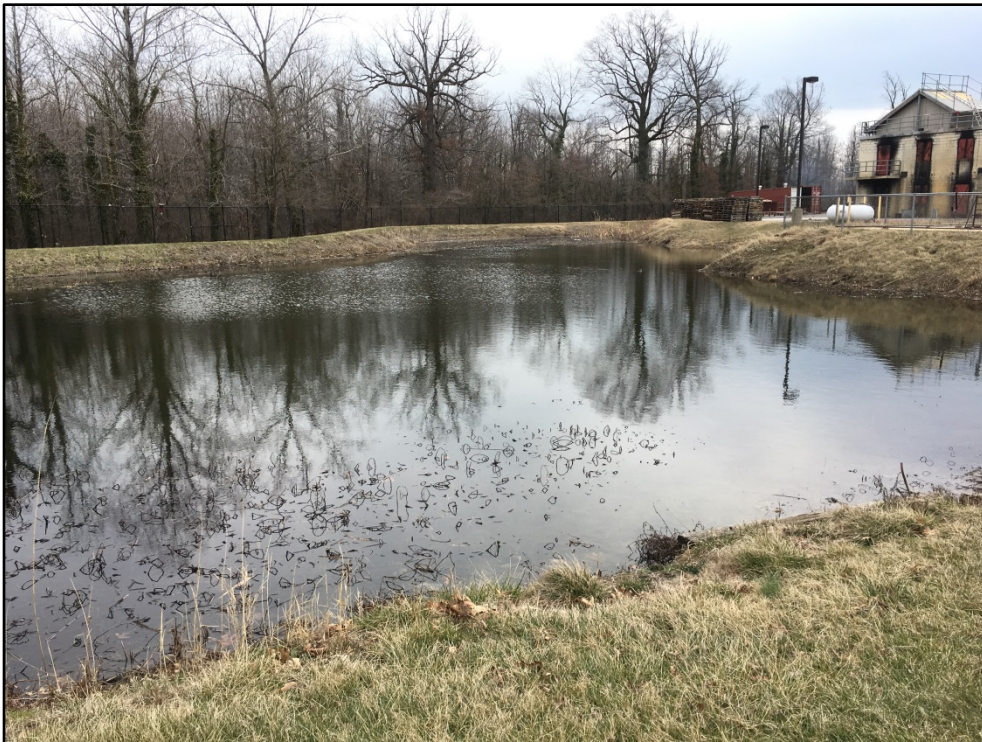
031518-14: View of the facility's stormwater retention pond facing southeast.

B.C.S.W.M. Pond Sediment		Site Walk/Aerial Imagery	Investigate potential impacts related to firefighting foams which may have been used in the past during drills and training at the Site.	2	B7-026 and B7-027	Total depth of 12 inches.	Top 12" of sediment at each location	VOC ^A , SVOC, Metals, DRO/GRO, O&G, PCBs, PFOS/PFOA
Parcel B7 Coverage/Historic Golf Course		1952 Aerial Imagery	Investigate potential impacts related to the historic golf course and any historical activities which may have occurred on the Site (potential leaks or releases).	17	B7-028 through B7-044	Total depth of 20 feet or groundwater.	0-1', 1-2', 4-5', 9-10' bgs. 4-5' interval may be adjusted in the field based on observations or field screening.	VOC ^A , SVOC, Metals, DRO/GRO, O&G, PCBs (0-1'), Pesticides (0-1' and 1-2')
Parcel B7 Coverage/Fire Training Area			Investigate potential impacts related to fire fighting activities and any historical activities which may have occurred on the Site (potential leaks or releases).	1	B7-045	Total depth of 20 feet or groundwater.	0-1', 4-5', 9-10' bgs. 4-5' interval may be adjusted in the field based on observations or field screening.	VOC ^A , SVOC, Metals, DRO/GRO, O&G, PCBs (0-1'), PFOS/PFOA

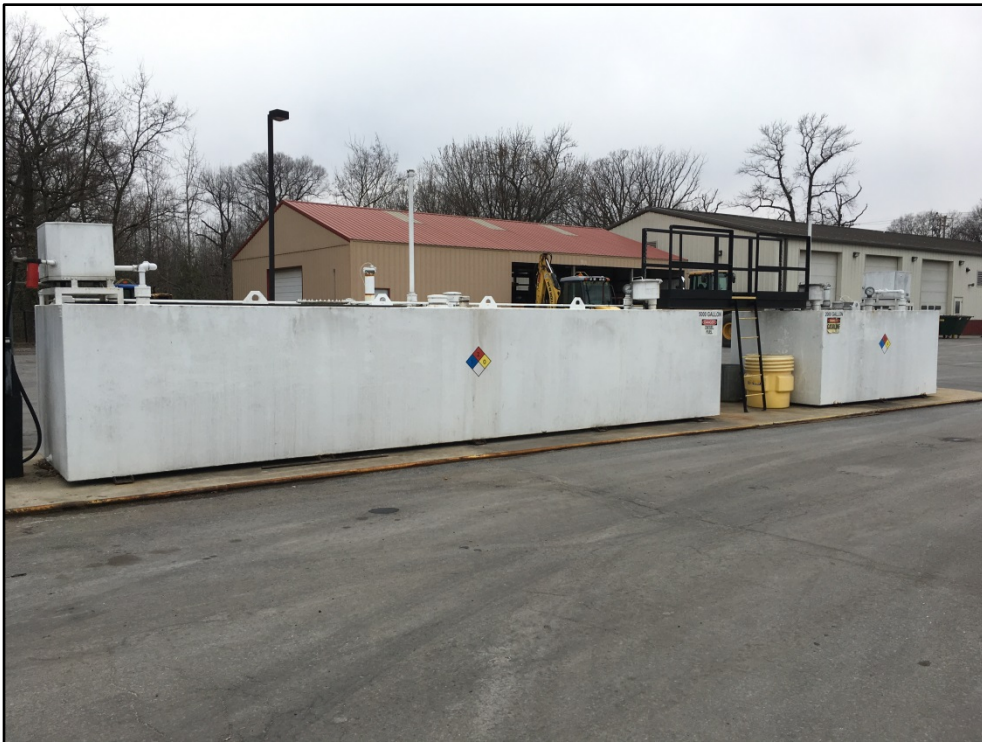
031518-16: View of one 5,000 gallon diesel AST and one 2,000 gallon gasoline AST located along the southern portion of the facility.

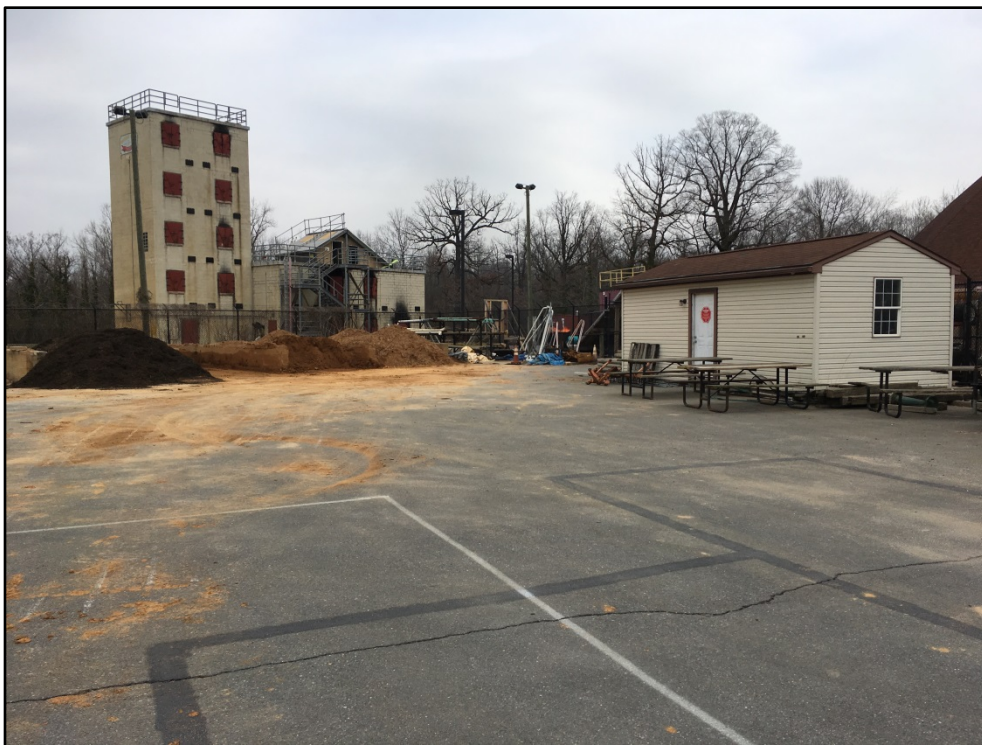
031518-18: View of material stockpile area and pesticide storage area within the shed to the right all located adjacent to the Fire Station #57.

Pesticide Storage Shed		Site Walk/Aerial Imagery	Investigate potential impacts related to pesticide storage shed at the Baltimore County Vehicle Maintenance Facility (potential leaks or releases).	2	B7-007 and B7-008	Total depth of 20 feet or groundwater.	0-1', 4-5', 9-10' bgs. 4-5' interval may be adjusted in the field based on observations or field screening.	VOC [^] , SVOC, Metals, DRO/GRO, O&G, PCBs (0-1'), Pesticides (0-1')
Oil Recovery Unit		Drawing 5030	Investigate potential impacts related to any historical activities which may have occurred in the vicinity of the Oil Recovery Unit (potential leaks or releases).	3	B7-009 through B7-011	Total depth of 20 feet or groundwater.	0-1', 4-5', 9-10' bgs. 4-5' interval may be adjusted in the field based on observations or field screening.	VOC [^] , SVOC, Metals, DRO/GRO, O&G, PCBs (0-1')

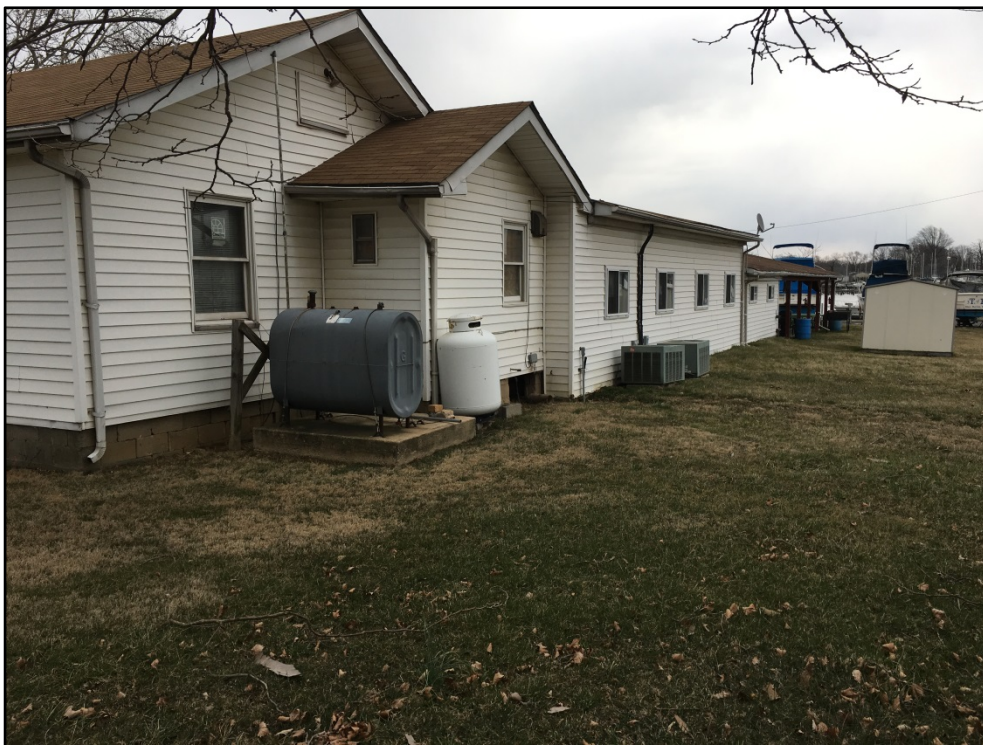
During the site walk of Parcel B25, ARM personnel noted the presence of two ASTs containing heating oil, with one AST located at each of the Yacht Clubs. Both of the ASTs appeared to be in good condition. Boat storage areas and outdoor recreation areas were also observed at each of the Yacht Clubs. Both the North Point and Pleasant Yacht Clubs had playset areas for children, and a pair of horseshoe pits was also observed at the North Point Yacht Club. An additional AST covered by a tarp was present at the Pleasant Yacht Club adjacent to the restroom. This AST is believed to be used in place of a septic tank. There were no indications of releases from the tank, and the tank was not targeted as part of this investigation.

031518-2: View of a heating oil AST located along the southwest corner of the main building.

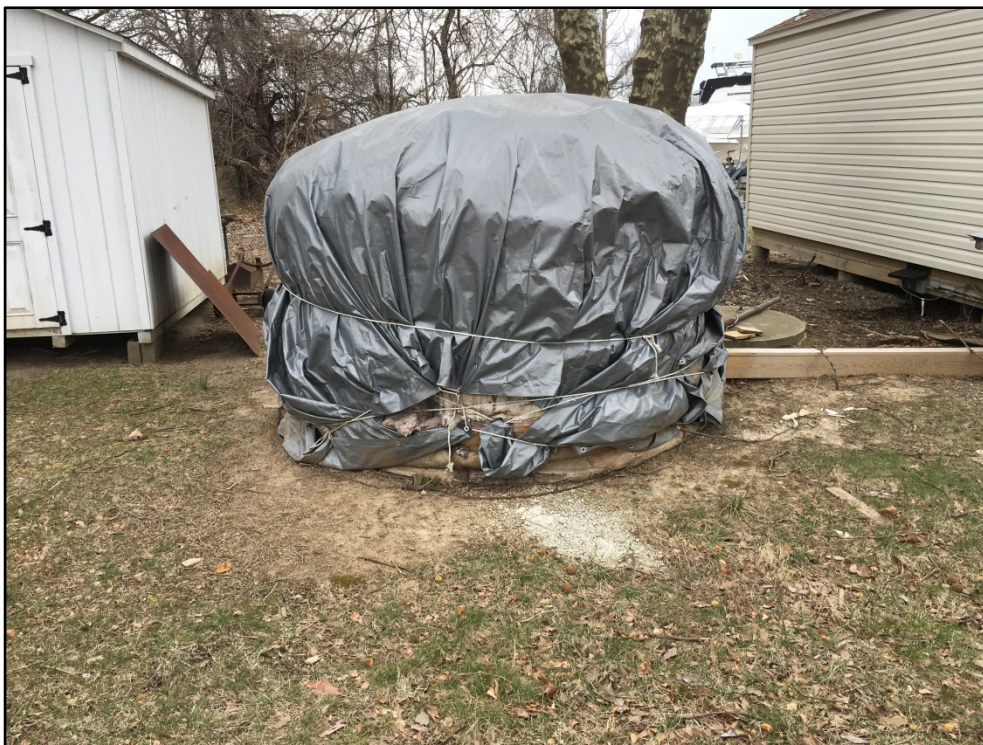
031518-4: View of an AST with unknown contents, potentially sewage, located between the restroom building and a shed north of the main building.

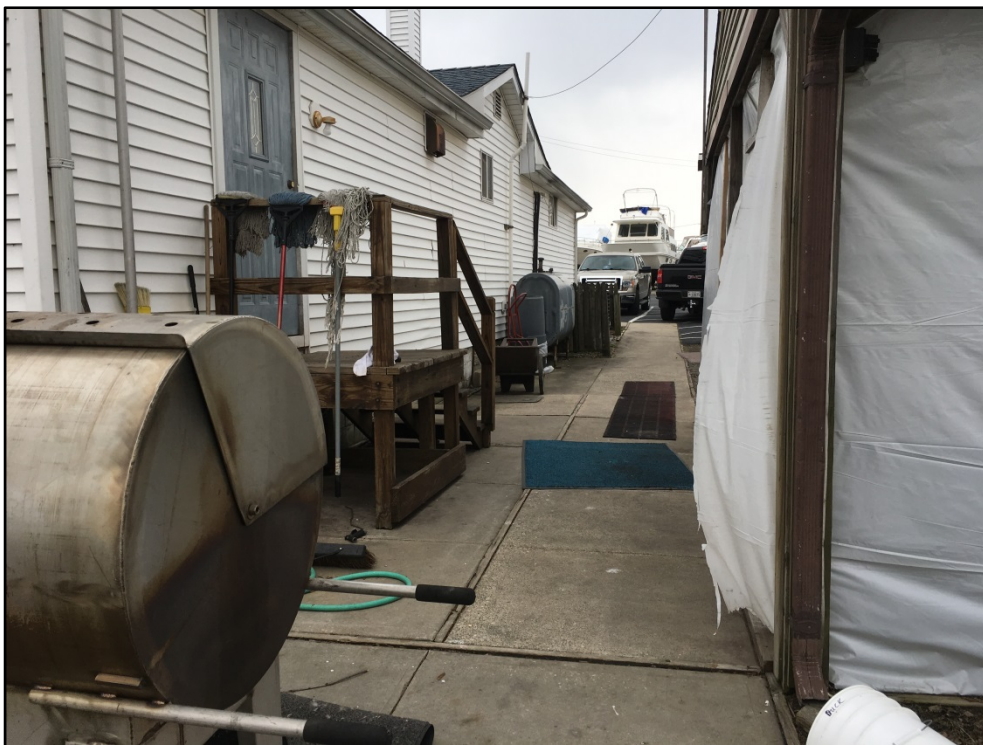
031518-6: View of a heating oil AST located along the northern wall of the main building.

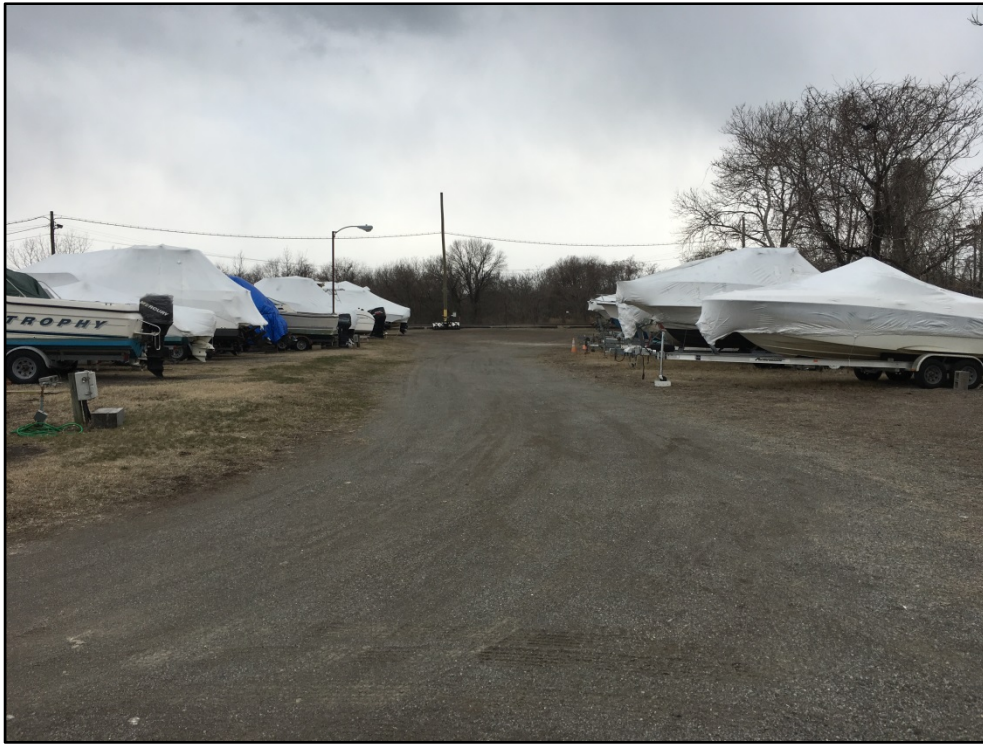
031518-9: View of the boat storage and maintenance area located along the northern perimeter of the yacht club facing west.

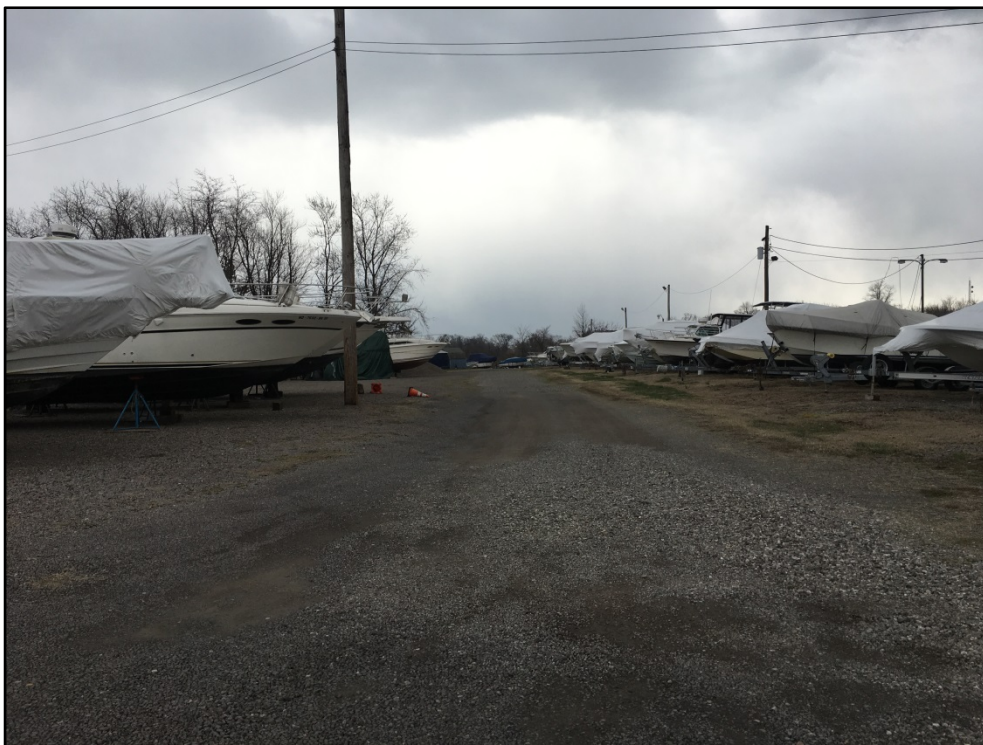
031518-10: View of another boat storage and maintenance area located along the western perimeter of the yacht club facing south.

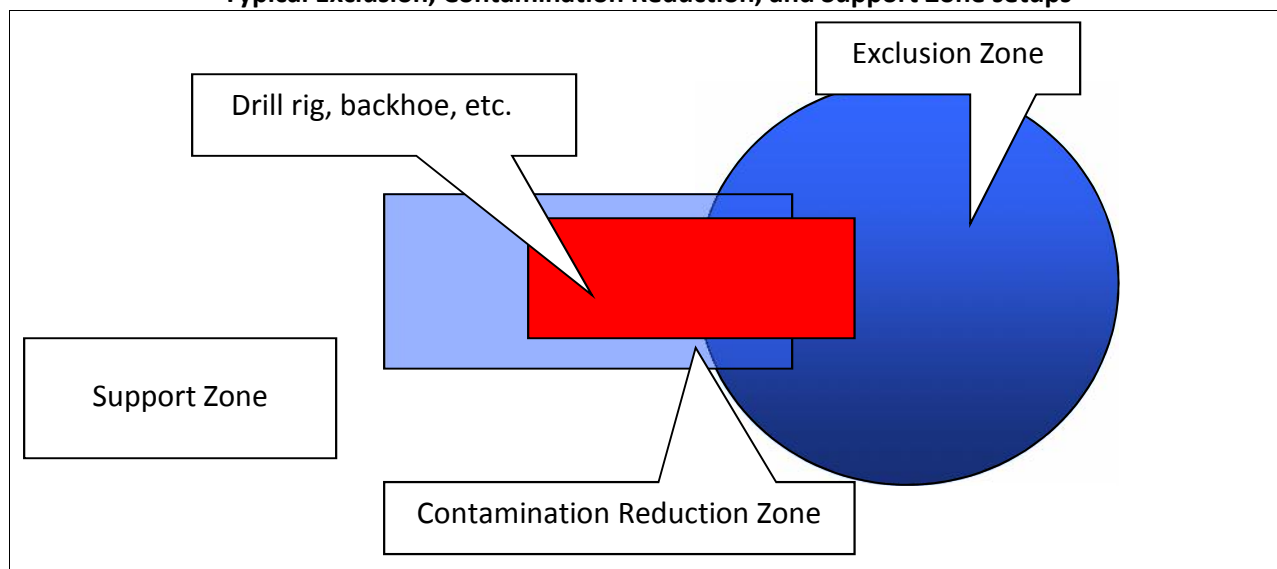
Figure 9-1
Typical Exclusion, Contamination Reduction, and Support Zone setups

The Support Zone will be considered a non-contaminated area. The location of support facilities in the SZ will be upwind of the EZ (where possible) and readily accessible to the nearest road. The field office/support facilities, equipment vehicles, a first aid station and a visitors/personnel entry and exit log for the work site will be located in this zone. Potentially contaminated personal clothing, equipment and samples are not permitted in this zone unless properly containerized.
