WETLANDS LICENSE NO. 22-0268 EVERGREEN MARINE CORP (TAIWAN) LTD

Survey of Potential Impacts on Oyster Populations from the Grounding of the M/V *Ever Forward* on Natural Oyster Bar 4-2

Blue Crab Potential Impact Assessment for the M/V Ever Forward Grounding Event

Proposed Conditions (AS-BUILT) Project: Dredging

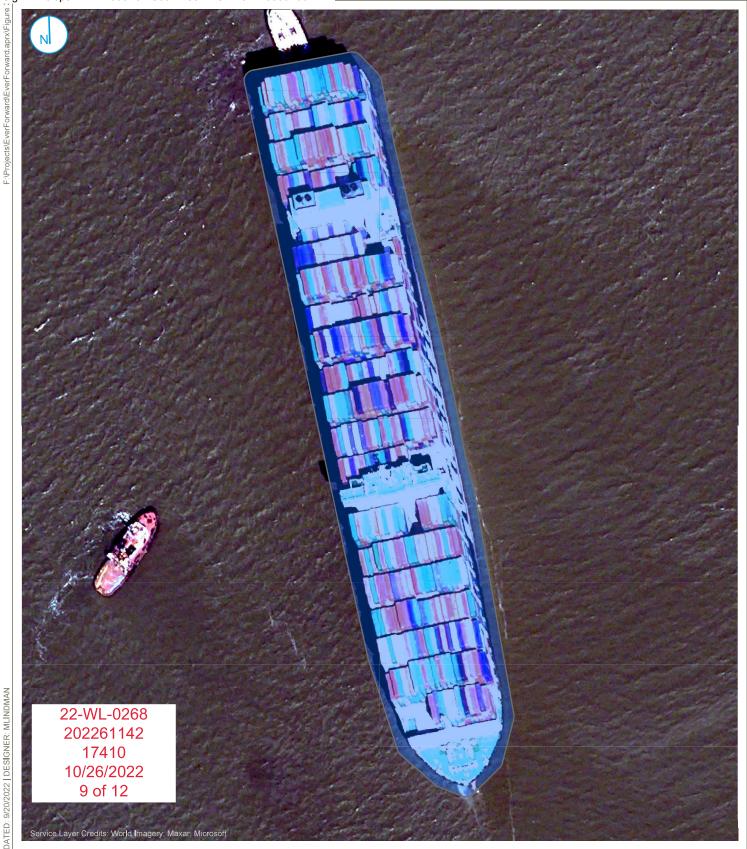
EVERFORWARD APPROXIMATE VESSEL AREA

Vessel Area with 5m Buffer

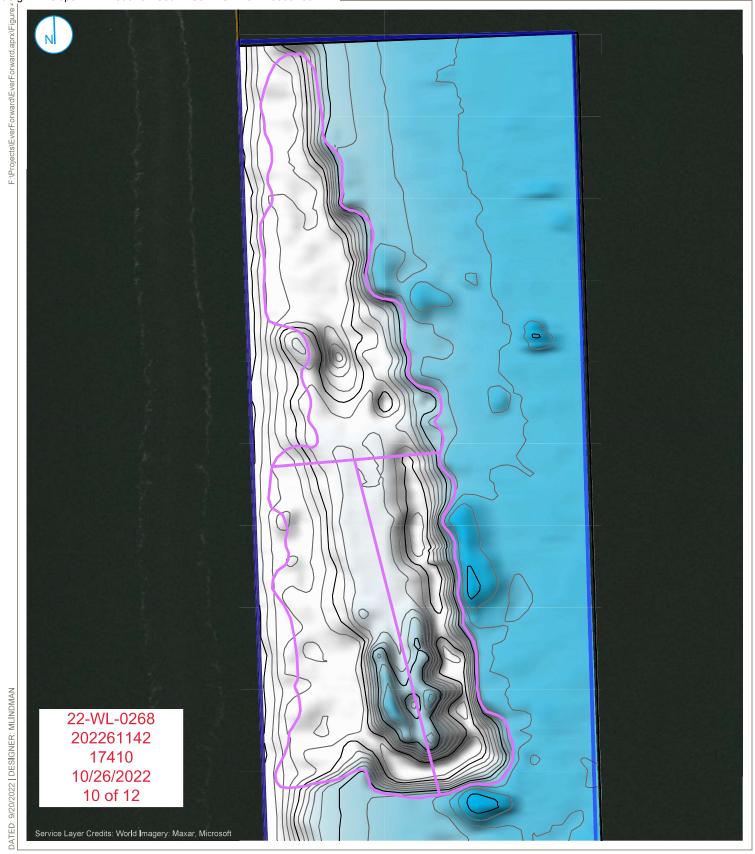
EVERFORWARD APPROXIMATE AREA OF DREDGING IMPACT

Area of Dredging Impact (Approximate)

- I. Mechanically dredging an area of 170,056 square feet around the stern of the vessel, an area of 132,159 square feet around the starboard side of the vessel, and 99,205 square feet around the port of the vessel resulting in a total of 401,420 square feet to a maximum depth of 47.1 feet at mean low water; and to deposit approximately 213,872 cubic yards of dredged material in the upland placement cell at the Poplar Island Ecosystem Restoration Project

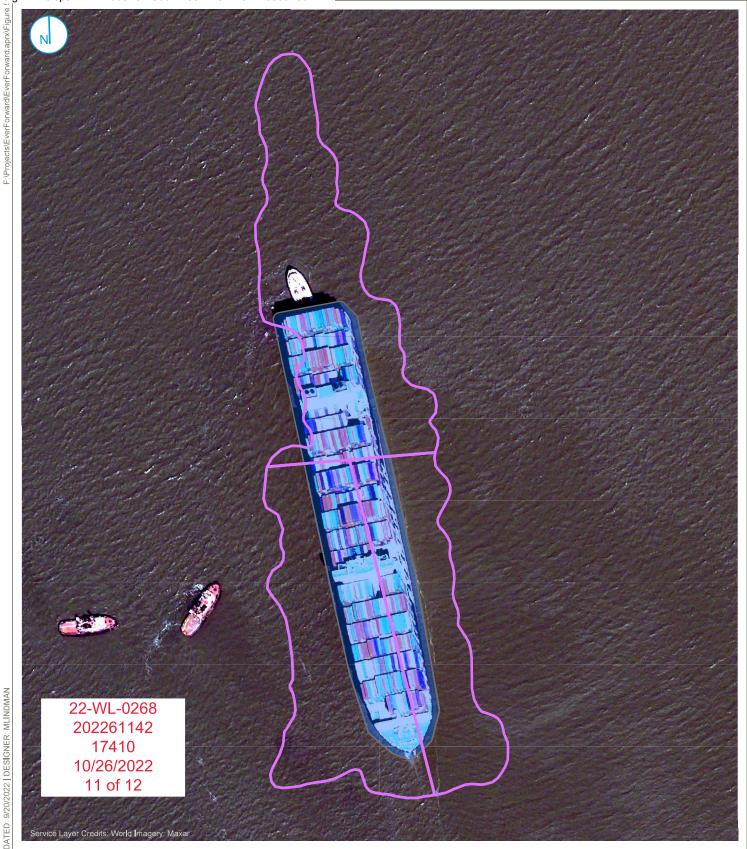
EVERFORWARD APPROXIMATE Vessel Area with 5m Buffer **VESSEL AND DREDGING AREAS OF IMPACT**

Area of Dredging Impact (Approximate)

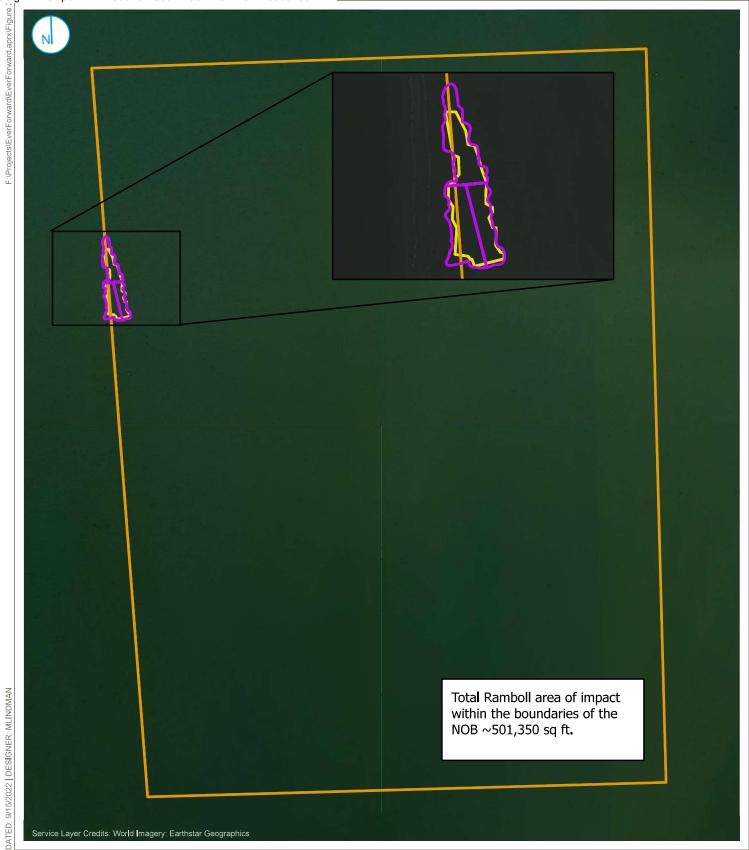
MGS Area of Impact (Approximate)

Ramboll Area of Impact (Approximate)
NOB Boundary
