DEVELOPMENT COMPLETION REPORT

AREA B: SUB-PARCEL B4-1
TRADEPOINT ATLANTIC
SPARROWS POINT, MARYLAND

ARM Project No. 20010204

Revision 1 – July 15, 2020

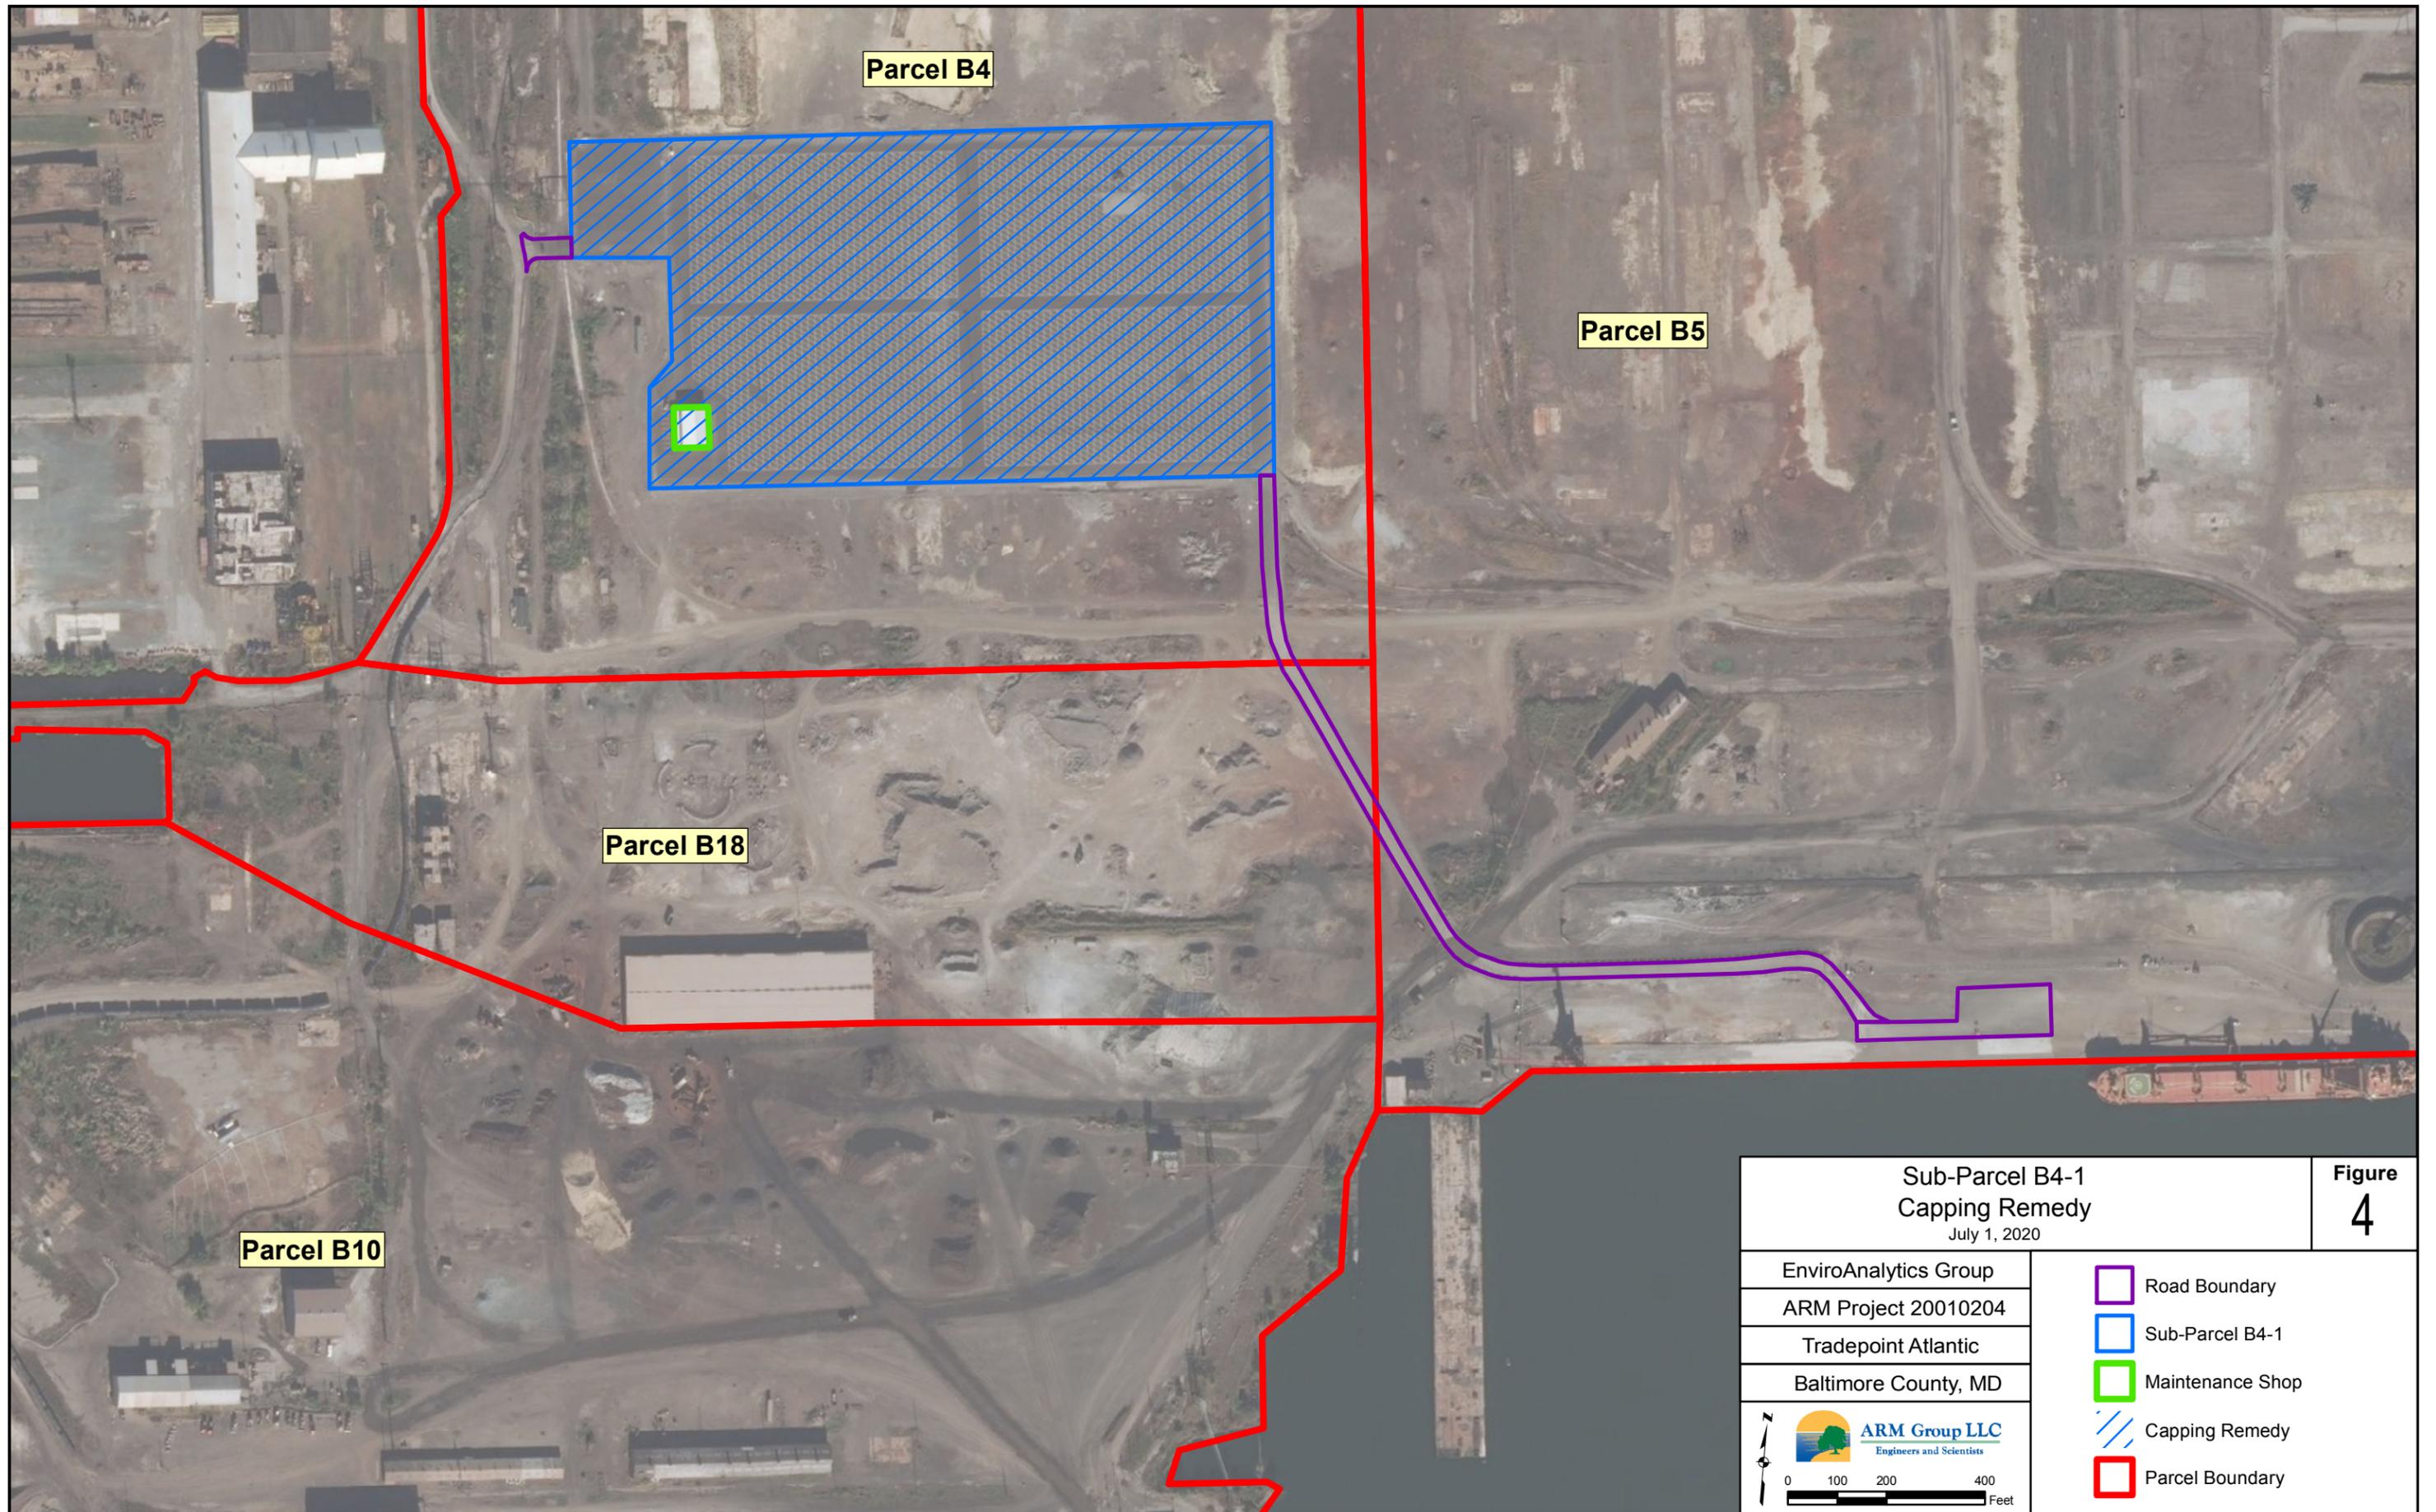
Sub-Parcel B4-1 Capping Remedy July 1, 2020		Figure 4
EnviroAnalytics Group		
ARM Project 20010204		
Tradepoint Atlantic		
Baltimore County, MD		
ARM Group LLC Engineers and Scientists

Maintenance requirements will include maintenance of the capped areas shown on **Figure 4** to minimize degradation of the cap which could lead to exposures to the underlying soil. Because processed slag was used as subbase across the entire Site, the full Sub-Parcel B4-1 development area, including the access road and Fender area, will be subject to inspection and maintenance requirements.

The responsible party will perform cap maintenance inspections, perform maintenance of the cap, and retain cap inspection records. Areas of the cap in Sub-Parcel B4-1 that have degraded to a Pavement Condition Index (PCI) of 4.0 will be repaired within 30 days of discovery. The MDE shall be notified within 10 business days of any repairs that are the result of a PCI of 4.0 or greater. The notification will include documentation of the conditions being repaired and the location of the repair.

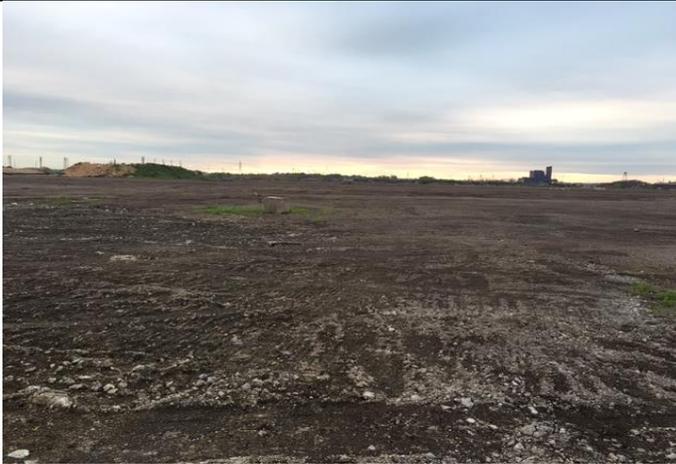
Figure 1: site conditions week of 5/16.

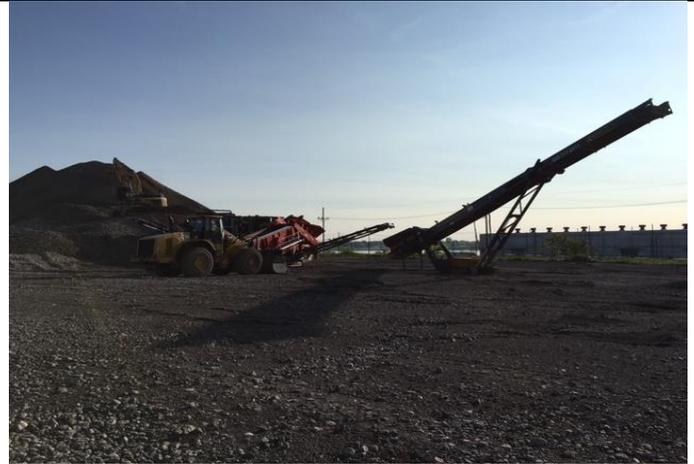
Figure 2: Crushing operation staging at Pile "H".

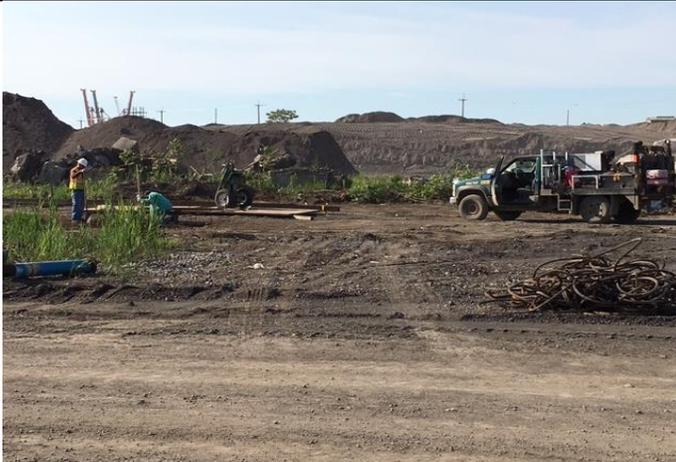
Figure 3: Mobilizing the crushing operation.

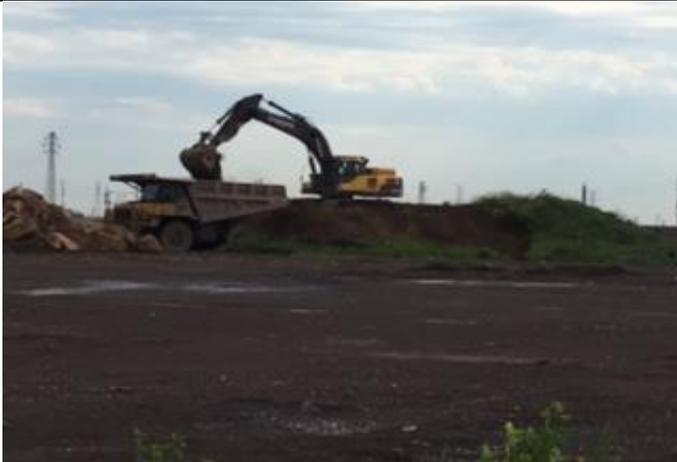
Figure 1: MCM moving dirt pile off of the RORO parking lot limit of disturbance.

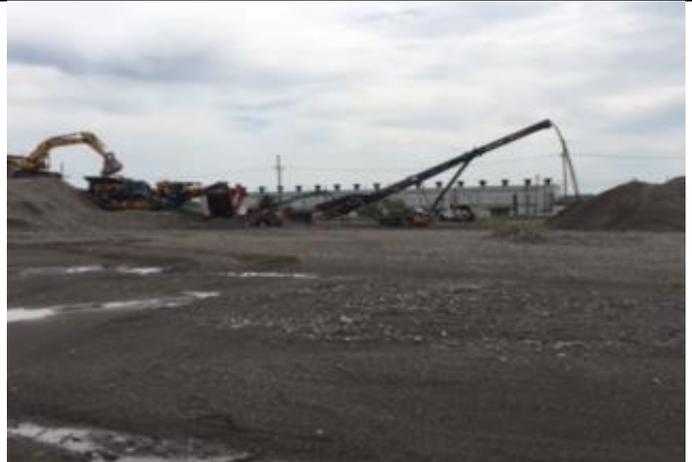
Figure 2: Crushing operation at Pile "H".

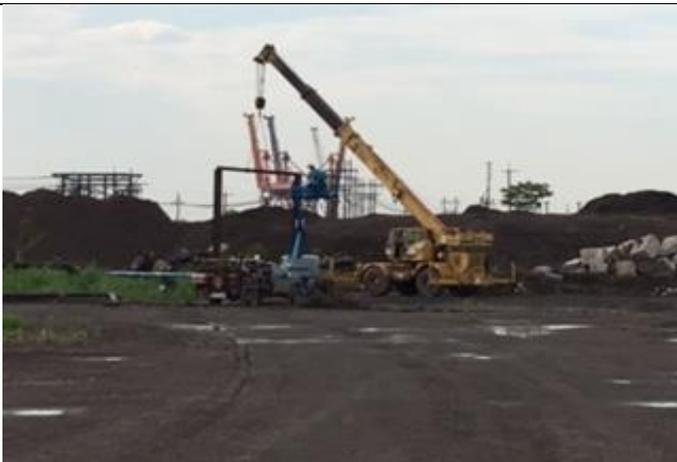
Figure 3: TPA installing water truck access pipe.

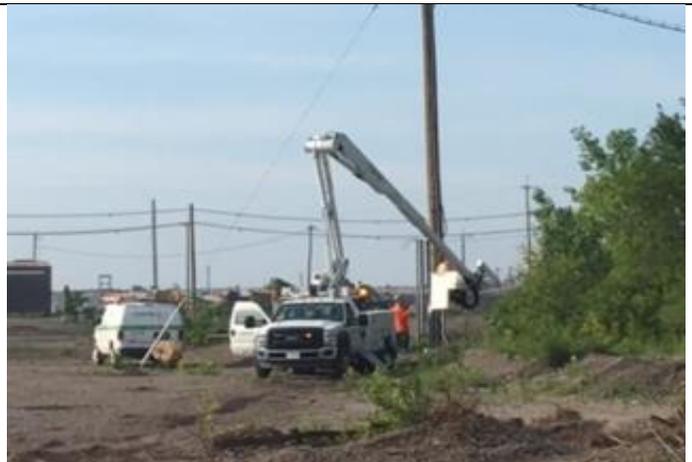
Figure 4: Installing temporary power for the trailer.

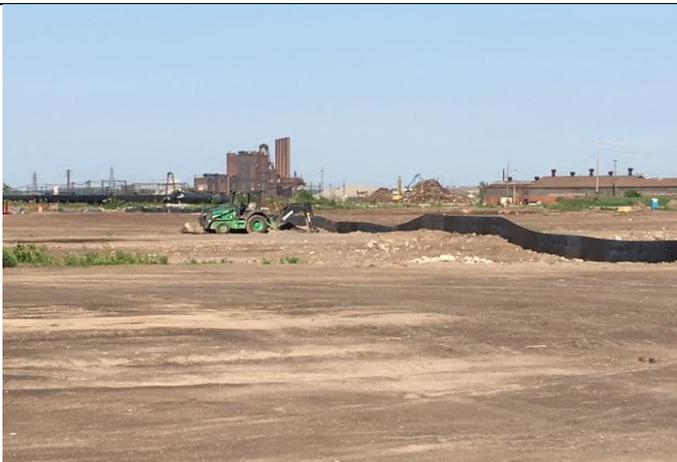
Figure 5: Silt fence installations began this week.

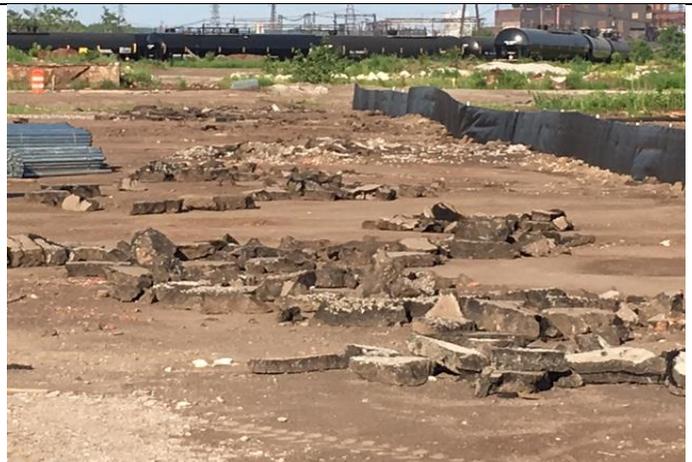
Figure 6: Silt fence progress.

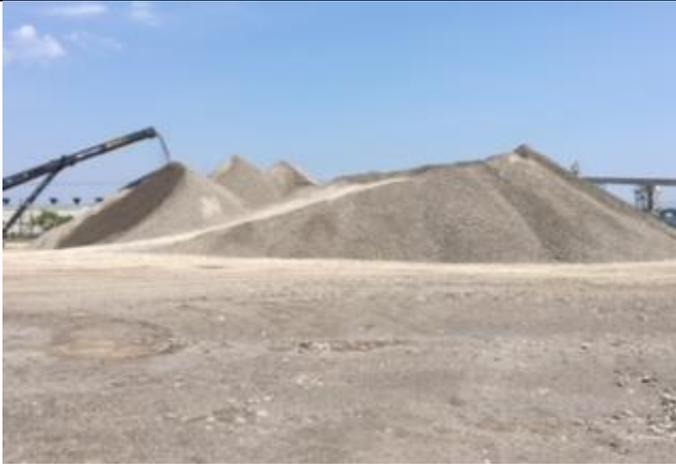
Figure 1: Processing slag at pile H

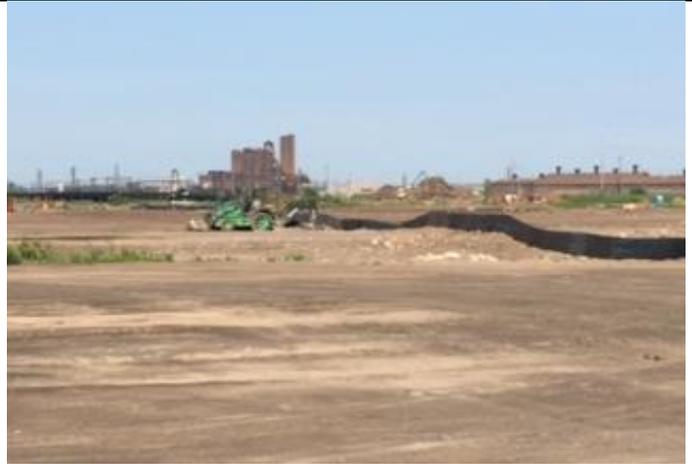
Figure 2: Silt Fence installation progress along the south side of the site.

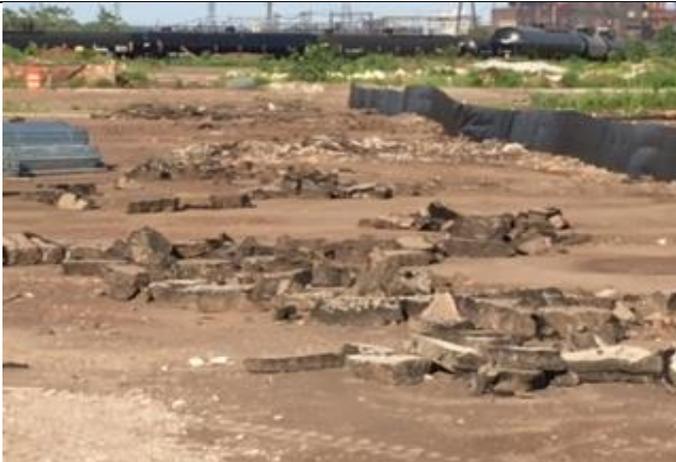
Figure 3: Silt Fence installation (and demolition) progress.

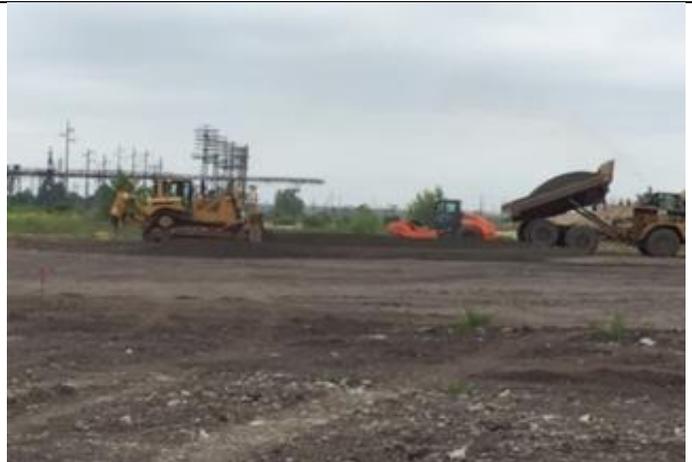
Figure 4: G&S placing slag for fills.

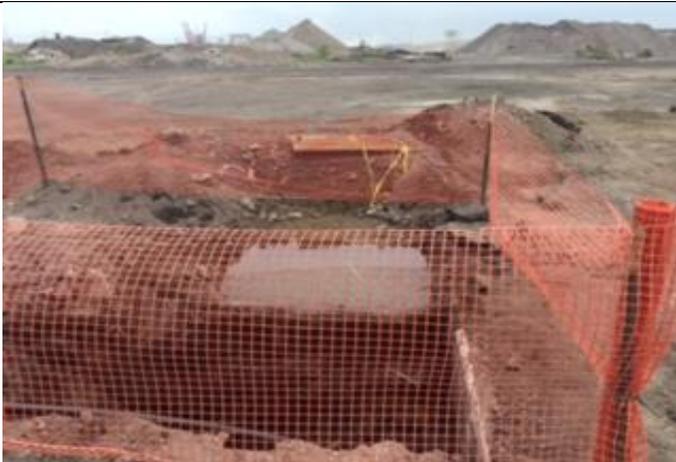
Figure 5: Main valve tie in for domestic water installation.

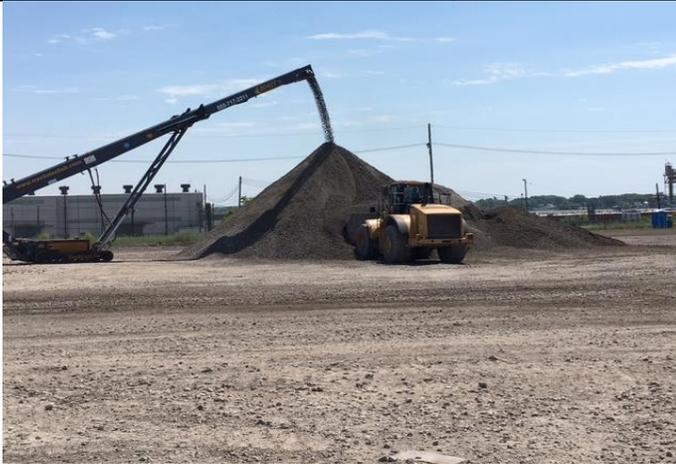
Figure 1: Processing slag at pile H

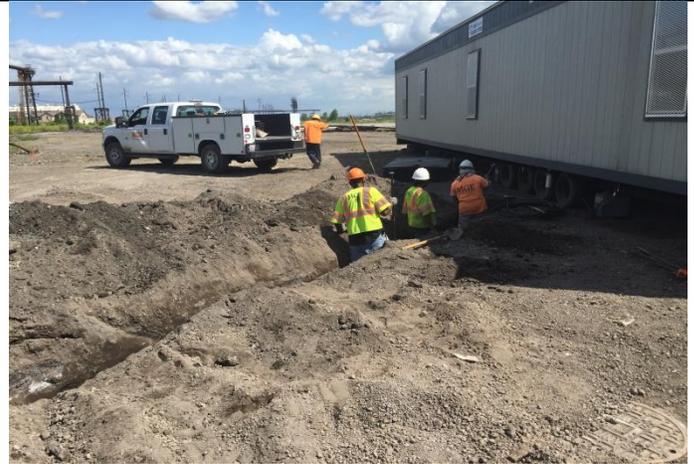
Figure 2: Installing the plumbing line to the trailer.

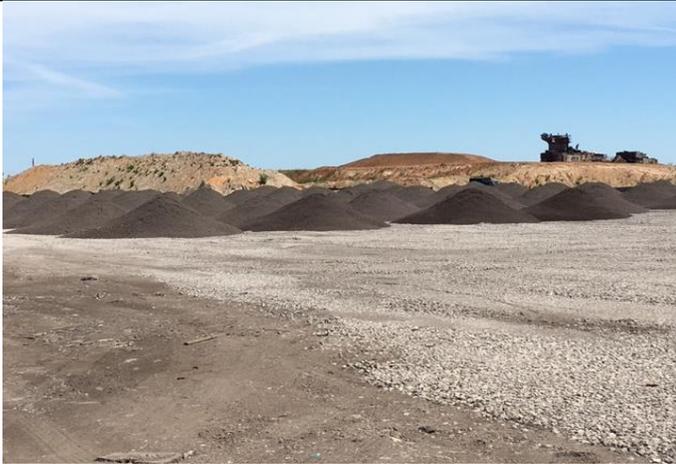
Figure 3: Steel slag staged on the RORO site.

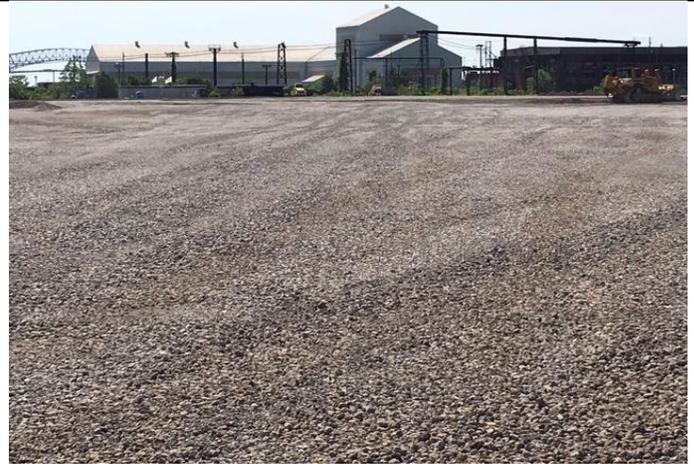
Figure 4: Slag installation progress facing W.

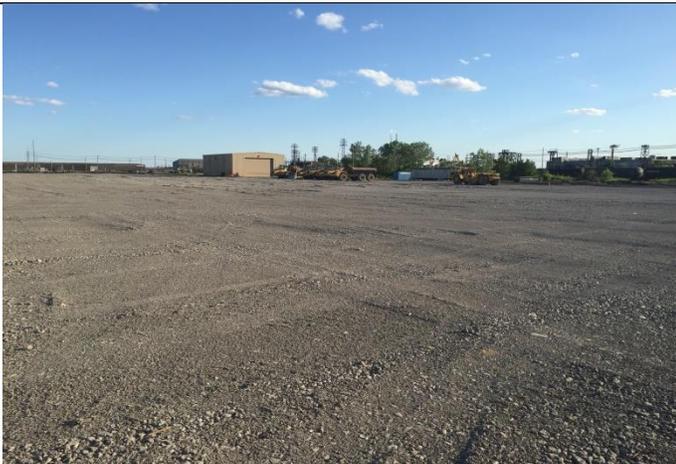
Figure 5: Slag installation progress facing S towards the Phoenix Building.

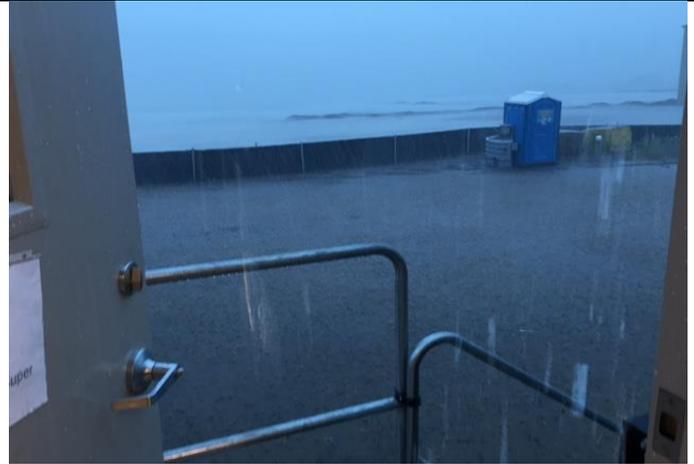
Figure 2: Rainfall on Tuesday June 21, 2016 accumulating approximately 1½”.

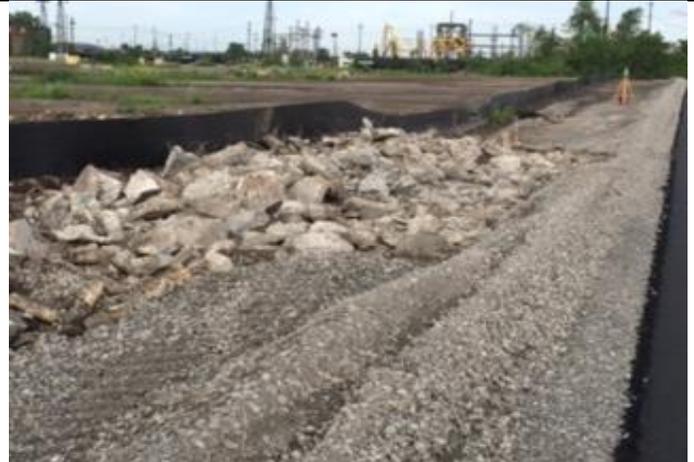
Figure 2: Demolished concrete (unforeseen) in the swale. Concrete removed for storm structure installation.

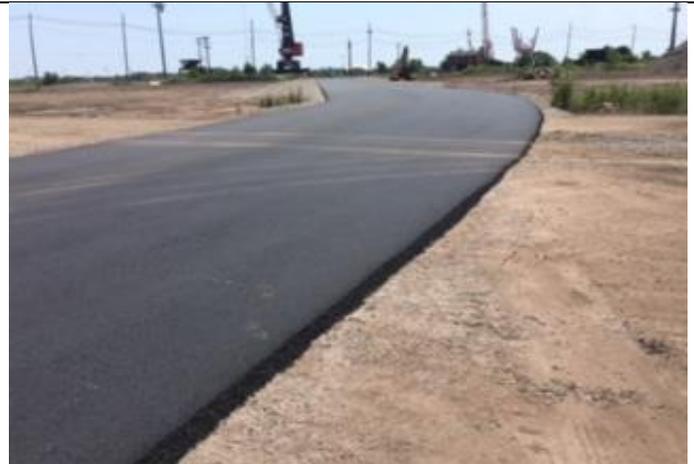
Figure 4: Asphalt paving along the northern half of the stern road. Awaiting final design to complete tie-in.

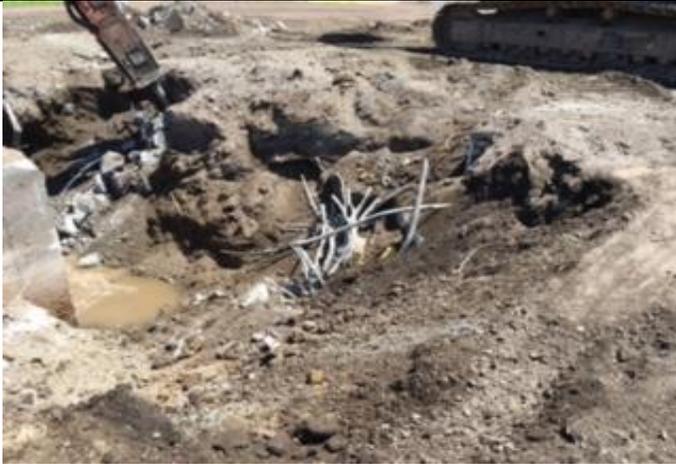
Figure 1: Unforeseen concrete and rebar during excavation.

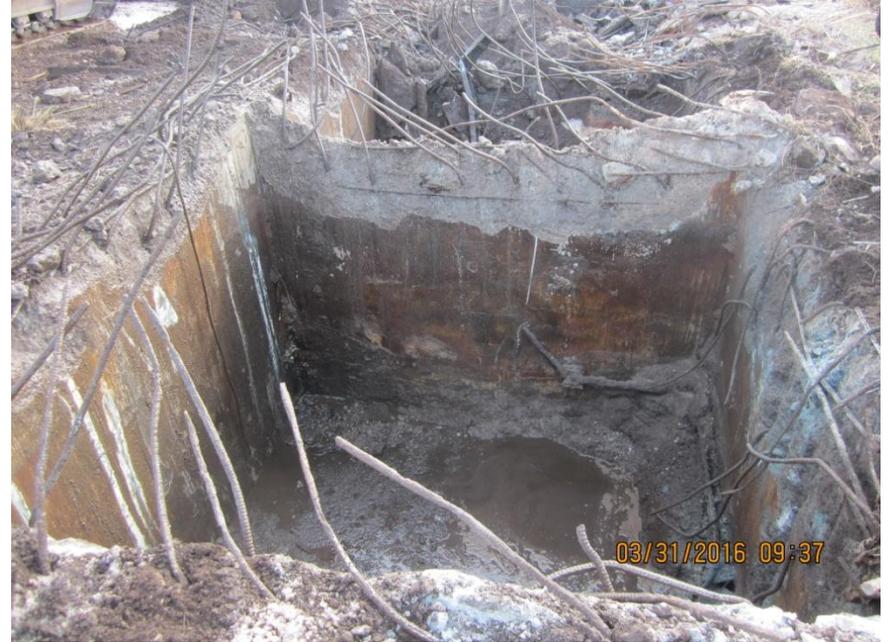
SGS 61 Minimal GW Infiltration
